## STAFF REPORT

COMMUNITY PLANNING AND PRESERVATION COMMISSION  
REQUEST FOR LISTING IN THE ST. PETERSBURG REGISTER OF HISTORIC PLACES

| Landmark Name: | <b>Standard Oil Service Station</b> |
| Street Address: | 2439 4 <sup>th</sup> Street South |

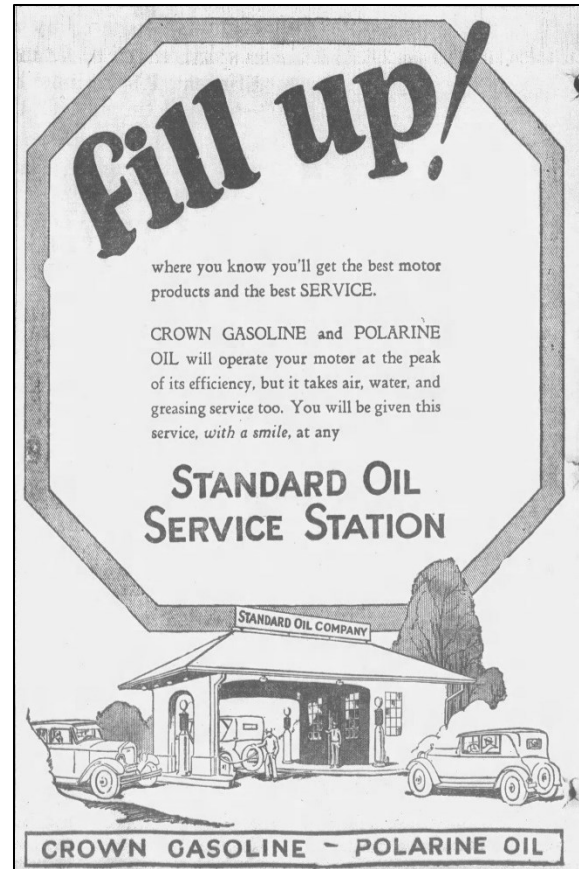
**Figure 3: Advertisement for Standard Oil Service Station with a full depiction of the standardized design. *St. Petersburg Times*, June 23, 1926.**

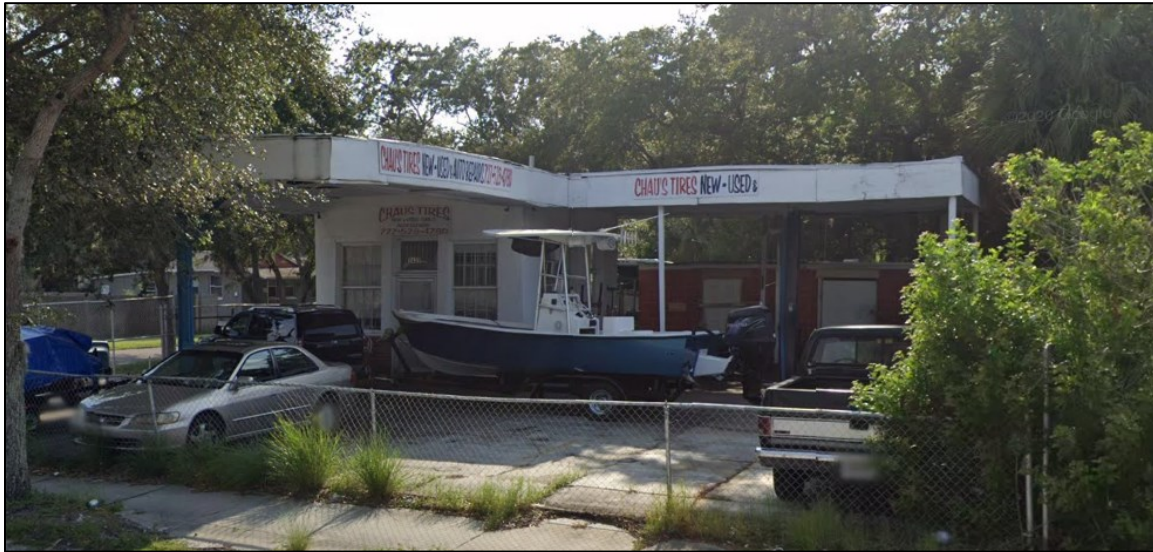
**Figure 4: Google Streetview capture of the building from 2019, prior to rehabilitation.**

The structure has undergone several alterations in its lifetime. In 1962, Standard Oil pulled a permit to remodel the roof and construct side roof addition. It appears that these new roofs were constructed in a flat-roof style, removing the key architectural feature of the hipped-roof canopy on the front. While the building still provide automotive-centered services for several more decades, operating as a gas

When the current owners purchased the property in 2019, the building had the later constructed flat roof canopy, and the side canopy extension. The building was in poor condition, suffered several decades of neglect, and had several active code cases on the property. Given the condition, the owner demolished the additions to the structure and the flat roof canopy. The applicant used the examples in Plant City, Florida and Bowling Green, Kentucky on the way to reconstruct the hipped roof, which is a key architectural feature for the building. The owner states that the original windows were in such poor condition, that they needed to be replaced. Even though, it's another loss of original materials, the replacement does retain the eight-over-eight sash windows, which are also a key feature to the building. The owner also restored the original brick water table, which had deteriorated as well.

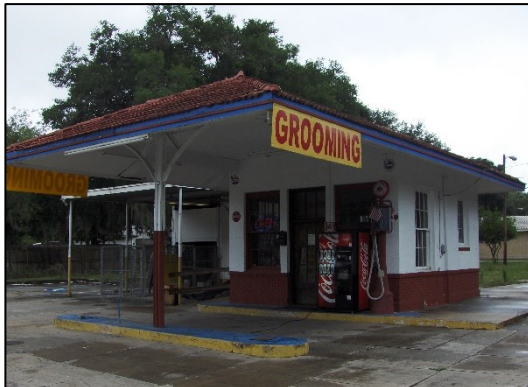
**Figure 5: Standard Oil Service Station in Plant City, Florida. Photograph from University of North Florida.**

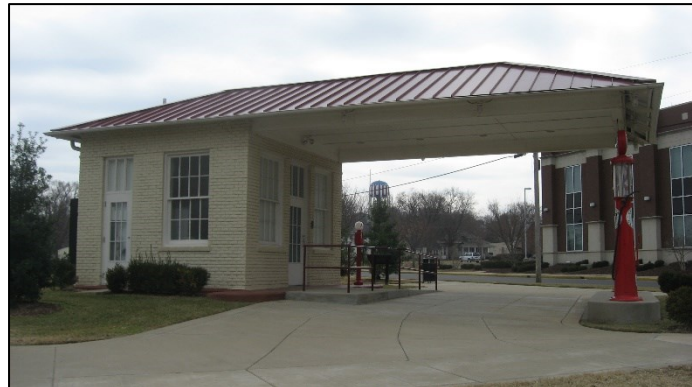
**Figure 6: Standard Oil Company Filling Station in Bowling Green, Kentucky. Photograph from Wikipedia.**

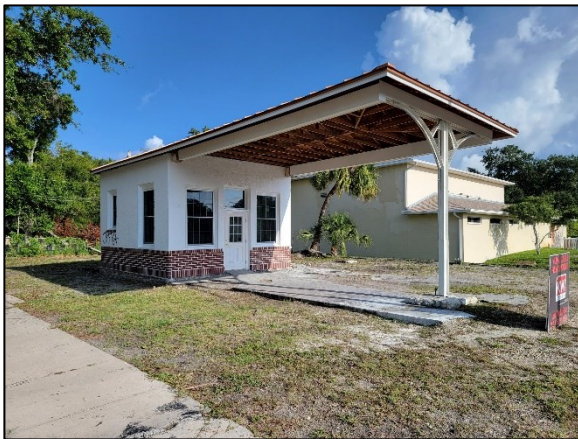
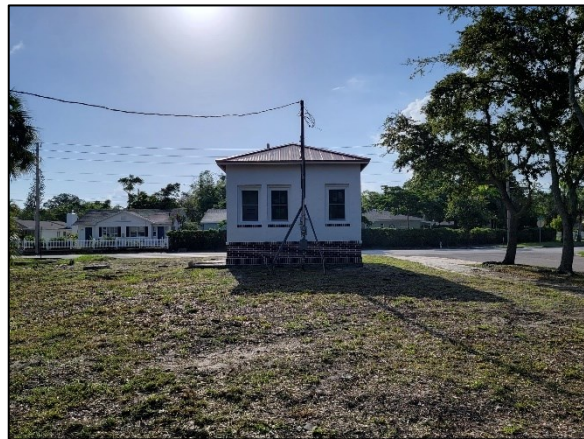
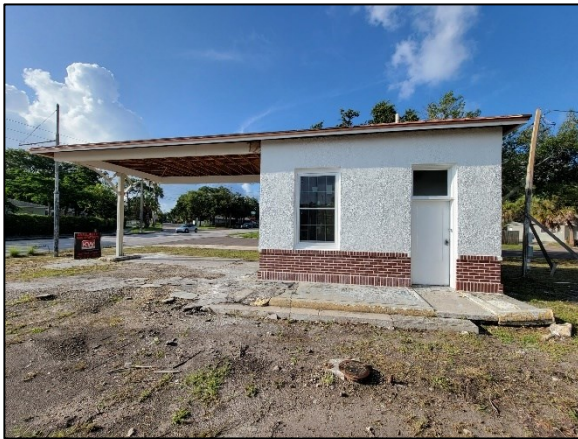
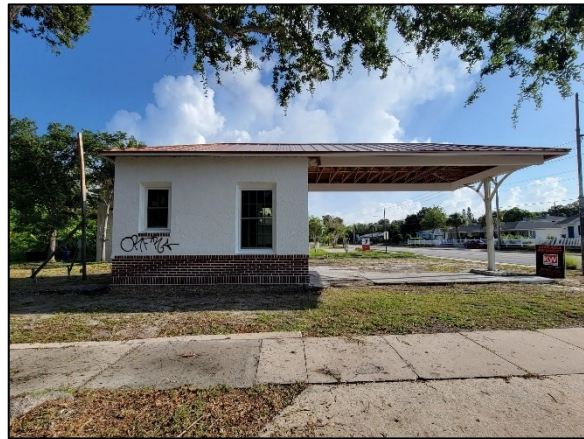
- One-story, small rectangular box with symmetrical façade,
- Front canopy with hipped roof,
- Stucco and brick finish
- Large eight-over-eight sash windows,
- Large transom window over central front door,
- Deep overhanging eaves,
- Y-shaped metal truss supporting the front canopy, and
- Brick water table around exterior stucco cladding.

During renovation, extensive work was done to restore the building to its historic appearance while regaining structural integrity. The original hip roof system and ceramic tile roof had long been removed and was replaced with a non-code flat roof that had collapsed. The Applicant replicated the original joist pitch and topped it with a standing seam aluminum roof with a copper colored finish.

The building also had extensive termite damage and was tented. Original windows were missing and/or replaced with Plexiglas and plywood in many areas by prior owners. These windows were replaced with double hung impact windows with grills to match the original light panels. The two window transoms were repaired, with the original wooden frames sanded and restored.

When paint was stripped off the exterior brick, the Applicant discovered the brick was structural instead of stamped concrete. However, in multiple places, damaged brick had been patched in with stucco. The Applicant located original Plainville brick and had it shipped to St. Pete to repair and replace the stucco areas with period, salvaged materials. The brick was then professionally repointed for integrity. The original stucco was repaired, sealed, and retained, and has been repainted period-appropriate white.

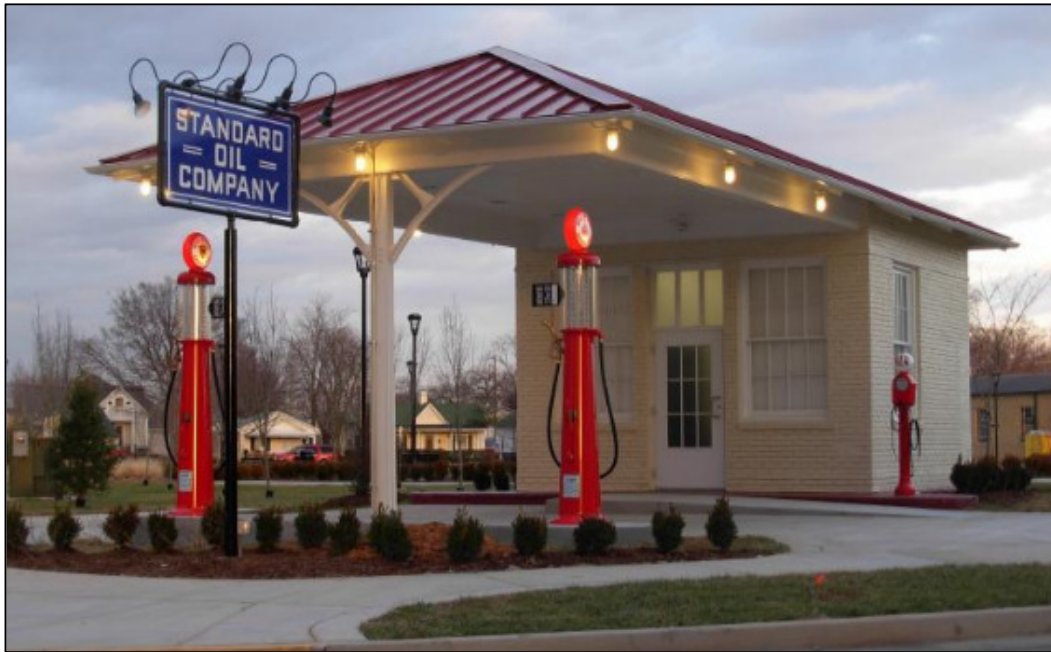
*Standard Oil Station in Bowling Green, Kentucky*

The former Standard Oil Service Station was constructed in 1926 and is masonry vernacular in style. The late date of construction is unique; there are two other surviving, almost identical Standard Oil Service Stations that are listed as National Register properties (Plant City, Florida and Bowling Green, Kentucky), though they were built 5 years earlier in 1921. The National Register of Historic Places Registration Form for the Standard Oil Service Station in Plant City is attached hereto as Attachment #1.

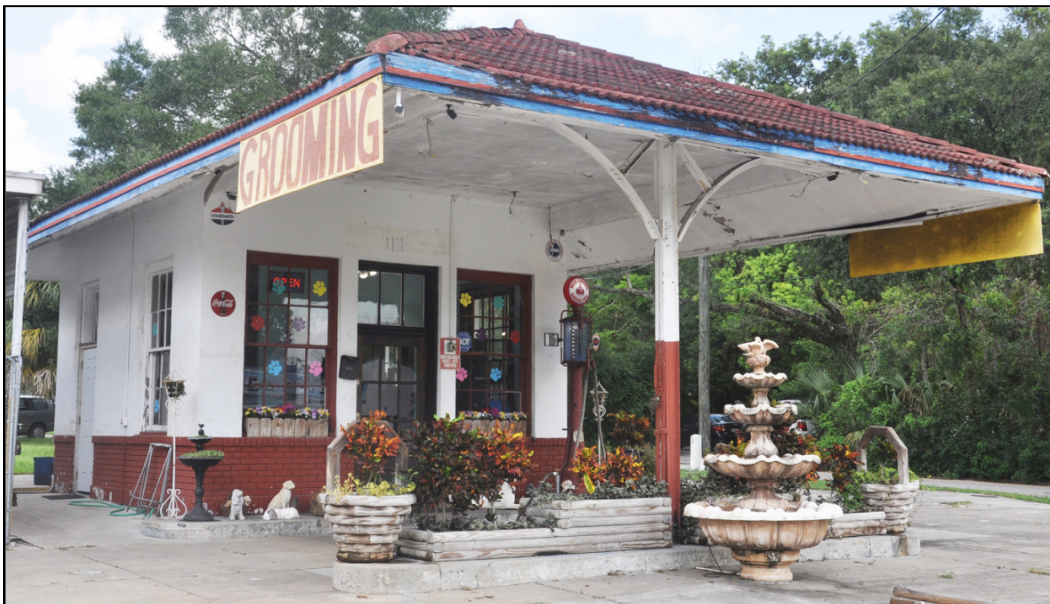
*Standard Oil Station in Plant City, Florida (now a dog grooming business)*
