# **Preliminary Engineering Report Water System Performance Improvements 1**

City of Truth or Consequences, New Mexico

Project No. 20-600-211-00

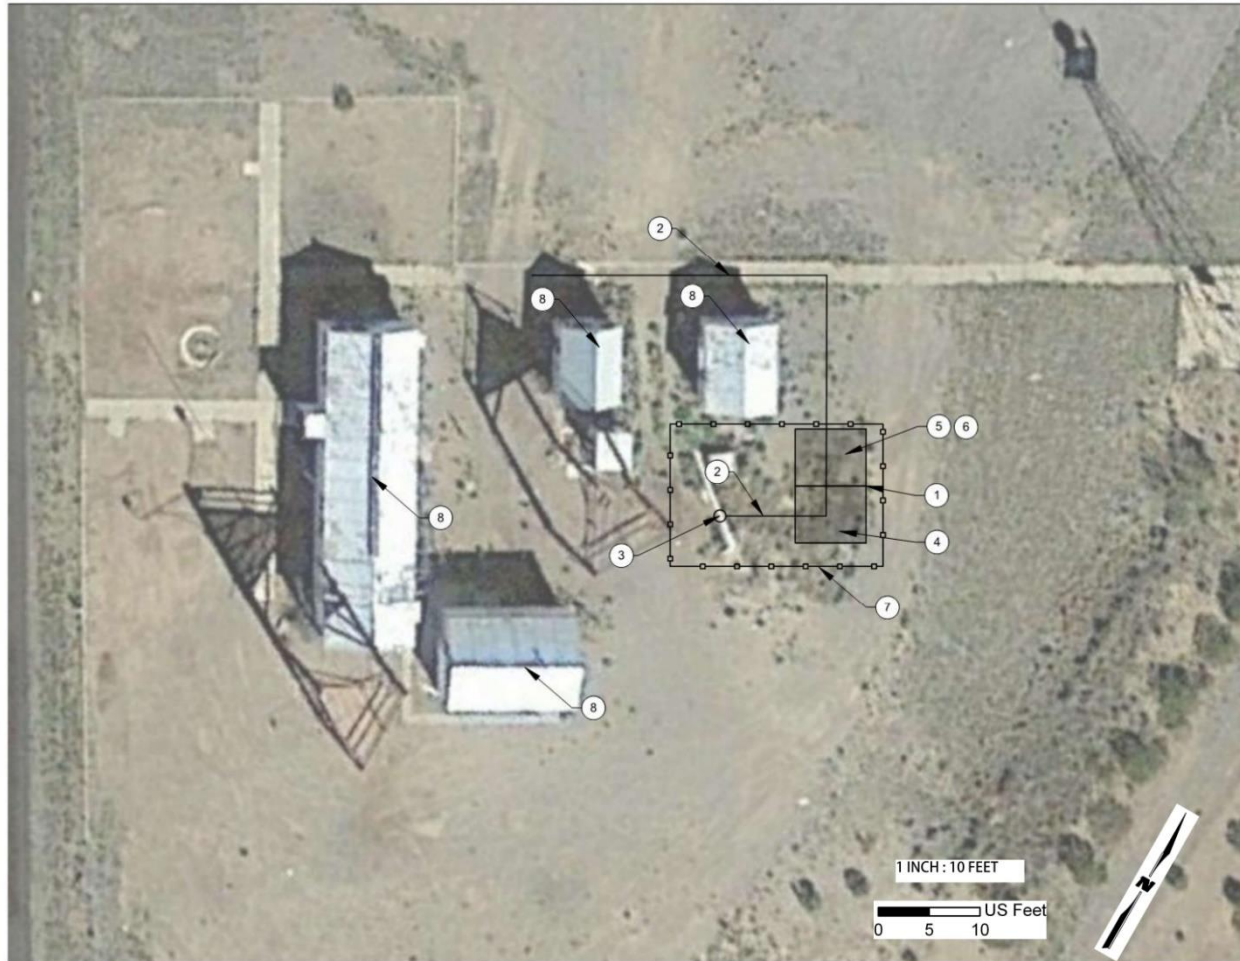
#### Legend

- 1. Two Room Storage Building  
12'x15'
- 2. Six6 Inch Waterline
- 3. Well Sanitary Seal Pitless  
Unit With 8 Inch Concrete Slab
- 4. Chlorination System
- 5. Panel Control
- 6. 2-200 Gallon Pressurized  
Tanks
- 7. 30'x45' chain-link fence
- 8. Existing Building

Alternative IX-Airport 1	
20 Yrs O&M PW	\$33,305
Construction Cost	\$342,862
Non-Construction Cost	\$90,328
Total	\$466,495

The annual 2020 Operation and maintenance is \$2,086. See the breakdown of Annual Operation and Maintenance cost is provided in **Appendix 5** and full construction and non-construction cost breakdown is in **Appendix 4**.

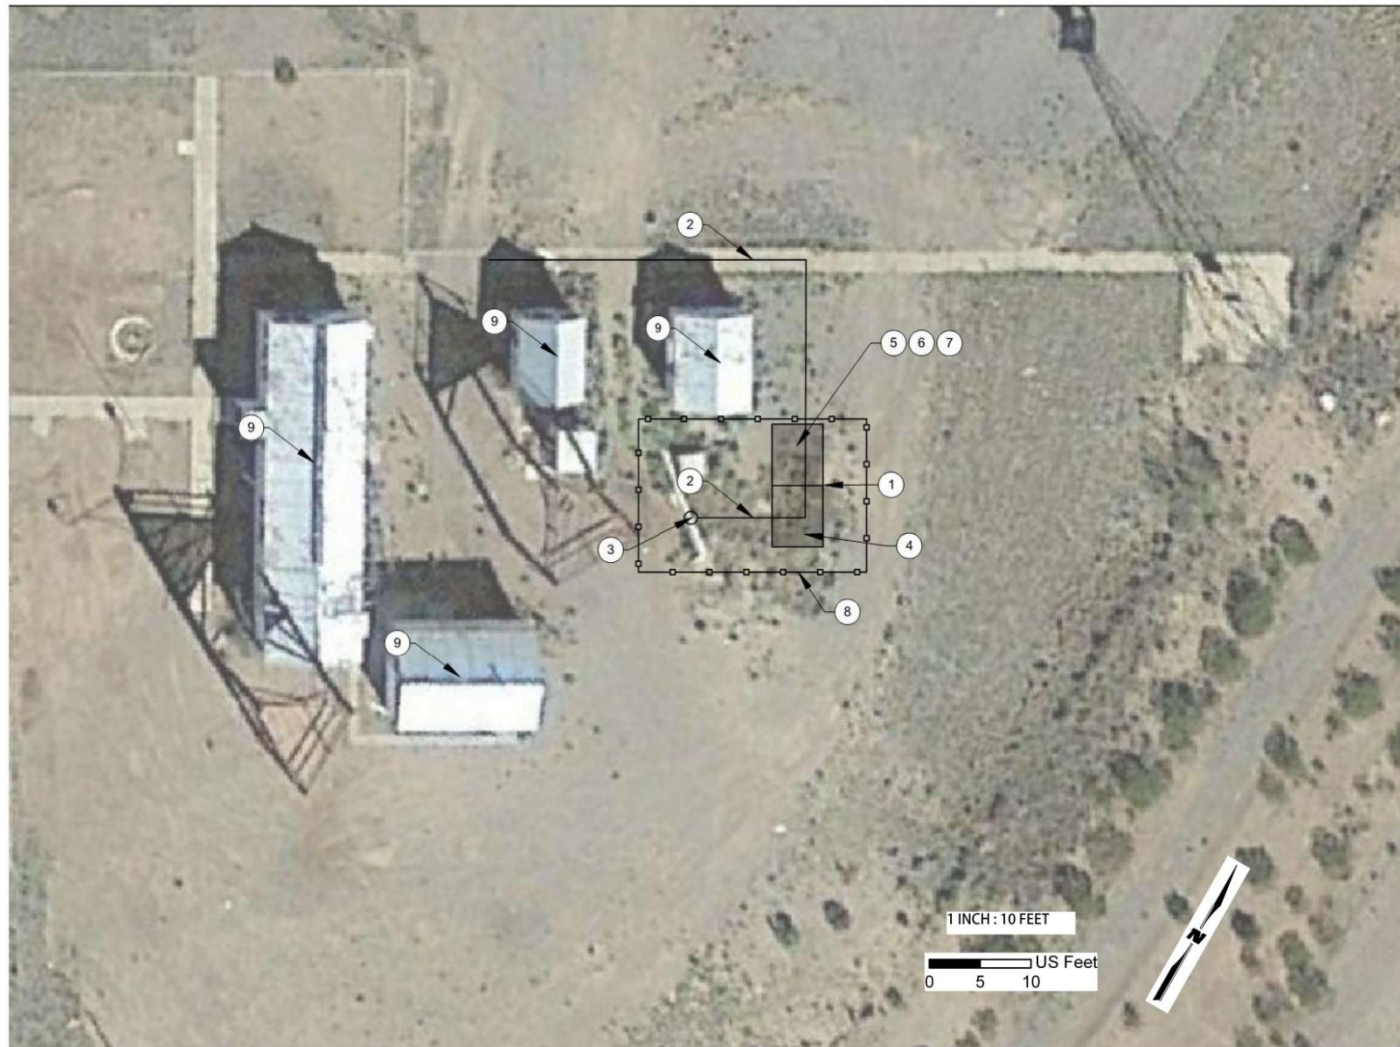
**Legend**

1. Two Room Storage Building 12'x10'
2. Six Inch Waterline
3. Well Sanitary Seal Pitless Unit With 8 Inch Concrete Slab
4. Chlorination System
5. Panel Control
6. 30 Gallon Pressurized Tanks
7. VFD - Variable Speed Booster Pack
8. 30'x45' chain-link fence
9. Existing Building

Alternative XII -Airport 4	
20 Yrs O&M PW	\$38,021
Construction Cost	\$393,623
Non-Construction Cost	\$98,618
Total	\$530,262

The annual 2020 Operation and maintenance is \$2,382. See the breakdown of Annual Operation and Maintenance cost is provided in **Appendix 5** and full construction and non-construction cost breakdown is in **Appendix 4**.
