# FISHERIES & AQUATIC HABITAT RESTORATION FEASIBILITY STUDY

## ROYAL RIVER RESTORATION PROJECT YARMOUTH, MAINE

**Stantec Consulting Services Inc.**  
30 Park Drive  
Topsham, Maine 04086

November 2010

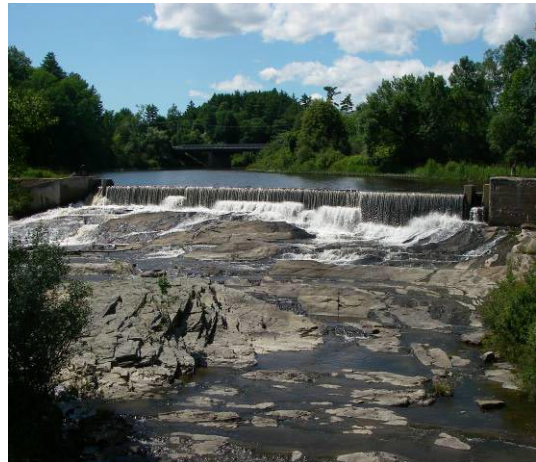
*Bridge Street Dam as viewed from north side of the  
Bridge Street bridge*

The Bridge Street Dam is located approximately one-quarter mile upstream from the head-of-tide at a site known as the Second Falls of the Royal River in Yarmouth. The dam is a reinforced concrete, gravity-type, run-of-river structure spanning the river approximately 250 feet northeast of Bridge Street. The dam, which is founded on visible bedrock, measures approximately 275 feet in length and has a 10-foot structural height. It has a sloped upstream face and a vertical downstream face. The dam's spillway is located near the center of the dam and is approximately 75 feet long. Low-flow sluiceways are cast into the concrete at either end of the spillway and controlled by removable weir planks. A concrete Denil-type fishpass is situated at the southwest end of the spillway. Water flow into the fishpass is controlled by a vertical lift gate mounted on a steel I-beam frame; however, the gate was severely damaged in the spring floods of 2010 and is currently inoperable. An intake forebay constructed on a triangular plan measuring 40 by 60 feet is located on the northeast end of the dam. This substructure is surrounded by a chain link fence and is protected on its upstream side by a metal trash rack mounted on a rolled steel I-beam frame. The frame also supports a maintenance catwalk. A vertical lift gate is located on the downstream side of the forebay with a wood and timber frame and wood plank gate leaf. This gate is still operable and controls water into an approximately 200-foot-long welded steel penstock (a.k.a. flume) that supplies water to an operating micro-hydroelectric plant in the basement of what is now commonly referred to as the Sparhawk Mill. Due to additional topographic relief drop between the dam and the Sparhawk Mill tailrace, approximately 18-feet of head are assumed to feed the micro-hydroelectric plant. A granite retaining/training wall constructed of split-faced tabular block lines the river channel behind the penstock. Fish passage facilities were not part of the original dam configuration.

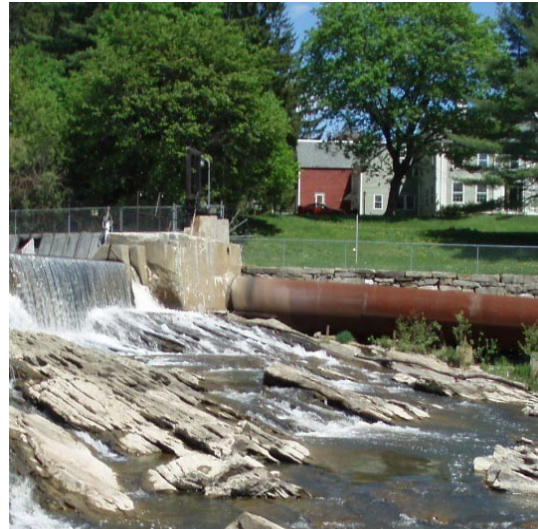
*Bridge Street Dam Head Gate Structure and Sparhawk Mill Penstock*

The use of the use of the penstock during periods of moderate to low flows (i.e., flows less than 100 cfs), such as those commonly encountered during the warmer months of the year, shifts water that would otherwise spill over the Bridge Street Dam to be largely diverted around the reach of river immediately downstream from the dam (utilizing a penstock diversion maximum diversion capacity of 90 cfs). Water remaining in the channel during such periods is largely passed through the fishway, with minor leakage occurring along the face of the dam. The impact of rapidly wetting and drying this reach of river has a detrimental effect on the fish community, as fish trapped in isolated pools as the water recedes face asphyxiation and/or predation as the isolated pools warm and shrink with evaporative water losses.
