# ROYAL RIVER YARMOUTH, MAINE AQUATIC ECOSYSTEM RESTORATION STUDY

CONTINUING AUTHORITIES PROGRAM  
SECTION 206

AUGUST 13, 2024

## SECTION 206 ROYAL RIVER FISH PASSAGE TSP HEC-RAS RESULTS SUMMARY

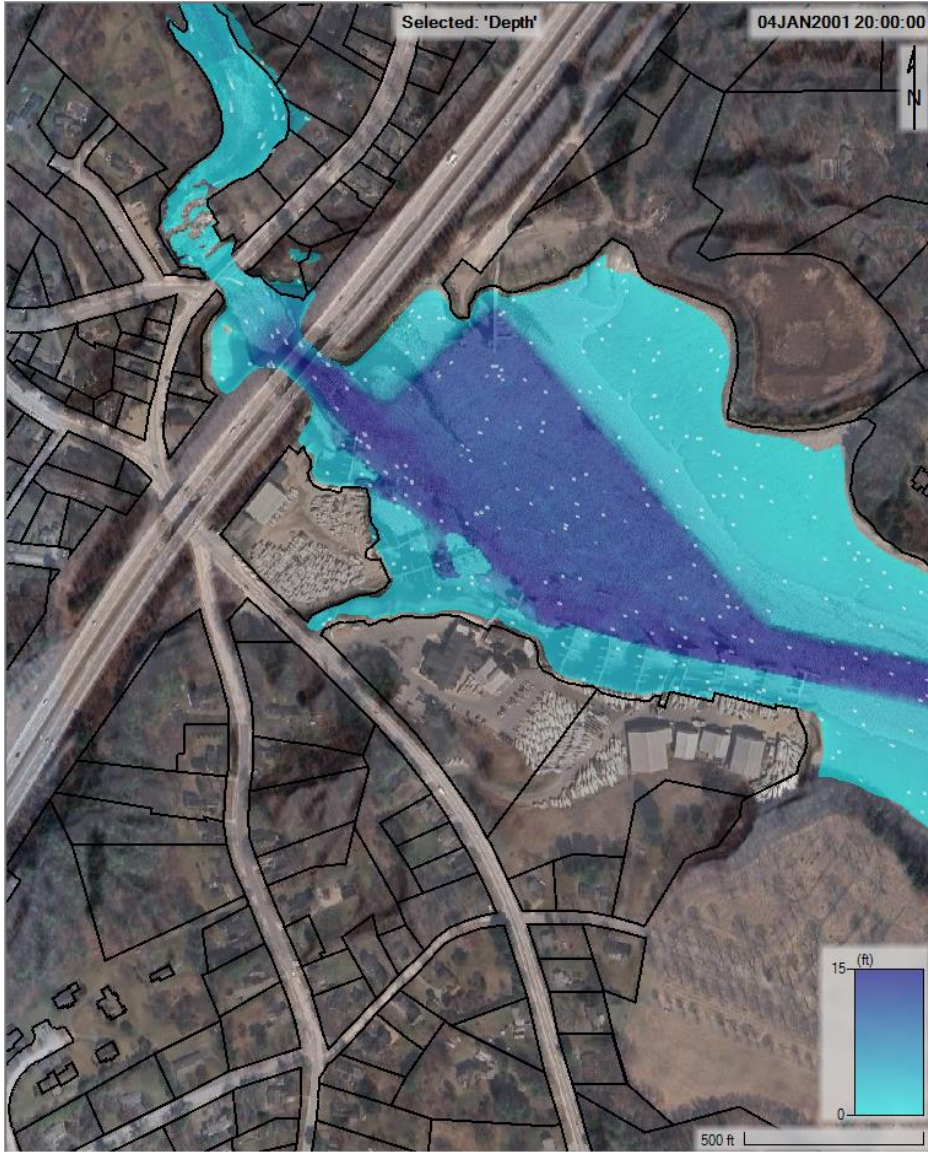
# DEPTH COMPARISON – ANNUAL MEDIAN AVERAGE DAILY FLOW

## HARBOR TO LOWER FALLS OVERVIEW

EXISTING CONDITIONS

TENTATIVELY SELECTED PLAN

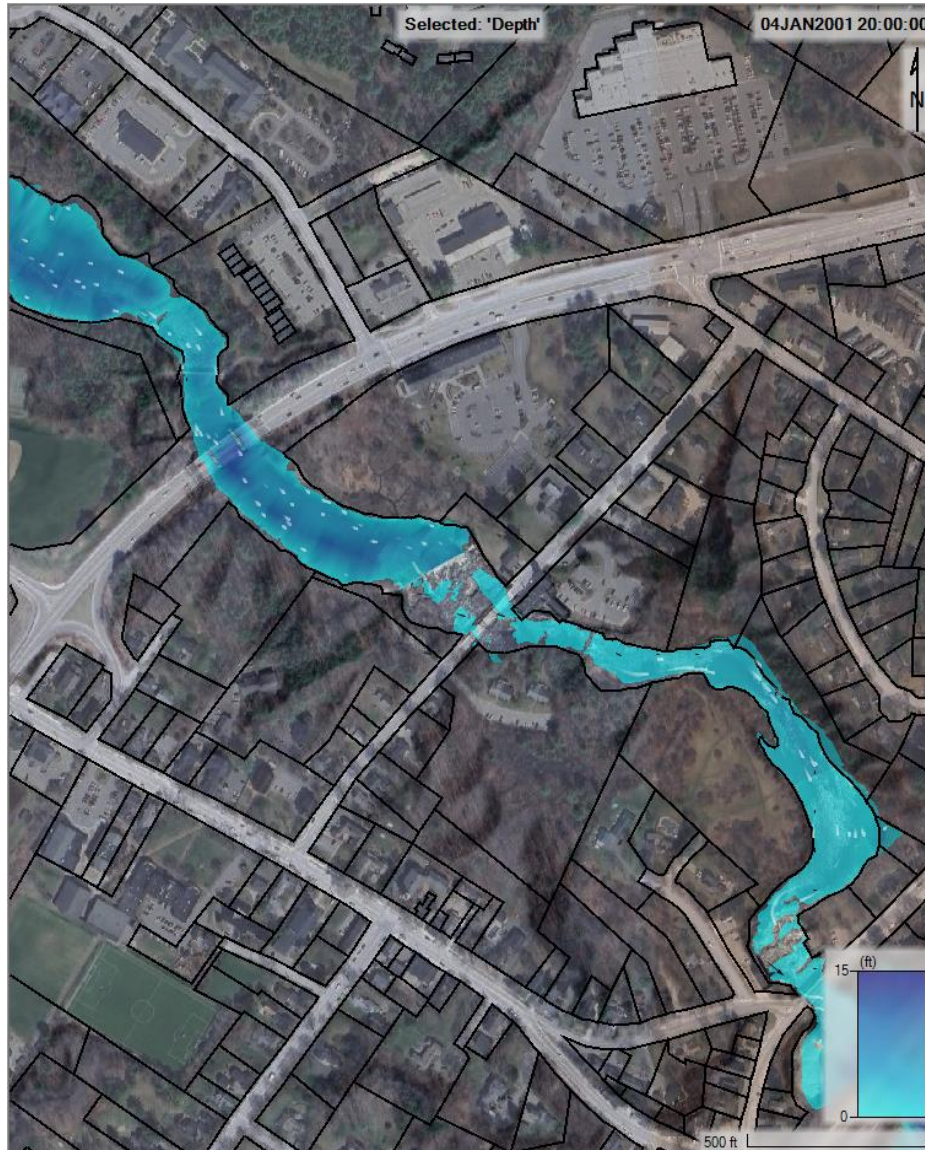
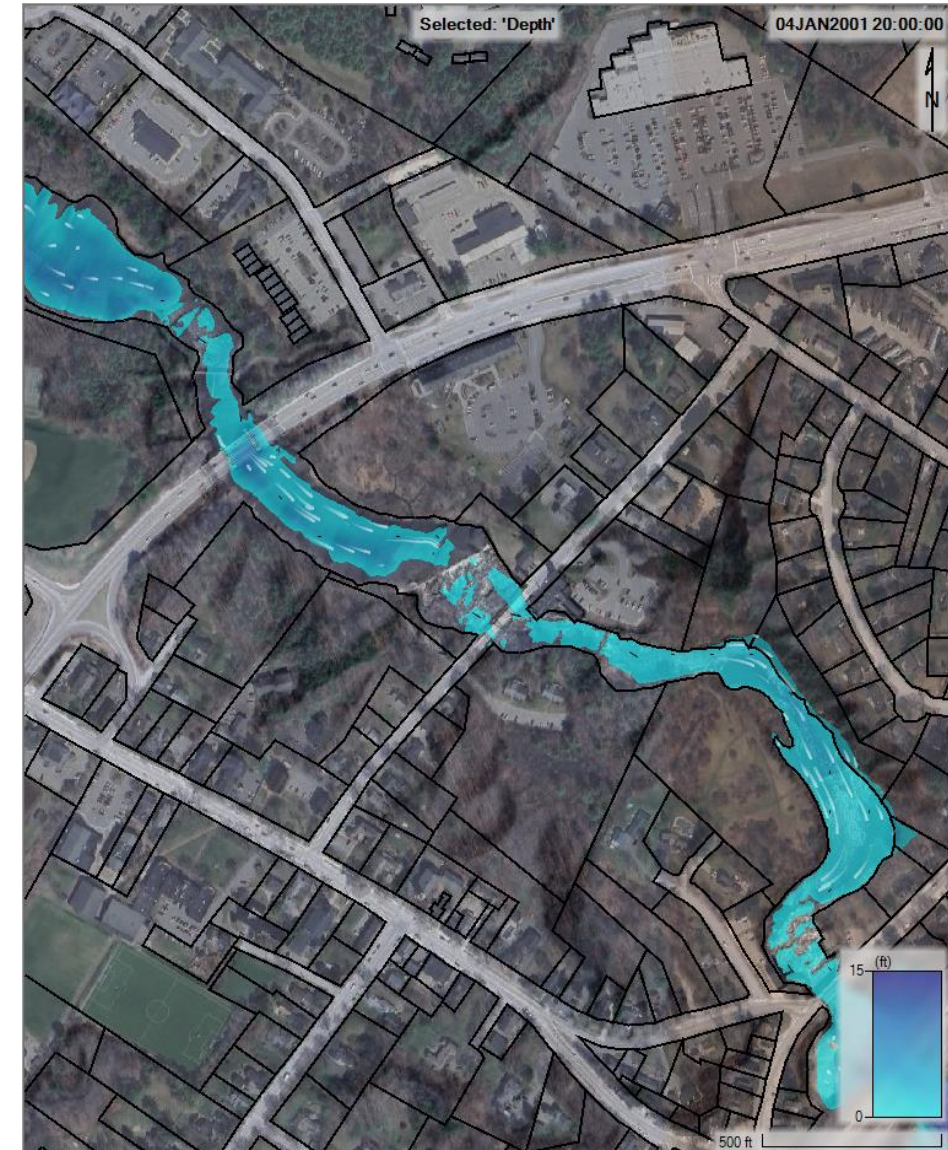
# DEPTH COMPARISON – ANNUAL MEDIAN AVERAGE DAILY FLOW

## LOWER FALLS TO MIDDLE FALLS OVERVIEW

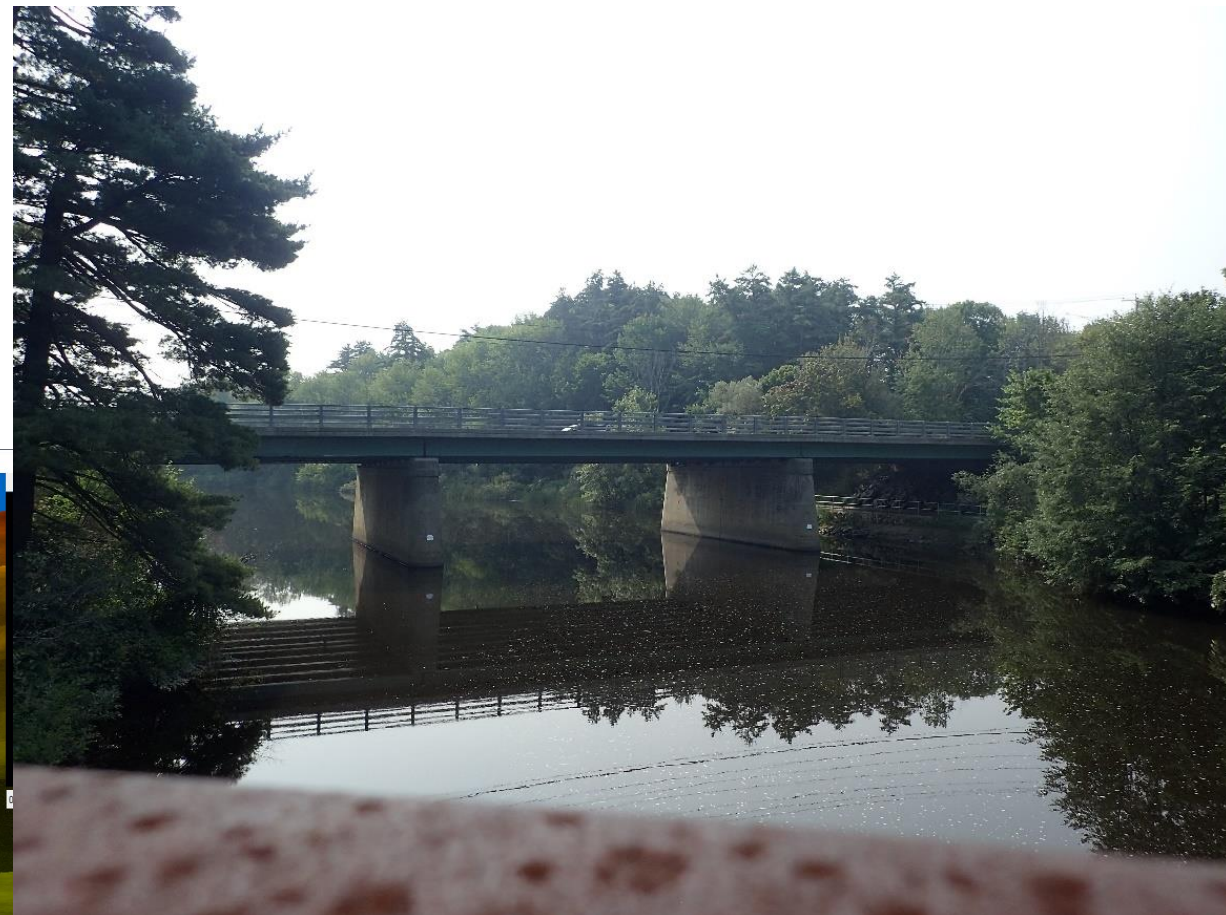
# ROYAL RIVER TSP - LOOKING DOWNSTREAM FROM BETH CONDON MEMORIAL PEDESTRIAN BRIDGE

APPROX.  
EXISTING WATER  
LEVEL

MODEL HEIGHTS EXAGGERATED X3

- New rock ledges exposed at two locations
  - Upstream of Beth Condon Memorial Pedestrian bridge
  - Upstream of Elm Street Bridge
- Elm Street Dam Impoundment Water levels approx. 4-ft lower; four locations could be less than 1.5-ft deep
- Gooch Island back channel
- During low flow periods, flow levels may be lower than depicted.

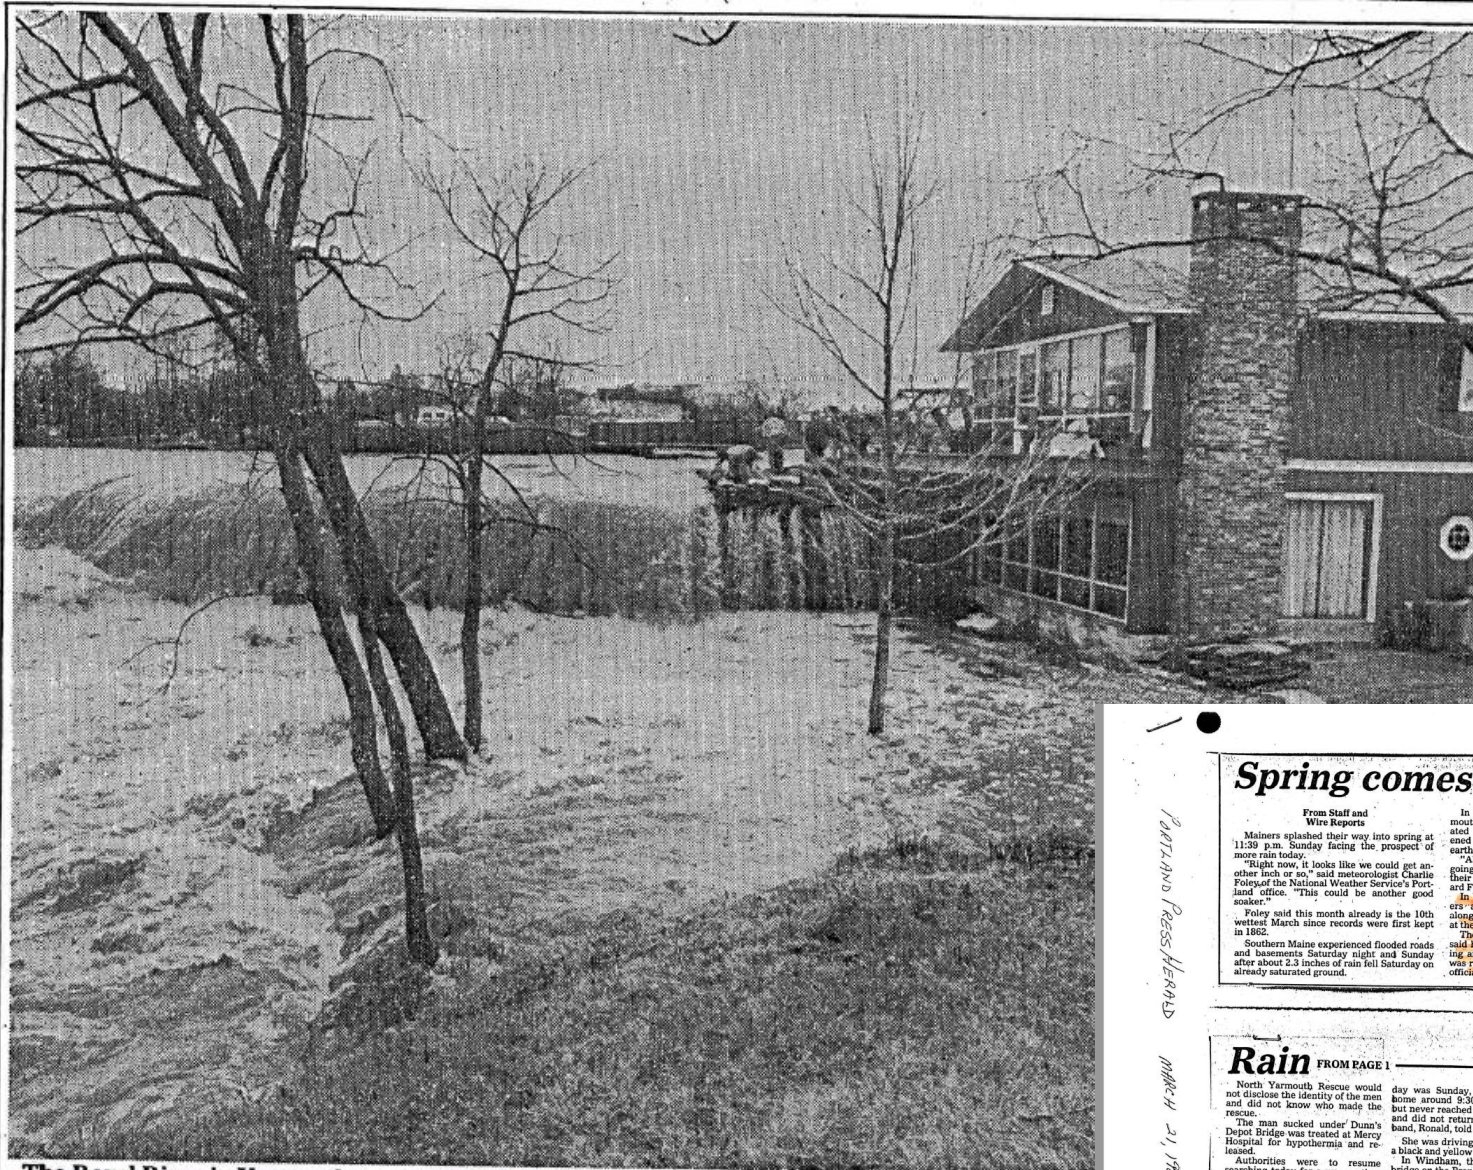
**The Royal River in Yarmouth overflows its banks Sunday, endangering the Thomas Trainor home.**

Thomas Trainor, occupant of the house, said he cannot remember the river overflowing after a single day's rainstorm. The river was running about 8 feet higher than normal, officials said.

Part of the Royal River Parkway, a walkway along the river, was lost to erosion.
