MEMORANDUM

Re: Transfer Station Safety Issues

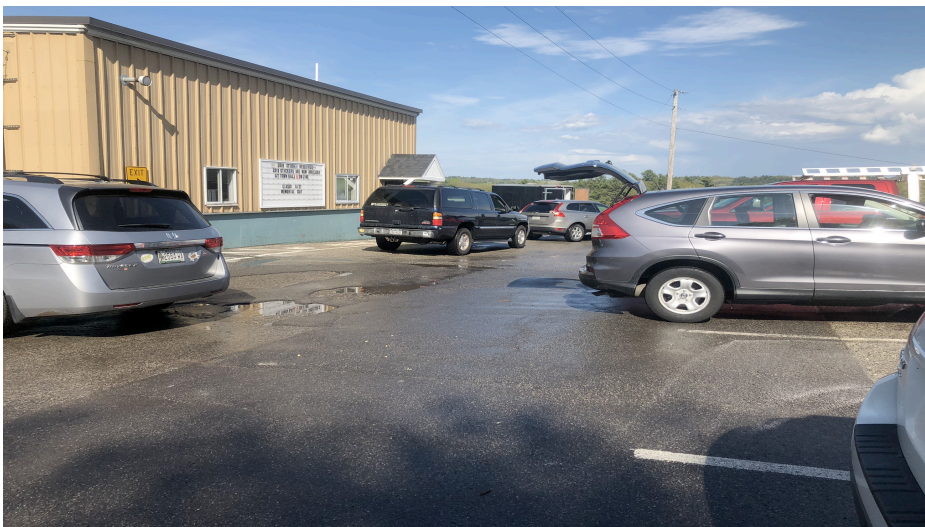
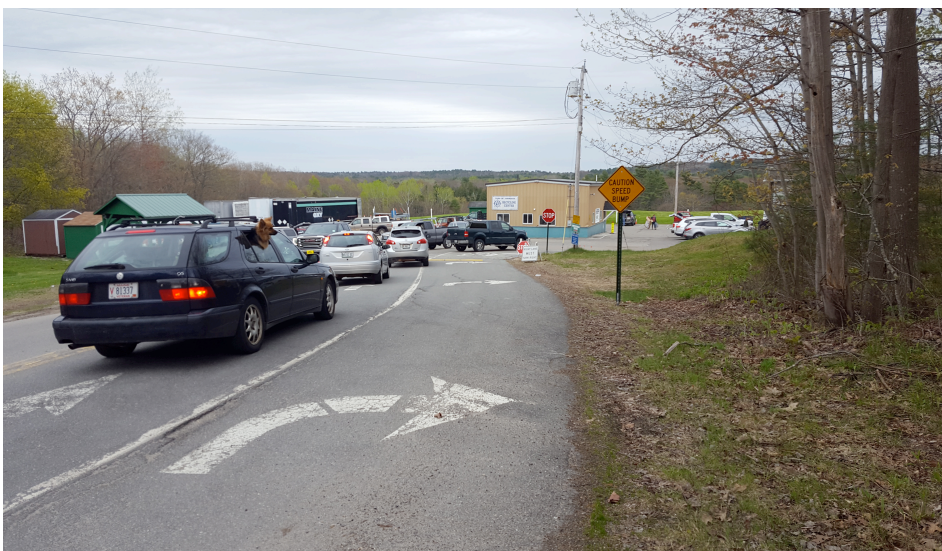
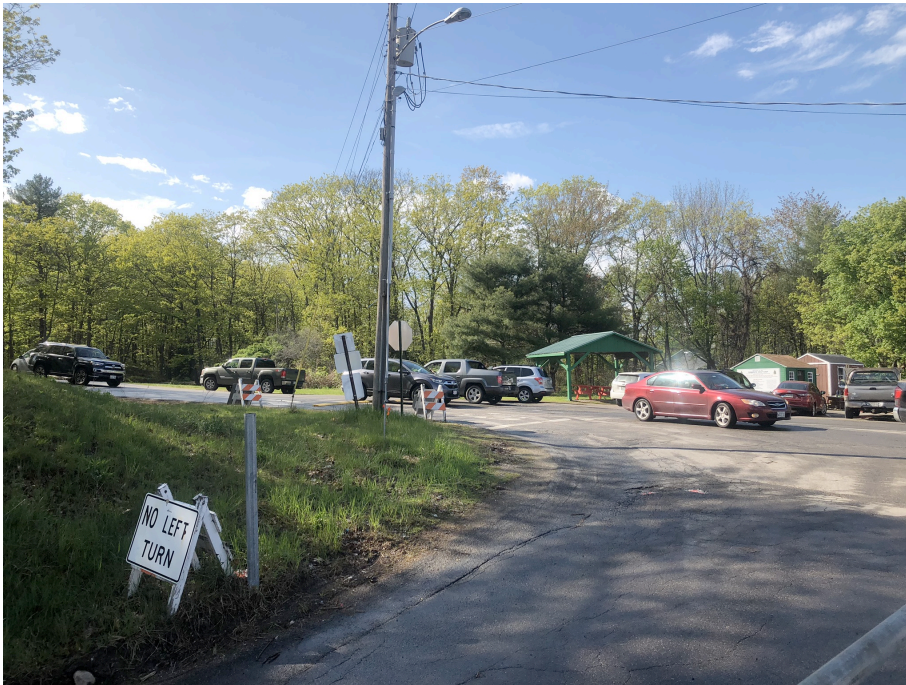
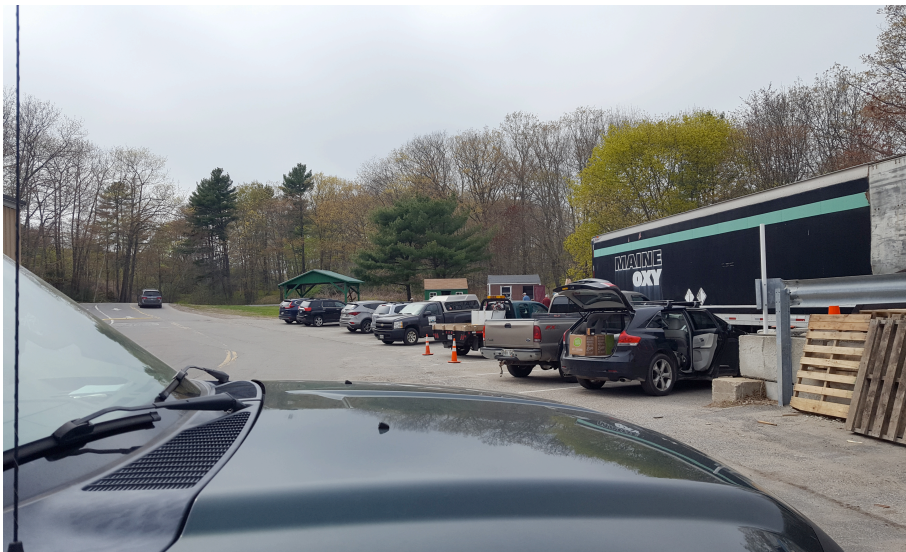
Pictures of Traffic Congestion

1. Vehicle Congestion around the compactor area further hindered by an array of different traffic movements and vehicle sizes.
2. The need for pedestrian movement amongst the congested areas.

“Overall, it was observed during the site visits that mixing of the vehicle and pedestrian at the compactor, recycling containers and the existing garage causes congestion, reducing efficient traffic flow and increases the risk of accidents”

3. Traffic patterns with-in the facility are not predictable and lead to confusion, congestion and safety issues. Width of bulky waste road not adequate for two-way traffic, striping is confusing, limited signage. (Some of the striping and signage issues have been addressed since the report).

Transfer station staff, recycling committee and I are very concerned about safety at this facility. We feel very strongly that any new program or facility design needs to address traffic flow, minimize turning / backing movements and pedestrian / vehicle interaction. It is our recommendation that facility and safety improvements be done as a complete package so that the PAYT / Recycling Program can function as intended and staff can safely and efficiently do their job.

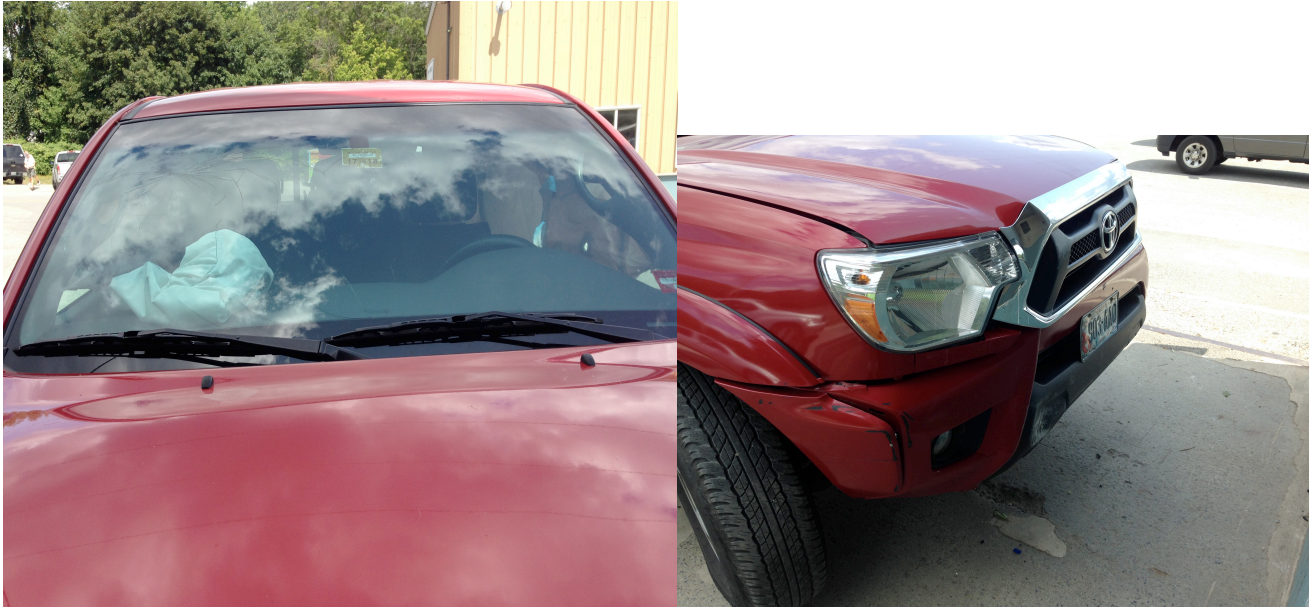
October 2018 –Vehicle hit the compactor wall. Town filed an insurance claim for \$3900.00 for damage done to the compactor wall. Driver accidentally hit the gas instead of the brake. We were very fortunate no one was walking in front of the hopper at that time. Air bag deployed, windshield was broken, driver's door was buckled.
