DIVER INVESTIGATION SURVEY OF POTENTIAL BURIED UTILITIES INTRACOASTAL WATERWAY, CUT PB-36 THROUGH CUT PB-41 PALM BEACH COUNTY, FLORIDA

TAYLOR ENGINEERING, INC.

DATE: FEBRUARY 15, 2018 COMMISSION NUMBER: 5303.16

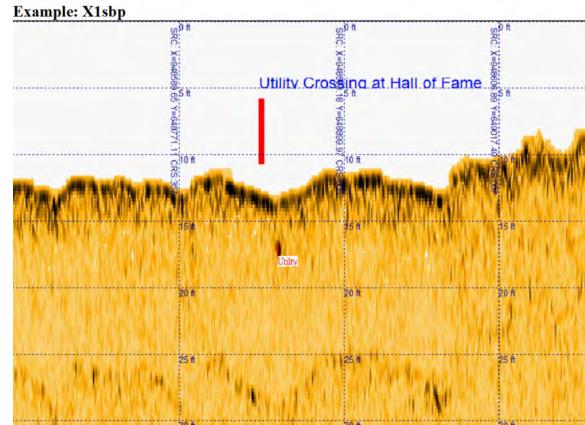
Utility located by SB-216s System in Florida Intracoastal Waterway

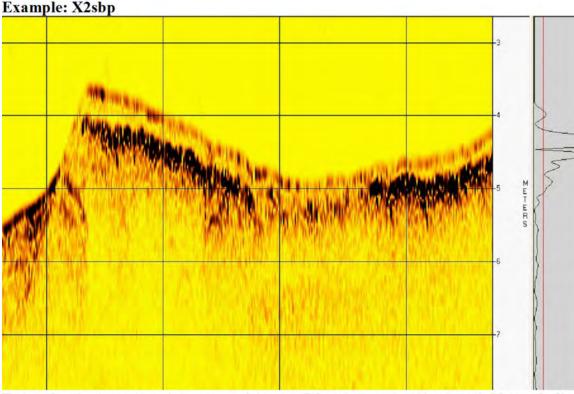
Example of apparent point source object at 5.3meters presenting partial hyperbolic pattern. Bottom is 4.4meters at that point thus object may be buried 0.9meters.

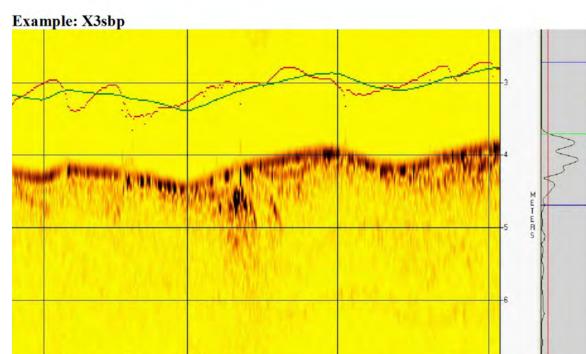
Example of possible backfill pattern.

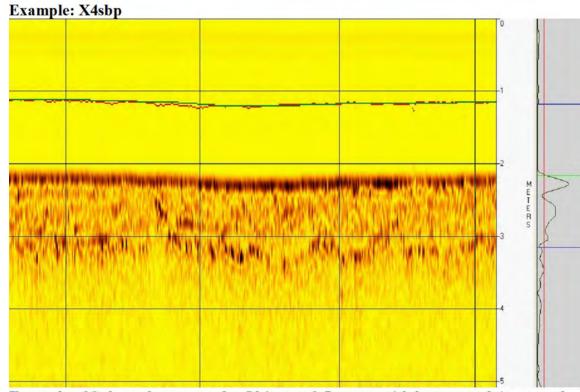
Example of Sub-surface anomaly. Object at 2.5meters with bottom at 2.1meters thus top of object may be buried 0.4meters. Note masking of sub-bottom reflector by
