Levee Inspection Report

Name of System: Bennington Flood Control Project

Name of Segment: Bennington, Roaring Branch Left Bank

Date(s) of Inspection: 06/06/2022 - 06/07/2022

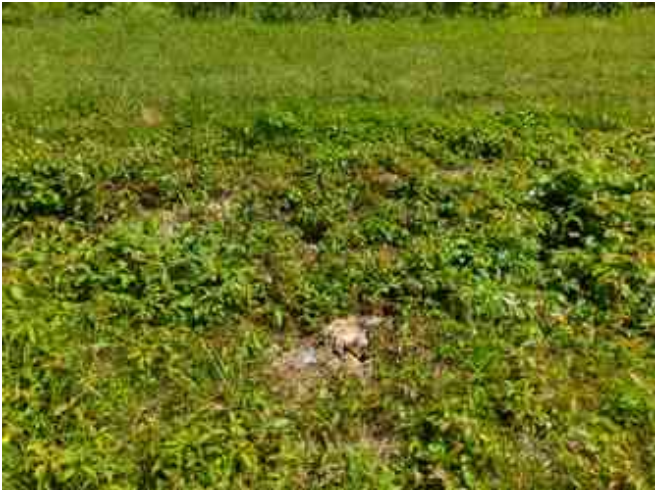
| | <p>Inspect ID: 2016-0096 Title: _2_20220607T145104.jpg Rated Item: 1. Unwanted Vegetation Growth Caption: Rating: Minimally Acceptable; Remarks: 8 inch tree stump on unprotected levee slope. Stump appears to be decomposing.; Action: Maintain vegetation free zone in accordance with USACE guidelines.</p> |

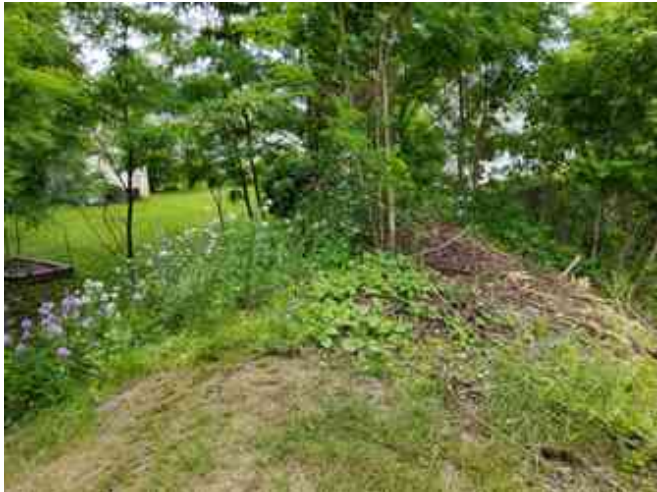
| | <p>Inspect ID: 2016-0153 Title: _4_20220607T164214.jpg Rated Item: 1. Unwanted Vegetation Growth Caption: Rating: Minimally Acceptable; Remarks: Vegetation on the levee crown at DS #4.; Action: Maintain vegetation free zone in accordance with USACE guidelines.</p> |

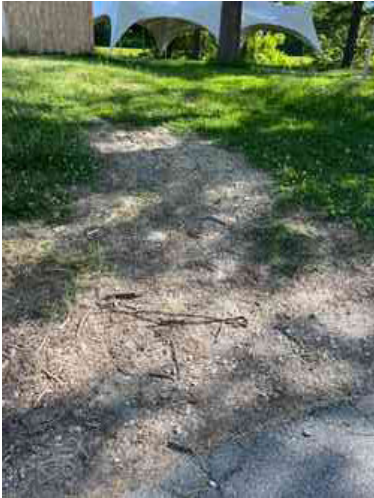
| | <p>Inspect ID: 2016-0004 Title: 4504000006_CENAN_2022_B_0004_3_20220621T173629.jpg Rated Item: 2. Sod Cover Caption: Rating: Minimally Acceptable; Remarks: Poor sod cover where new school entrance crosses levee.; Action: The crown of the levee from the original school entrance to the pump station was to be a 12" gravel access to the station 10 ft wide. This access must be restored.</p> |

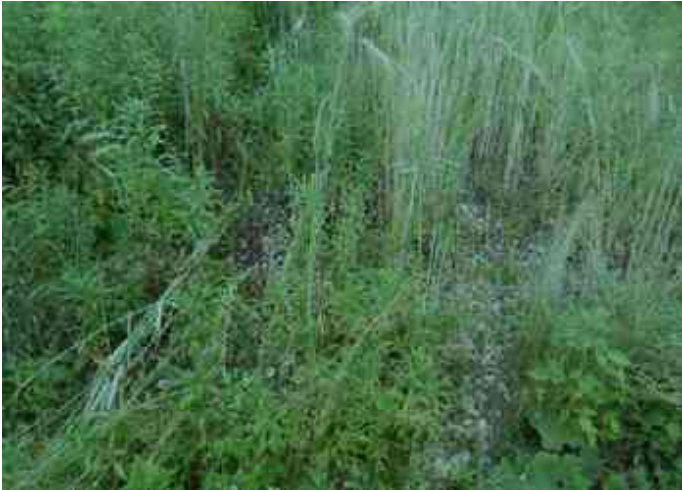
| | <p>Inspect ID: 2016-0075 Title: 4504000006_CENAN_2022_B_0075_3_20220615T194522.jpg Rated Item: 2. Sod Cover Caption: Rating: Minimally Acceptable; Remarks: Pervious toe drain material surfacing through sod cover at levee toe protected side. Cannot confirm in 2022 inspection due to vegetation. Action: NY district should review this observation with respect to the current USACE policy on the type of cover for pervious toe drains.</p> |

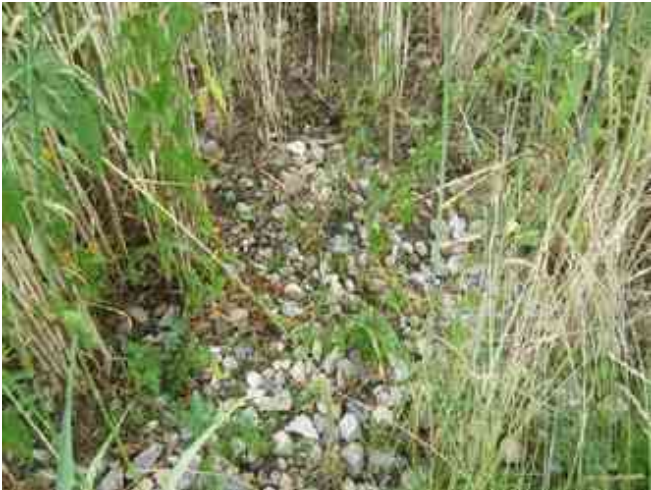
| | <p>Inspect ID: 2016-0075 Title: 4504000006_CENAN_2022_B_0075_2_20220615T194839.jpg Rated Item: 2. Sod Cover Caption: Rating: Minimally Acceptable; Remarks: Pervious toe drain material surfacing through sod cover at levee toe protected side. Cannot confirm in 2022 inspection due to vegetation. Action: NY district should review this observation with respect to the current USACE policy on the type of cover for pervious toe drains.</p> |

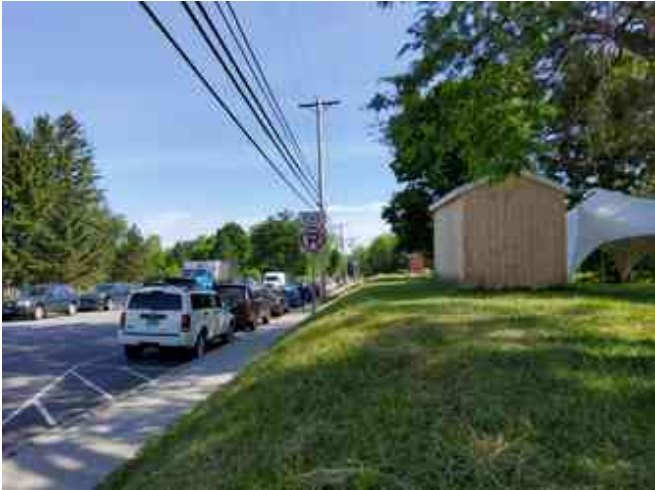
| | <p>Inspect ID: 2016-0006 Title: _2_20220607T125333.jpg Rated Item: 3. Encroachments Caption: Rating: Minimally Acceptable; Remarks: Road signs and telephone poles at levee toe unprotected side. ; Action: There are no known authorization for this encroachment. The local sponsor should be asked to either remove it, or seek authorization for it to remain.</p> |

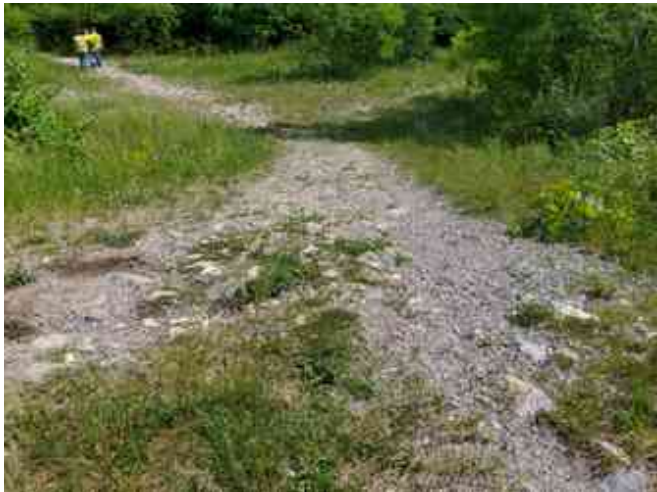
| | <p>Inspect ID: 2016-0080 Title: _2_20220607T142357.jpg Rated Item: 3. Encroachments Caption: Rating: Minimally Acceptable; Remarks: Gravel ramp running up unprotected side of levee and crown.; Action: There are no known authorization for this encroachment. The local sponsor should be asked to either remove it, or seek authorization for it to remain.</p> |

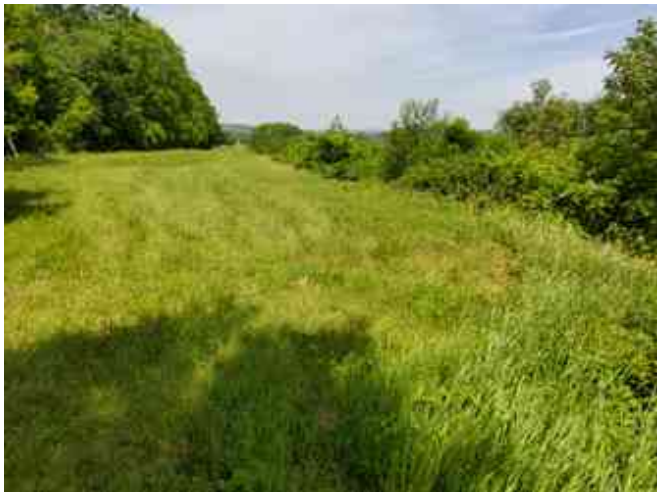
| | <p>Inspect ID: 2016-0099 Title: _5_20220607T145656.jpg Rated Item: 3. Encroachments Caption: Rating: Minimally Acceptable; Remarks: Levee was widened on the riverside from the project cross section. Area of vegetation and possible settlement is located on the riverside of original levee slope.; Action: There are no known authorization for this encroachment. The local sponsor should be asked to either remove it, or seek authorization for it to remain.</p> |

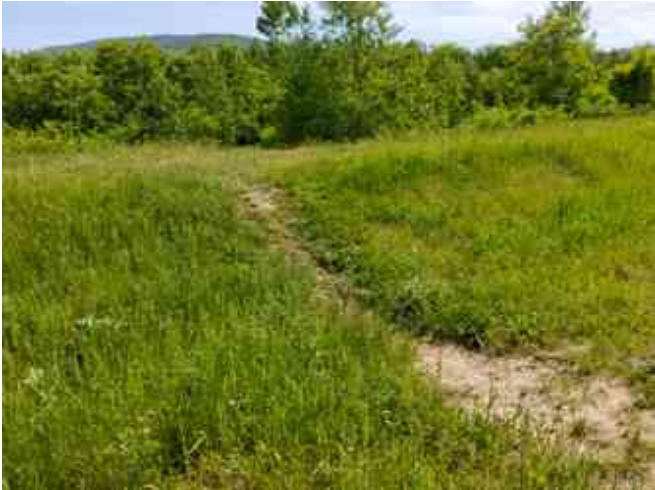
| | <p>Inspect ID: 2016-0078 Title: _2_20220607T142115.jpg Rated Item: 8. Depressions/ Rutting Caption: Rating: Minimally Acceptable; Remarks: Footpath on unprotected side of levee has formed a rut.; Action: The local sponsor take actions to minimize the impact of pedestrian trespass on the levee. Provide topsoil, seed and mulch in accordance with USACE guidelines.</p> |

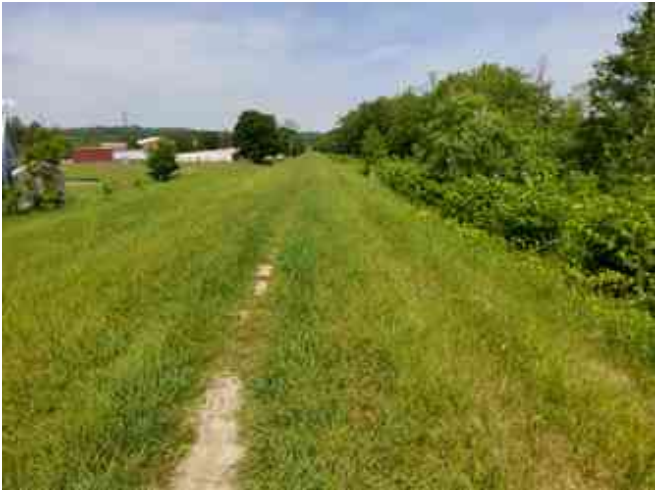
| | <p>Inspect ID: 2016-0085 Title: _3_20220607T142831.jpg Rated Item: 8. Depressions/ Rutting Caption: Rating: Minimally Acceptable; Remarks: Depression in levee crown extends from gravel ramp to power sub-station.; Action: Review survey data and verify crown elevation in this area. Re-establish line and grade of the levee as needed in accordance with USACE guidelines.</p> |

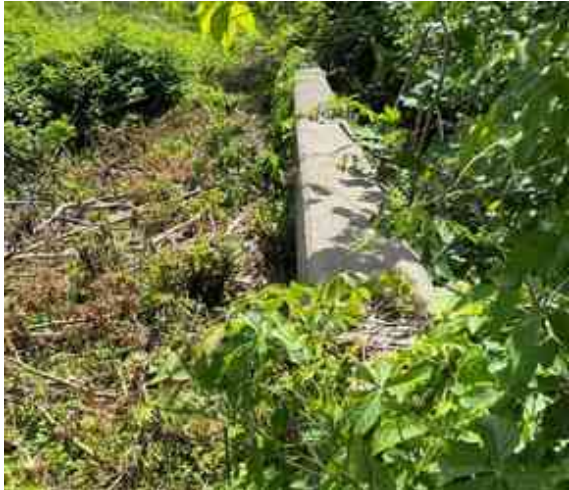
| | <p>Inspect ID: 2016-0105 Title: 4504000006_CENAN_2022_B_0105_2_20220622T135951.jpg Rated Item: 1. Unwanted Vegetation Growth Caption: Rating: Minimally Acceptable; Remarks: Unwanted vegetation growth on both protected and unprotected side of floodwall. Vegetation hinders inspection of floodwalls in 2022. ; Action: Maintain vegetation free zone in accordance with USACE guidelines.</p> |

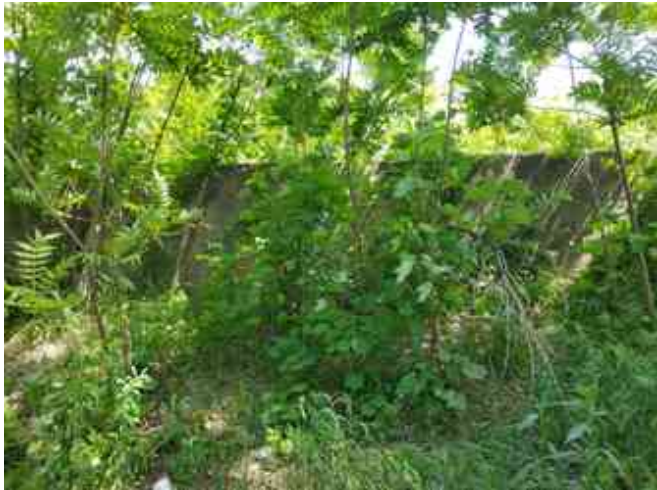
| | <p>Inspect ID: 2016-0110 Title: _1_20220607T152833.jpg Rated Item: 1. Unwanted Vegetation Growth Caption: Rating: Minimally Acceptable; Remarks: Large tree stump 3-ft diam. located within 15-ft of floodwall. Cannot confirm in 2022 inspection due to vegetation.; Action: Maintain vegetation free zone in accordance with USACE guidelines.</p> |

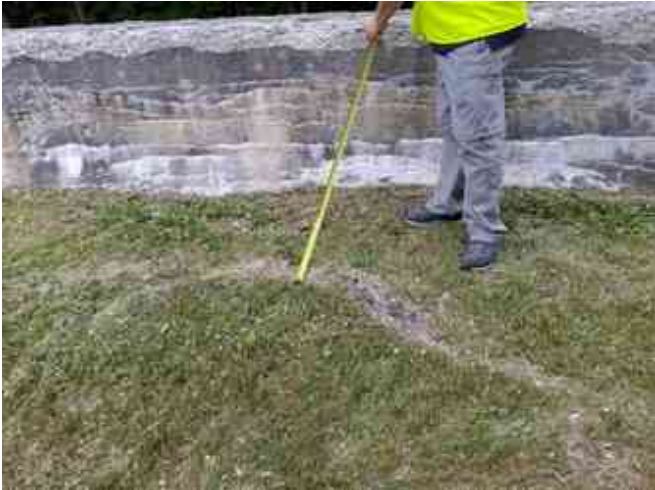
| | <p>Inspect ID: 2022-0007 Title: _1_20220607T163433.jpg Rated Item: 1. Unwanted Vegetation Growth Caption: Rating: Minimally Acceptable; Remarks: Large tree root 3' from wall.; Action: Maintain vegetation free zone in accordance with USACE guidelines.</p> |

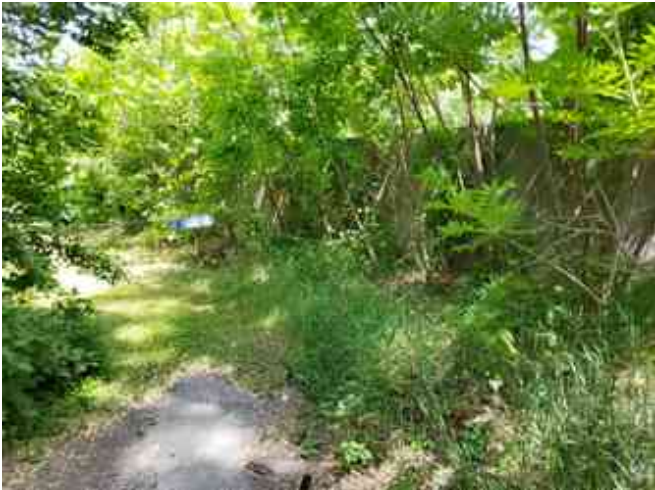
| | <p>Inspect ID: 2016-0109 Title: _3_20220607T152238.jpg Rated Item: 2. Encroachments Caption: Rating: Minimally Acceptable; Remarks: Debris obstructing access to floodwall protected side.; Action: The local sponsor should inform the property owner of the project boundary and have them remove their items from the project area.</p> |

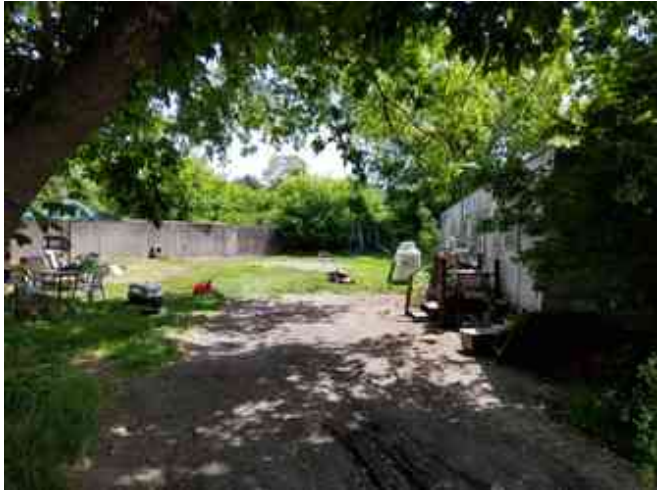
| | <p>Inspect ID: 2016-0111 Title: _2_20220607T153628.jpg Rated Item: 2. Encroachments Caption: Rating: Minimally Acceptable; Remarks: Vegetation and yard debris within 15-ft of local floodwall. ; Action: Maintain vegetation free zone in accordance with USACE guidelines. Survey project boundary and determine if encroachment is permissible.</p> |

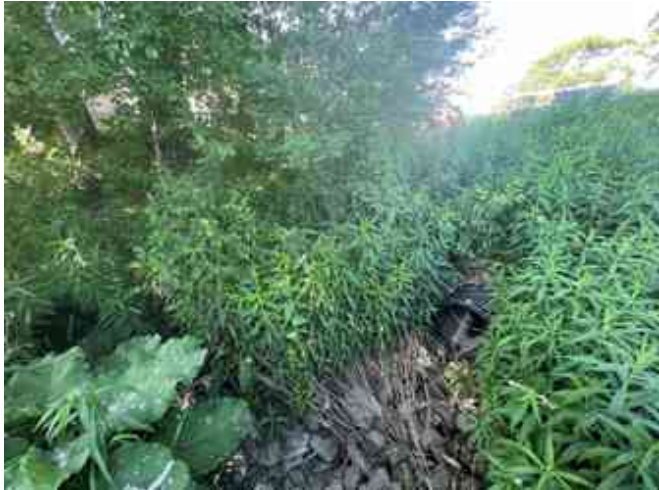
| | <p>Inspect ID: 2016-0008 Title: 4504000006_CENAN_2022_B_0008_3_20220622T142742.jpg</p> <p>Rated Item: 2. Encroachments Caption: Rating: Minimally Acceptable; Remarks: Two HDPE stormwater drains enter ponding area and are not shown on the project plans.; Action: Documentation of the review/approval of the Mt. Anthony Union High School Site Plan needs to be added to the project archives. Consider providing an appropriately sized drainage swale to connect the new site drainage to the ponding area.</p> |

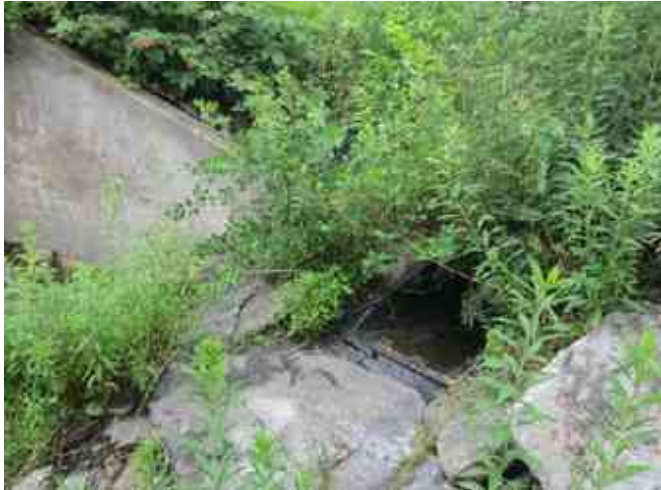
| | <p>Inspect ID: 2016-0032 Title: 4504000006_CENAN_2022_B_0032_4_20220622T143222.jpg Rated Item: 2. Encroachments Caption: Rating: Minimally Acceptable; Remarks: 15-inch HDPE at pumping station outlet not on project plans.; Action: There are no known authorization for this encroachment. The local sponsor should be asked to either remove it, or seek authorization for it to remain.</p> |

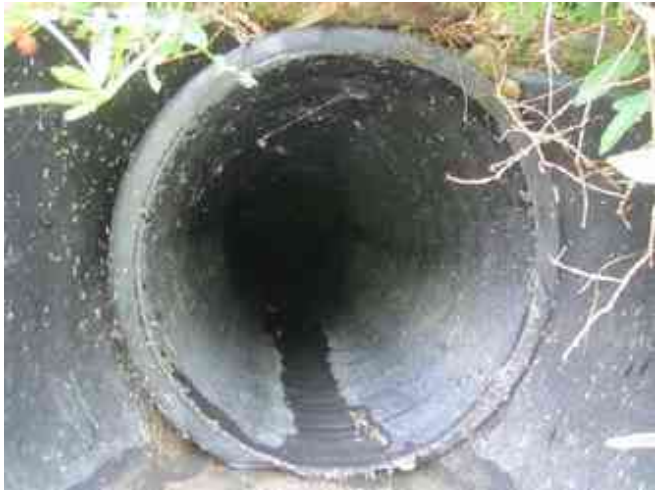
| | <p>Inspect ID: 2016-0032 Title: 4504000006_CENAN_2022_B_0032_2_20220622T143429.jpg Rated Item: 2. Encroachments Caption: Rating: Minimally Acceptable; Remarks: 15-inch HDPE at pumping station outlet not on project plans.; Action: There are no known authorization for this encroachment. The local sponsor should be asked to either remove it, or seek authorization for it to remain.</p> |

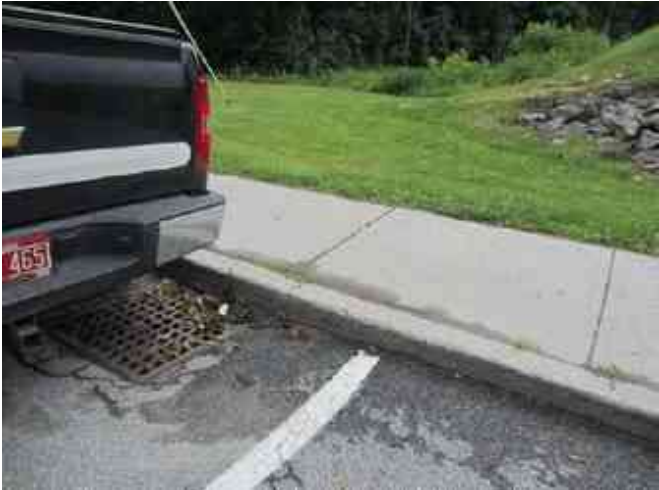
| | <p>Inspect ID: 2016-0032 Title: 4504000006_CENAN_2022_B_0032_3_20220622T143434.jpg</p> <p>Rated Item: 2. Encroachments Caption: Rating: Minimally Acceptable; Remarks: 15-inch HDPE at pumping station outlet not on project plans.; Action: There are no known authorization for this encroachment. The local sponsor should be asked to either remove it, or seek authorization for it to remain.</p> |

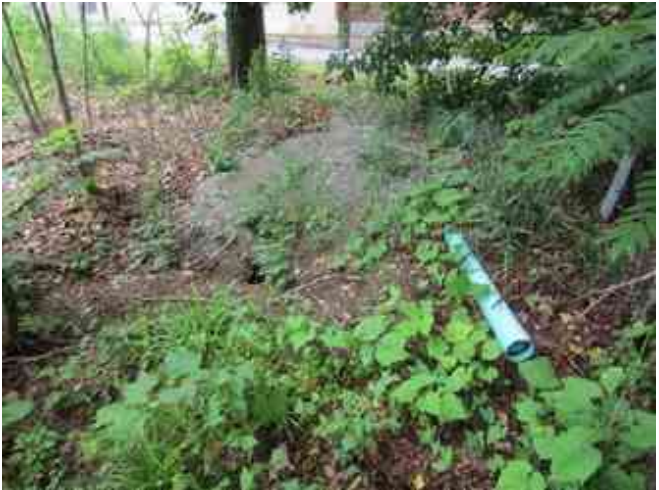
| | <p>Inspect ID: 2016-0064 Title: 4504000006_CENAN_2022_B_0064_2_20220622T143551.jpg</p> <p>Rated Item: 2. Encroachments Caption: Rating: Minimally Acceptable; Remarks: 4" PVC drainage pipe discharges into the drainage ditch is not shown on the project plans. Cannot locate in 2022 inspection due to vegetation.; Action: There are no known authorization for this encroachment. The local sponsor should be asked to either remove it, or seek authorization for it to remain.</p> |

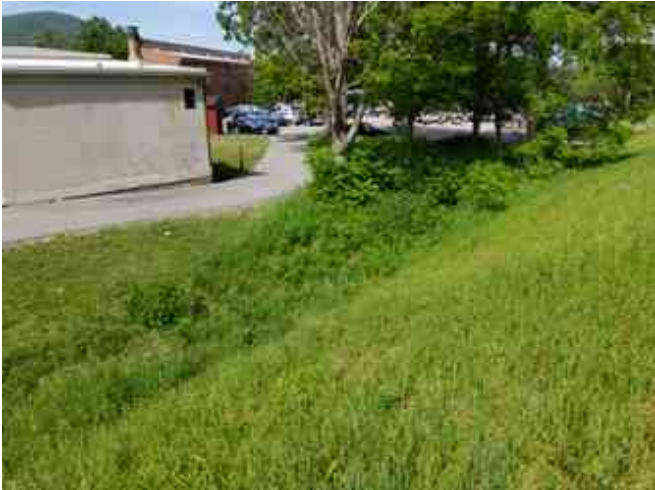
| | <p>Inspect ID: 2016-0067 Title: _2_20220607T140048.jpg Rated Item: 2. Encroachments Caption: Rating: Minimally Acceptable; Remarks: Asphalt driveway is approx. 16 feet from centerline of ditch.; Action: There are no known authorization for this encroachment. The local sponsor should be asked to either remove it, or seek authorization for it to remain.</p> |

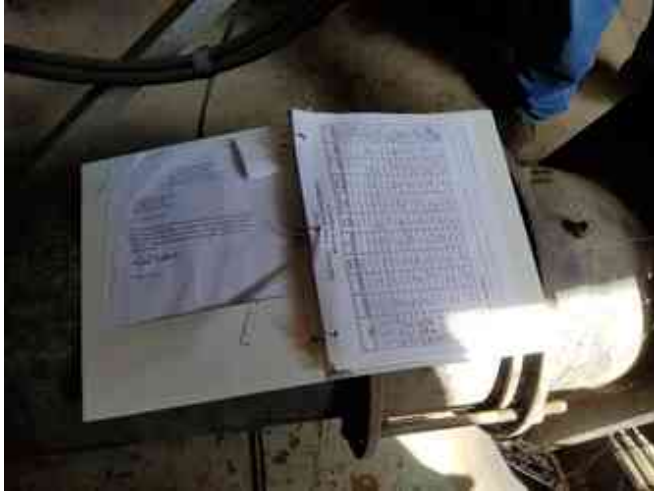
Inspect ID: 2016-0014 **Title:** _3_20220606T183935.jpg

Rated Item: 1. Pump Stations Operating, Maintenance, Training, & Inspection Records **Caption:** Rating: Minimally Acceptable Remarks: The original O&M manual is used for training. The station is tested once a month. The staff noted that to their knowledge, the station has not been operated since 1983. A log is kept of the monthly testing. No training records are present. Action: Records of training should be kept at the pump station and updated regularly.

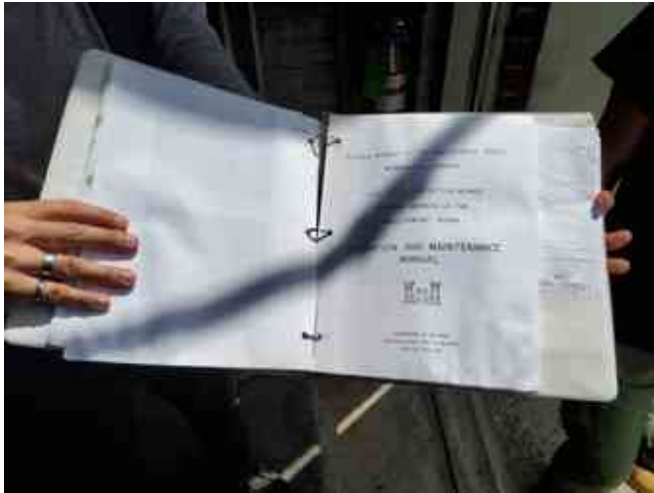
Inspect ID: 2016-0017 **Title:** _2_20220606T183844.jpg

Rated Item: 2. Pump Station Operations and Maintenance Equipment Manuals **Caption:** Rating: Minimally Acceptable; Remarks: A copy of the 1971 O&M manual was found at the pump station.; Action: O&M manual needs to be updated regularly

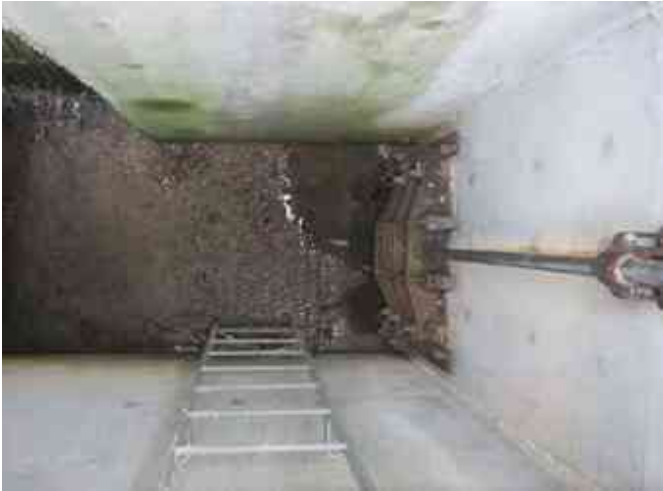
| | <p>Inspect ID: 2016-0024 Title: 4504000006_CENAN_2022_B_0024_3_20220622T155125.jpg</p> <p>Rated Item: 18. Sluice/ Slide Gates Caption: Rating: Minimally Acceptable; Remarks: They are manual gates and the portable handle is kept in the pump station. They are greased regularly. The outlet gate could not be closed completely. There may be debris in the seat. The manual gate operators take a long time and many turns to close.; Action: Clear debris from outlet seat. Look into providing new operators in order to close and open the gates quicker.</p> |

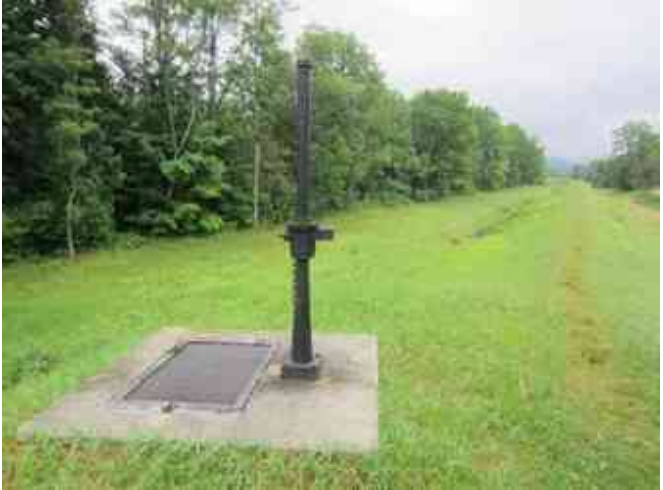
| | <p>Inspect ID: 2016-0024 Title: 4504000006_CENAN_2022_B_0024_4_20220622T155131.jpg</p> <p>Rated Item: 18. Sluice/ Slide Gates Caption: Rating: Minimally Acceptable; Remarks: They are manual gates and the portable handle is kept in the pump station. They are greased regularly. The outlet gate could not be closed completely. There may be debris in the seat. The manual gate operators take a long time and many turns to close.; Action: Clear debris from outlet seat. Look into providing new operators in order to close and open the gates quicker.</p> |

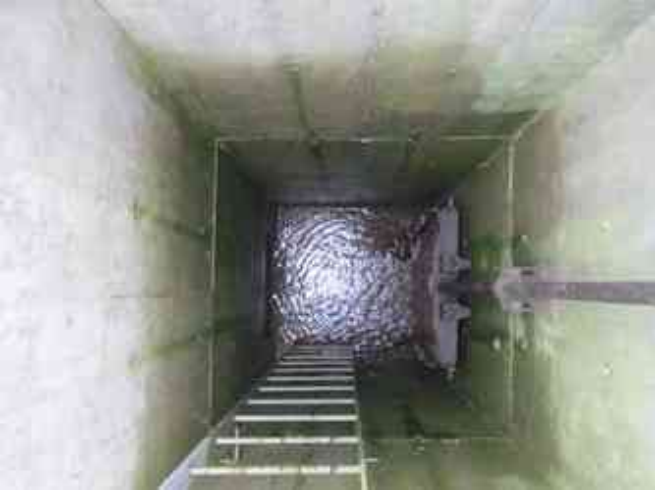
| | <p>Inspect ID: 2016-0024 Title: 4504000006_CENAN_2022_B_0024_5_20220622T155136.jpg</p> <p>Rated Item: 18. Sluice/ Slide Gates Caption: Rating: Minimally Acceptable; Remarks: They are manual gates and the portable handle is kept in the pump station. They are greased regularly. The outlet gate could not be closed completely. There may be debris in the seat. The manual gate operators take a long time and many turns to close.; Action: Clear debris from outlet seat. Look into providing new operators in order to close and open the gates quicker.</p> |

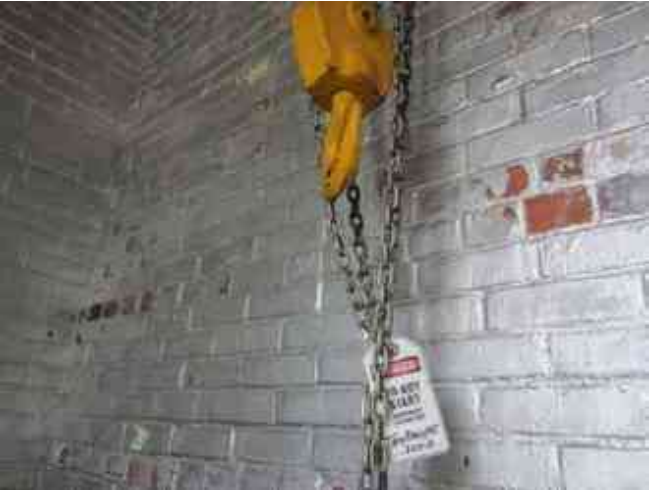
| | <p>Inspect ID: 2016-0025 Title: 4504000006_CENAN_2022_B_0025_1_20220622T155426.jpg</p> <p>Rated Item: 20. Cranes Caption: Rating: Minimally Acceptable; Remarks: The crane is no longer used and is locked out of service. The local sponsor uses portable crane to remove motor if necessary.; Action: The local sponsor should update the O&M manual with procedures to use a portable crane.</p> |
