Mystic River Restoration Project - Mill Creek Restoration Assessments

FY18 MassBays Healthy Estuaries Grant Program

Chelsea and Revere, Massachusetts

July 15, 2019

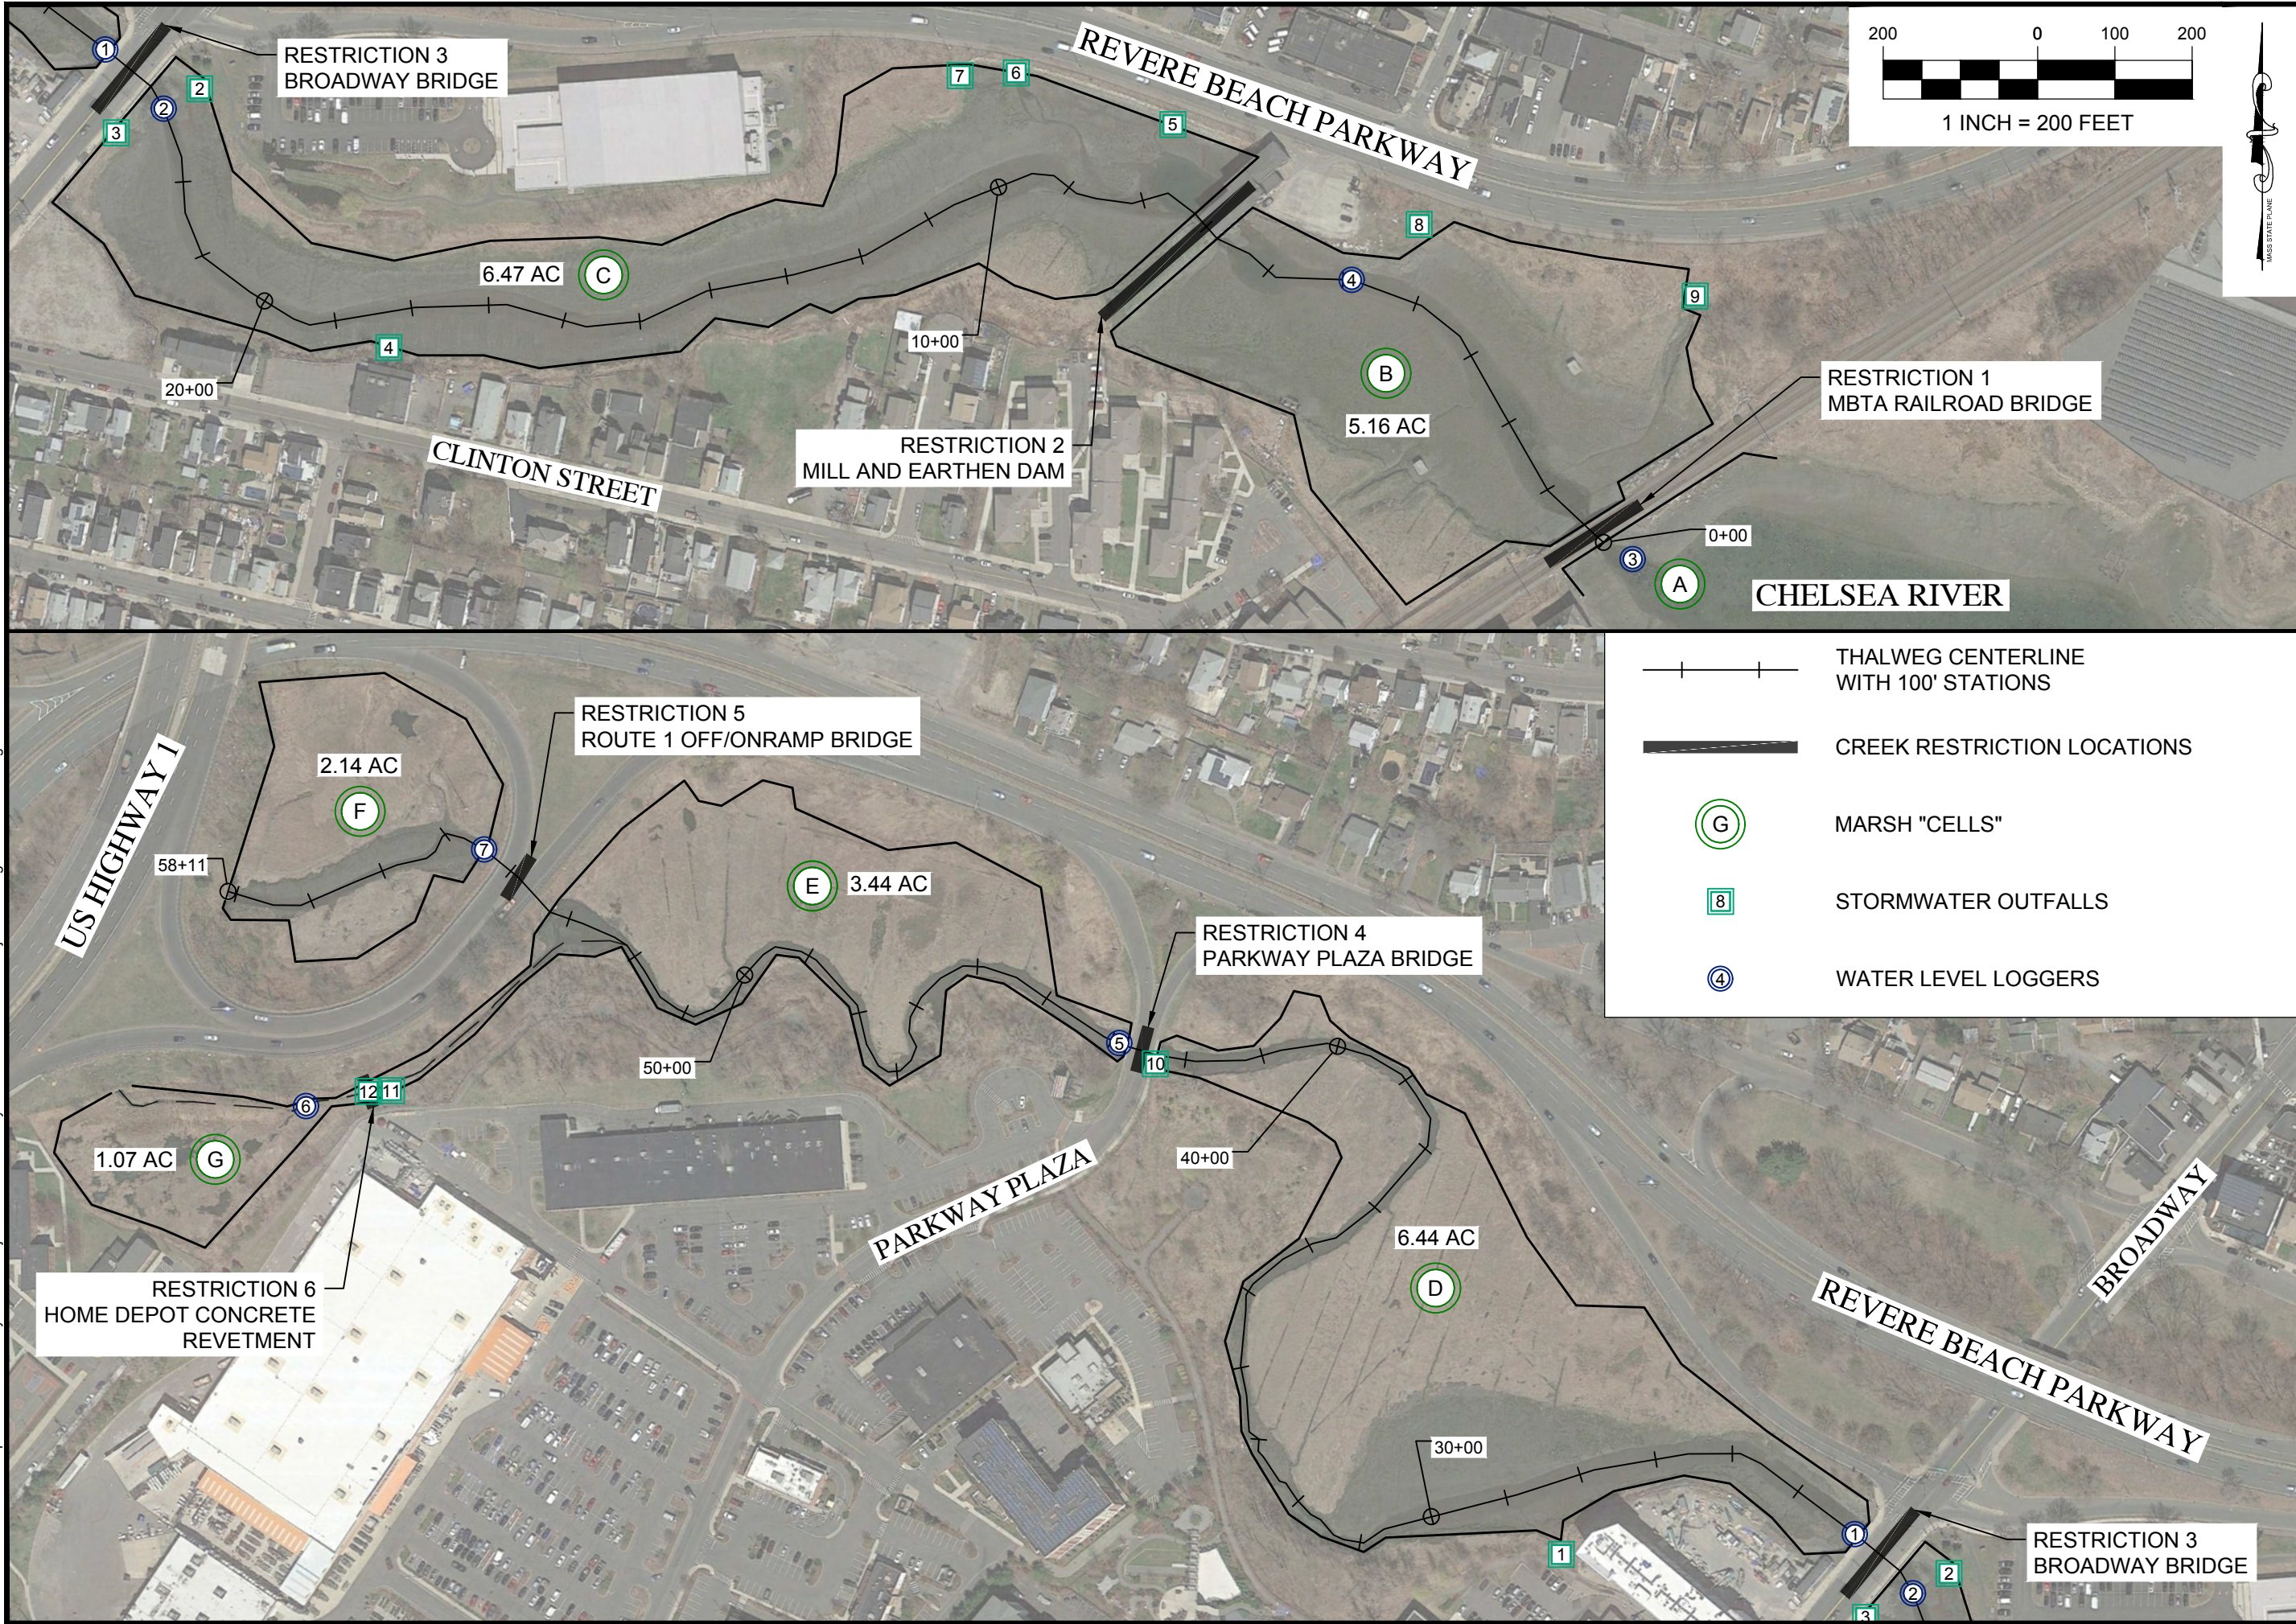
Six structures spanning the creek within the project area were identified as potential tidal restrictions: the MBTA railroad bridge; the Slade Spice Mill building and remnants of its' earthen-embankment dam; the Broadway Bridge; the Parkway Plaza Bridge; the culverts beneath the US Route 1 North off/on-ramp; and the concrete revetment immediately north of the Home Depot parcel along the Mill Creek tributary. These restrictions are numbered on Figure 4, starting downstream and moving upstream. Salt marsh areas between each of these potential tidal restrictions are identified herein as discrete marsh cells A through G, labeled on Figure 4 from downstream to upstream.

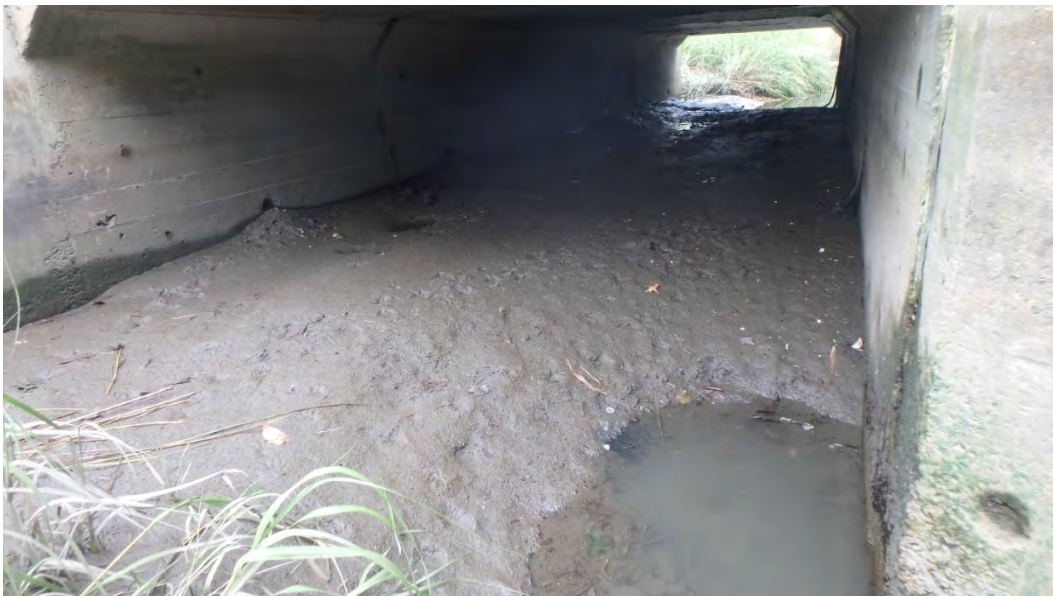
Photo 11. Northernmost Culvert of Parkway Plaza Bridge

A temporary improvement in flow conditions may be achieved by dredging one or more channels through the Parkway Plaza culvert and the Route 1 off/on-ramp culverts, removing some of the several feet of fine sediments that have accumulated in those narrow portions of the system (see Photos 11 and 24). However, hydraulic and/or sediment transport assessment and modeling would be necessary to determine what the sources and amounts of the current sediment deposits are to determine the overall impact of the removal and cost effectiveness. Further, modeling will help to determine whether there would be an increased flooding risk if those sediments were temporarily removed. Unless sediment sources from the subwatershed and in-stream erosion are addressed beforehand, sediment removal would offer only temporary improvement.

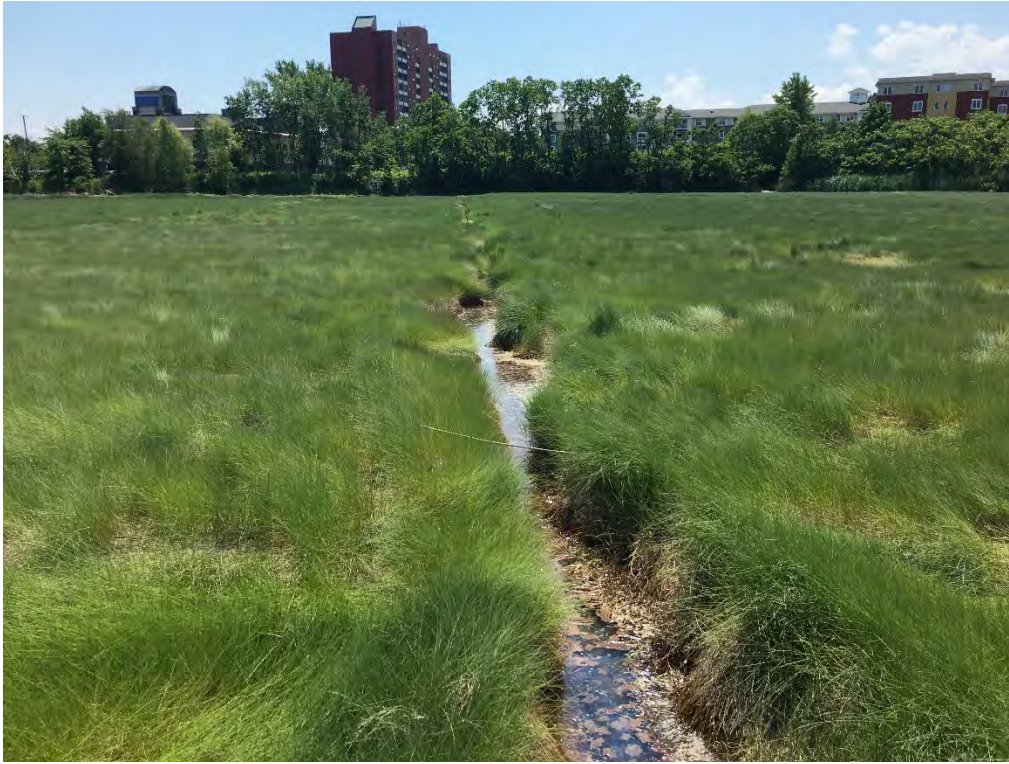
Photo 20. High Marsh with a Diverse Range of Plants

The marsh on the north side of the creek is a large expanse of mostly high marsh with a diverse range of salt marsh plants including smooth cordgrass, saltmarsh hay, spike grass, sea lavender, seaside goldenrod, spearscale orache (Photo 20). At the landward edges of the marsh, adjacent to Route 16, there is a fringe of common reed ranging from 20 to 100 feet deep. Upslope of the salt marsh, Japanese knotweed (*Fallopia japonica*), and tree-of-heaven were observed. The Japanese knotweed appeared unhealthy with a chemical-burn appearance to the leaves (Photo 21). Evidence of marsh “slumping” (Photo 22) was noted along the seaward edge of the marsh, as well as extensive areas of unvegetated mudflat where low marsh would typically be. On the south side of the creek there is a thin fringe of marsh between the creek and the paved parking areas. This marsh area is a thin ribbon, predominantly low marsh, and dominated by smooth cordgrass in the higher elevations of low marsh and by unvegetated mud in the lower portions of low marsh (Photo 23). Plant species present in the high marsh include spearscale orache, sea lavender, seaside goldenrod, tick quack grass (*Thinopyrum pycnanthum*). Plants upslope of the marsh included black locust (*Robinia pseudoacacia*), tree-of-heaven, Sycamore maple (*Acer pseudoplatanus*), Asian bittersweet (*Celastrus orbiculatus*), and multiflora rose (*Rosa multiflora*). Farther upstream the marsh area widens and the low marsh vegetation diversity increases. This area of salt marsh is a relatively healthy stretch until the marsh narrows near Route 16,

just downstream of the Parkway Plaza bridge. At this point the vegetation becomes dominated by Phragmites. The area nearest Parkway Plaza bridge had previously undergone common reed removal by excavation and manual removal in 2010 (Tetra Tech, Inc., 2009), which now appears to have returned.

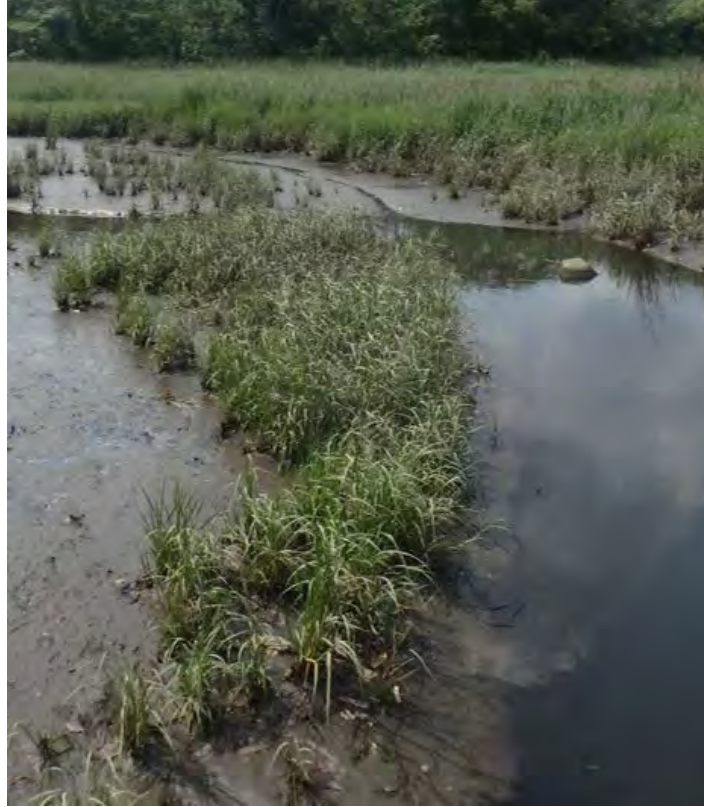
Photo 23. Ribbon of Low Marsh with Mudflat on Left Bank

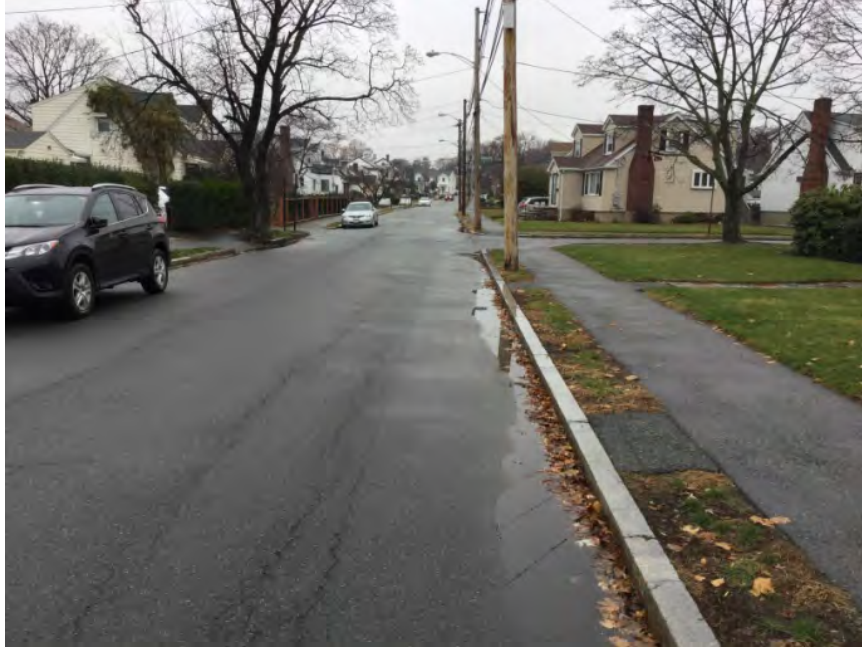
Photo 27: Vinal Street in Revere, MA

- 1) Excess impervious cover: Many of the ROWs and parking lots appeared to have excess pavement for the type and amount of use. For example, there were several one-way roads within residential areas of both Chelsea and Revere that were 24 to 30 feet or greater in width. In comparison, typical road widths are 11 to 12 feet and parking lanes 7 to 9 feet. Photo 27 below shows Vinal Street in Revere, a one-way road which has a 24-ft width. Road network
