# VILLAGE OF DECATUR

BUILDING ASSESSMENTS OF VILLAGE HALL & POLICE DEPARTMENT

DATE: April 15th, 2022

## BUILDING ASSESSMENTS OF PUBLIC WORKS DEPARTMENT

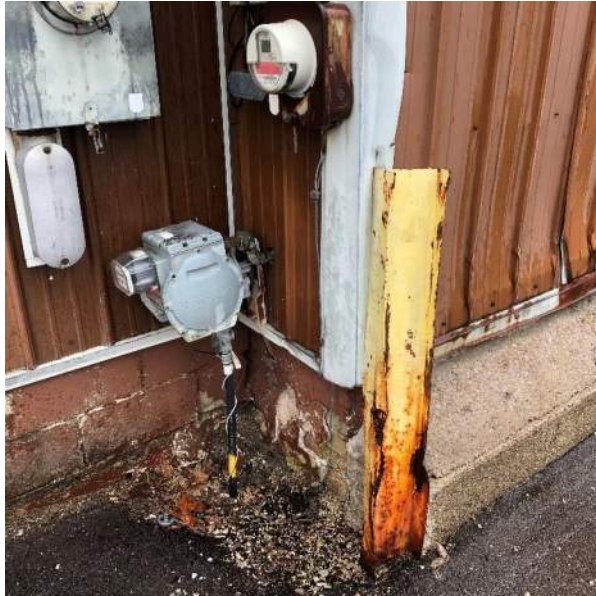
B-i: Vinyl Siding

- i. Metal siding is paint fading. (Photo B-i)  
**Recommendation:** Prep & Paint.  
**Cost Parameters:** \$3,000-\$5,000
- ii. Vinyl siding is broken. (Photo B-ii)  
**Recommendation:** Remove & Replace  
**Cost Parameters:** \$500-\$800
- iii. Dented Metal siding on North side corner of building. (Photo B-ii)  
**Recommendation:** Replace damaged metal siding.  
**Cost Parameters:** \$1,000-\$2,000
