EVART DEPOT

EVART CITY HALL

MAINTENANCE ANALYSIS AND PLAN

April 2, 2019

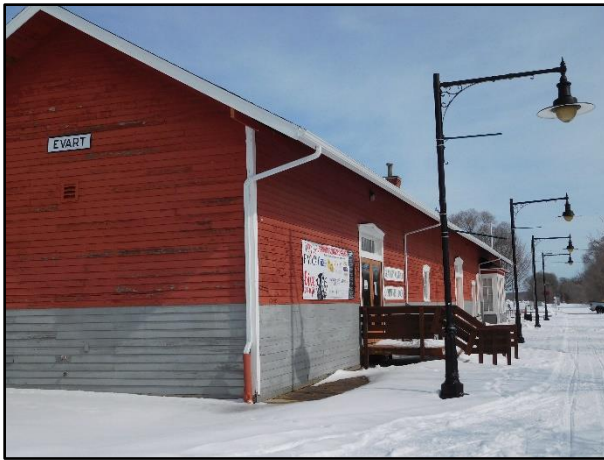
Railside – west and south facades

Siding and Paint – Some of the wood siding is in very poor condition and is breaking away or cracking. The vertical joints of the fiber cement board siding are opening up. Both of these situations will allow water behind the siding and will accelerate deterioration of the siding and the wall structure behind. The condition of the siding could be contributing to the energy inefficiency. Paint is peeling significantly on the exterior siding, particularly on the south façade. Some peeling is typical after 7-10 years, depending on the preparations made and paint used.
