Re: Greenfield Library Overview (Leavitt Hovey House)

Determination of Occupancy Load
And
Egress Requirements for Basement Meeting Rooms
Greenfield Public Library
420 Main Street
Greenfield, MA

**Greenfield Public Library
402 Main Street
Greenfield, Massachusetts**

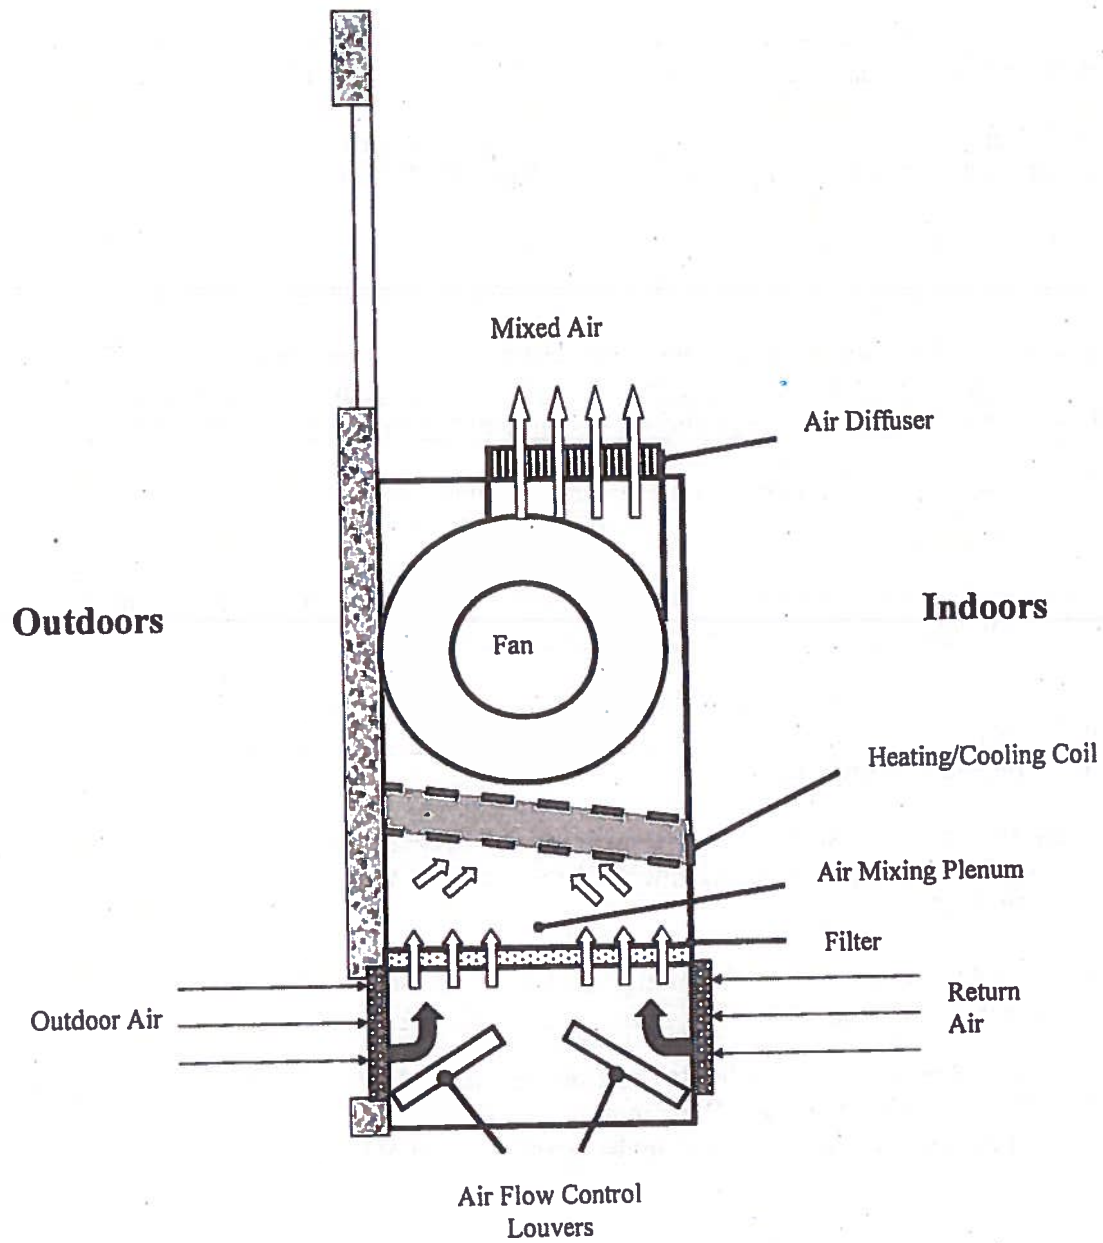
Figure 1: Unit Ventilator (Univent)

Fresh air is supplied by a unit ventilator (univent) system (Figure 1). Univents draw air from outdoors through a fresh air intake located on the exterior walls of the building and return air through an air intake located at the base of each unit. Fresh and return air are mixed, filtered, heated and provided to rooms through an air diffuser located in the top of the unit. Univents were functioning in the majority of areas examined.

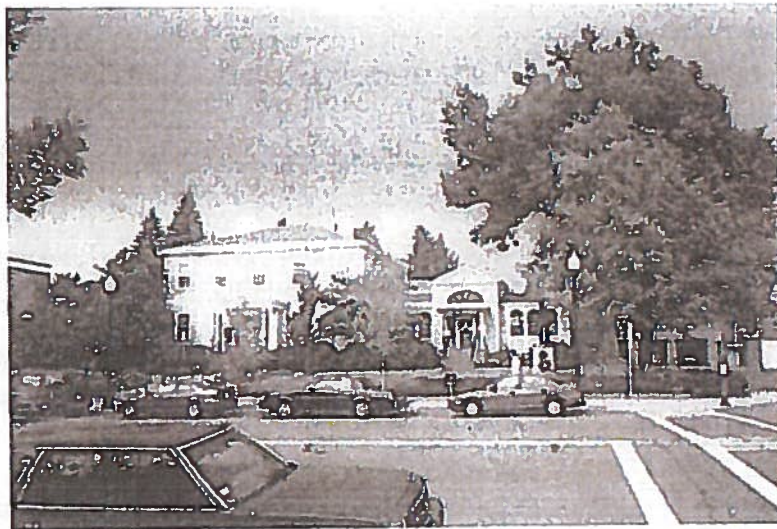
Picture 1

The library contains two wings in a split-level configuration. The original wing was a free standing, two-story, wood frame mansion constructed in 1797 (see Picture 1). A two-story brick wing was added to the rear of the building in the 1950s. The library occupies the first floor of the 1797 wing and the second floor of the 1950s wing. The second floor of the 1797 wing is used for administrative offices. The ground floor of the 1950s wing contains a conference room, an office and restrooms. The basement of the 1797 wing is used for storage of books and contains a mechanical room and the custodial office. An elevator shaft services each floor of the 1797 wing. Windows are sash windows that are not openable. The library exhaust ventilation was renovated in 1998 (MJA & KL, 1998). Exhaust vents were removed and new motors were added to the basement and first floor.

Wood Frame Mansion Constructed In 1797

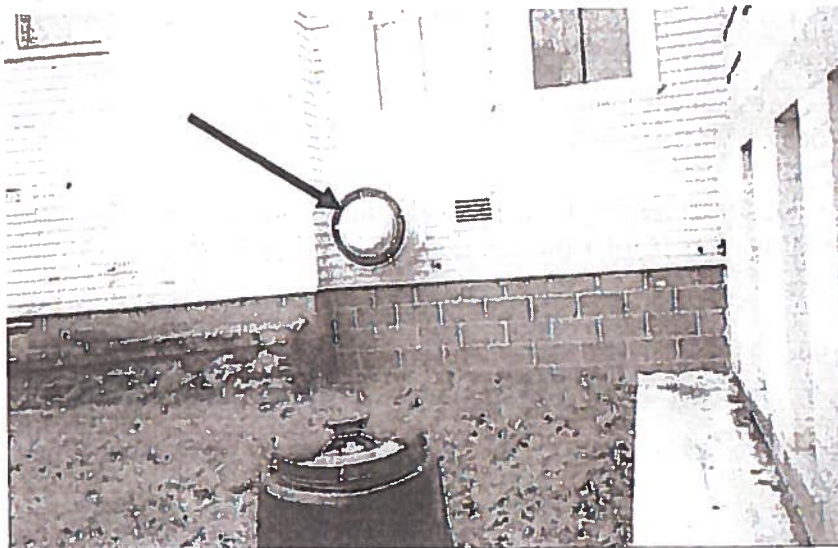
Picture 2

Exhaust ventilation is provided by ceiling-mounted exhaust vents in the first floor library areas. The basement conference room has a wall-mounted exhaust vent, which is connected to a large fan installed on the rear exterior wall (see Picture 2). In all areas examined, exhaust vents were deactivated. Without a functional exhaust system,

Exhaust Fan for Basement Meeting Room

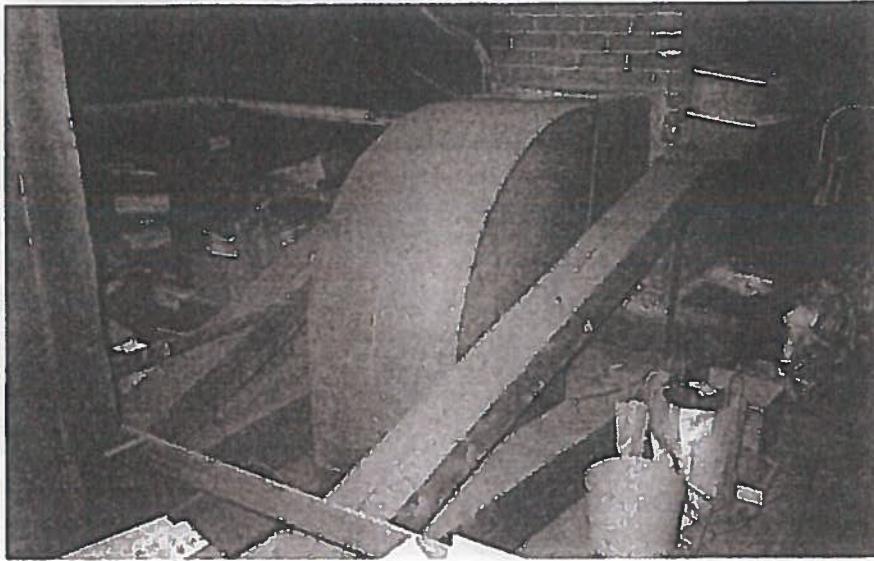
Picture 3

The administrative offices on the second floor do not have mechanical exhaust ventilation. The roof of the 1797 wing has two chimney-like structures, which appear to be exhaust ventilation airshafts. A large grill in the staff office appears to be connected to the western brick ventilation shaft by ductwork (see Picture 3) in the attic. A second large grill located at the top of the stairwell from the first floor may also be connected to the eastern brick ventilation shaft. The sound of vehicle traffic was noted emanating from this grill, indicating the airshaft is likely open to the outdoors. These vents are not mechanical, but use rising, heated air to draw environmental pollutants from the building. While this system can work well during the heating season to provide exhaust ventilation, the system does not work during the air-conditioning season. These vents may also serve as a moisture source during summer weather. Additionally, a number of areas in the basement do not have mechanical fresh air supply systems (see Tables).

Ductwork in Attic Connected to the Western Brick Ventilation Shaft

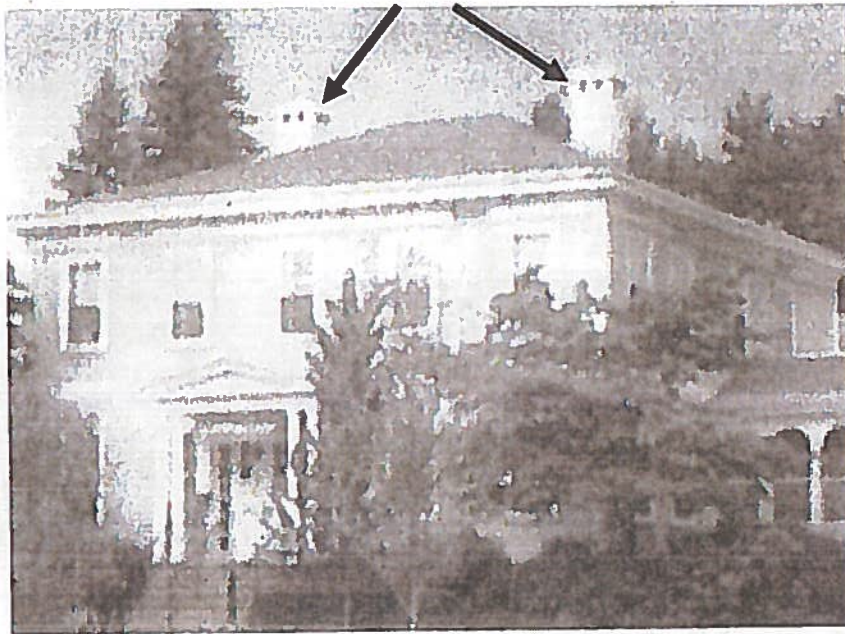
Picture 9

Chimney-Like Structures on the Roof Of the 1797 Wing
