July 30, 2018

Re: Feasibility Study Report Middlebury Police – Control Building Re-use EV# 18276

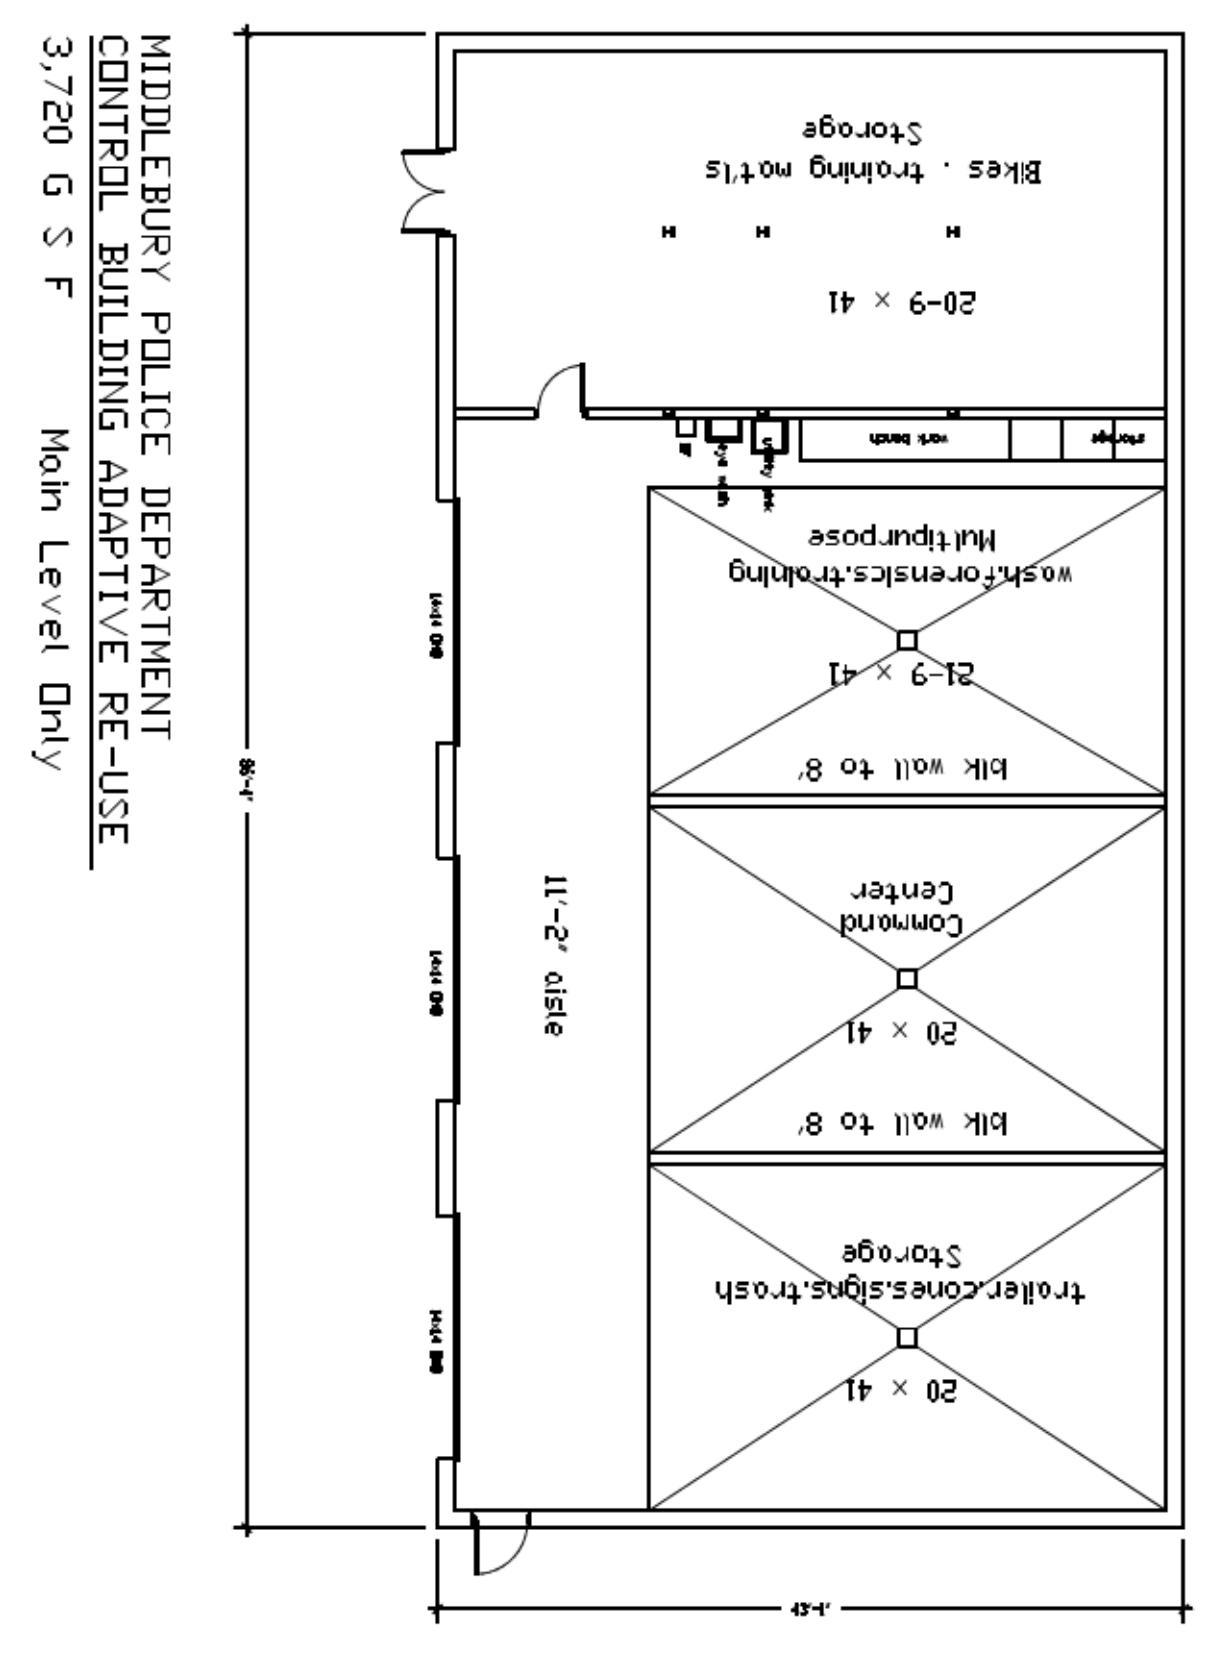
Figure 2: Proposed Plan

The current proposed layout for the space includes a southern dedicated storage area and a threebay garage, see Figure 2. Currently the openings are to be 14'x14' – taller and wider than existing openings. The larger openings will require the building height to increase by several feet. In addition to the new openings, the garage space will be increasing in plan area and will include space currently used as the building corridor. This will require relocating an existing interior CMU wall.

- The existing CMU in the garage space is to be removed down to the concrete bond beam. In addition to the CMU, the eastern portion of bond beam and exterior CMU walls are to be removed. This is required to provide room for the three larger new garage doors. East walls are to be replaced with new reinforced CMU walls and brick facade. A new bond beam around perimeter of building will be required and should be pinned to the existing concrete tie beam. If preferred, it may be possible to limit the new concrete beam to the eastern side of the building with a return on the north and south walls. A new reinforced CMU wall and brick facade is to be installed from beam to proposed parapet/roof elevation.

- The existing steel roof is to be removed and replaced. We anticipate new roof framing to include open web steel joists spanning east to west. The new trusses will be 24" deep K or LH series and will be top chord bearing. This will require the addition of embedded plates in the new CMU wall extension or concrete bond beam. Joists to be designed to accommodate framing required for new garage doors. A 1.5B steel deck will be required for both vertical and lateral capacity of roof. The deck will be fastened to supporting members with pins or screws at a spacing to be determined.
