Zero by Degrees LLC

Building Energy Plan

RE: March 15th & 27th, 2018 Energy Audit at the Middlebury Teen Center- Middlebury VT

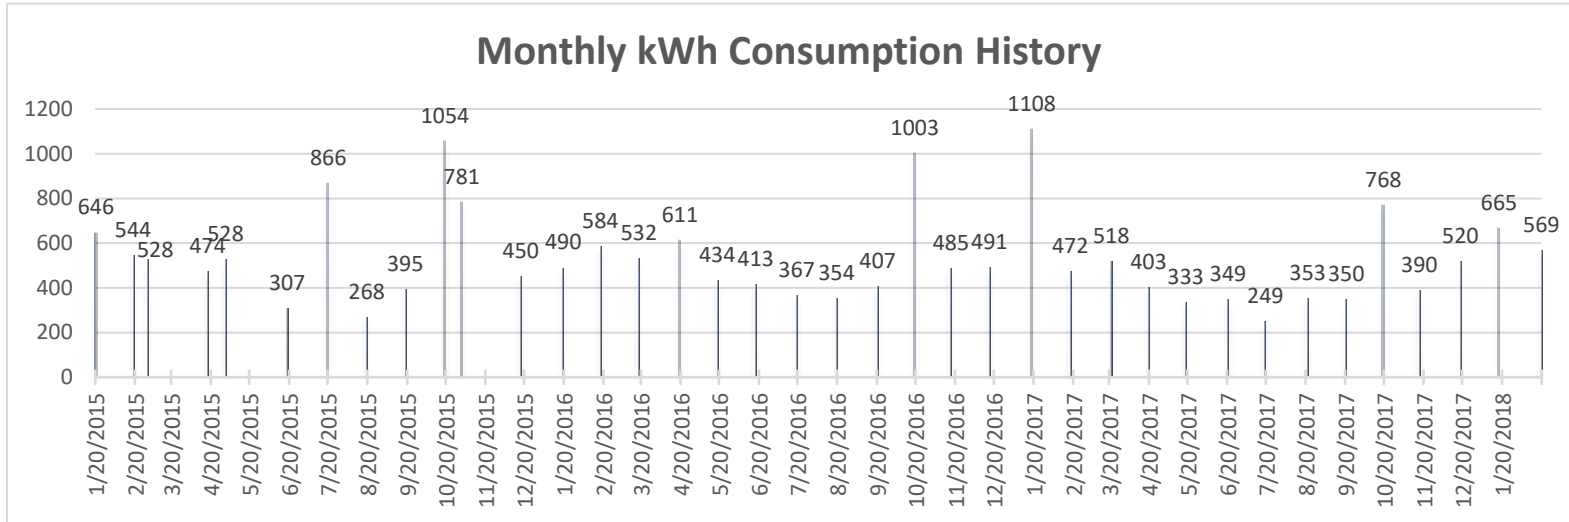
Electricity Consumption

The table above summarizes the building's electrical consumption by month over the past 3 years, given the consumption data provided to us. Generally speaking, there is a smooth pattern of usage with most months repeating consistently the next year. We've noted that the months of October tend to have consistent high spikes in usage. We understand that the ball field lights are connected to the same meter as the Teen Center and that they are used only in the fall months. Typical flood lights often contain high wattage lamps and so we suspect these consistent October spikes correlate with the usage of those ball field lights. The only other two anomalies fall on January of 2017 and July of 2015. Without further information it is difficult to say what may have caused these unique spikes, but it could simply be a matter of an appliance or high wattage lighting system that was left on for long periods of time, either intentionally or accidentally.
