Mitigation Visit Report Creek Road Middlebury, VT
DR-4330

October 23, 2017

By: Richard N. Downer, FEMA Mitigation

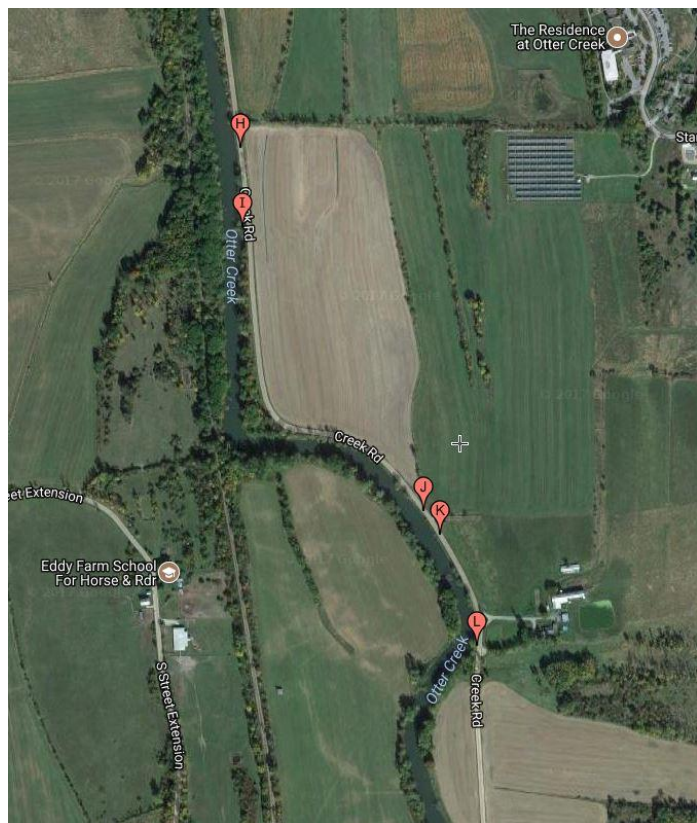
The purpose of this visit was to give mitigations suggestions for Creek Road in Middlebury, Vermont. During the July 1st event the bank of Otter Creek along Creek Road slipped toward the creek at five sites. The sites are located on the aerial photo below.

Site 1 “H” (43.990974 -73.164001)

Site 2 “I” (43.989769 -73.163963)

Site 3 “J” (43.985512 -73.160187)

Site 4 “K” (43.985168 -73.159843)

Site 5 “L” (43.983498 -73.159058)

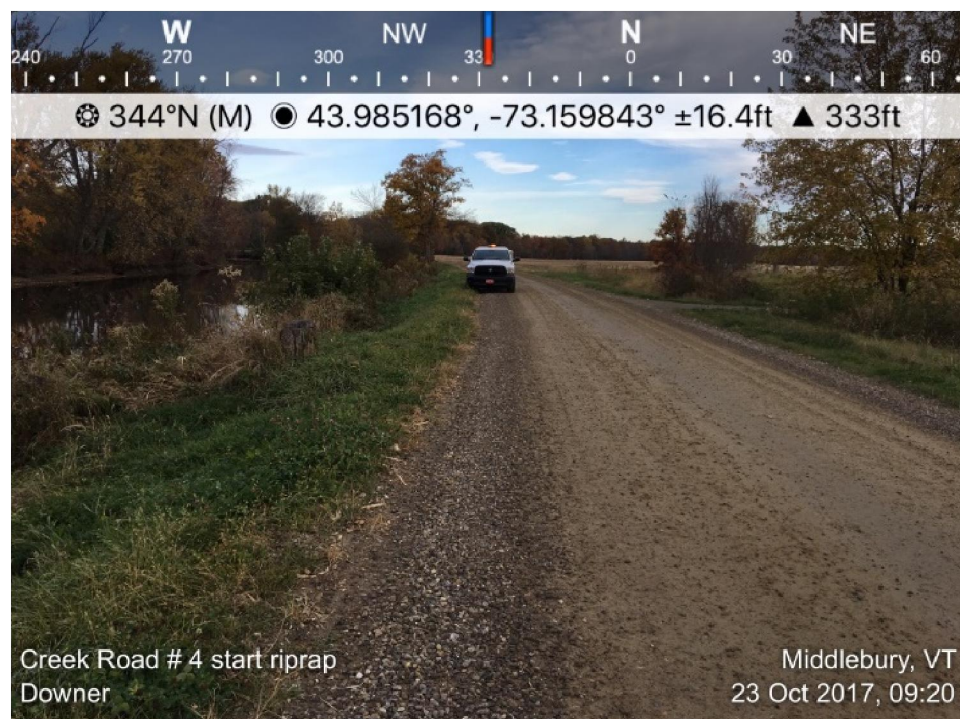
Site 4 "K"

◀ Section was previously cleared of trees and riprapped.

Do not add more stone or weight. Repair using mechanically stabilized bio-engineering techniques.

Insert geotextile, geogrids or geocells layers to add internal friction. Use thick geotextiles that add internal drainage or insert thin layers of free-draining crushed rock. Place large rip below water level to protect the bank toe.
