MARINA RE-DEVELOPMENT VULNERABILITY ASSESSMENT

November 2021

TASK ORDER No. 19-07-GP/ENV(S)
ENVIRONMENTAL SERVICES PROJECTS
PROJECT No. 21077-119

PREPARED FOR: CITY OF ST. PETERSBURG

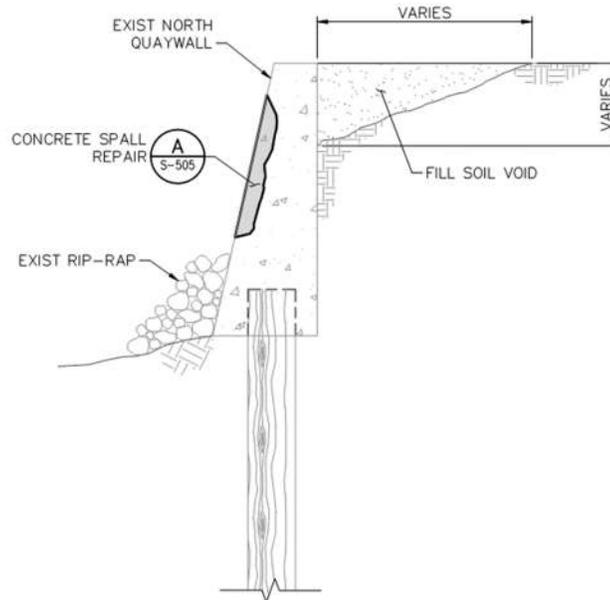
Figure 6: Wall detail from Marina Rehabilitation

The east end of the wall appears to be of similar construction to the wall at Central Basin (Demens). Repair details for that section of wall (Figure 6) are part of rehabilitation plans prepared by Moffatt & Nichol. It is unknown how the construction of the wall was verified for creation of this detail. Another possible construction detail for the wall is shown in Figure 7. This detail was developed by the St. Petersburg Department of Public Works in 1926 for an adjacent area. Due to the similar time of construction, it is likely Figure 7 reflects the actual construction of the wall.

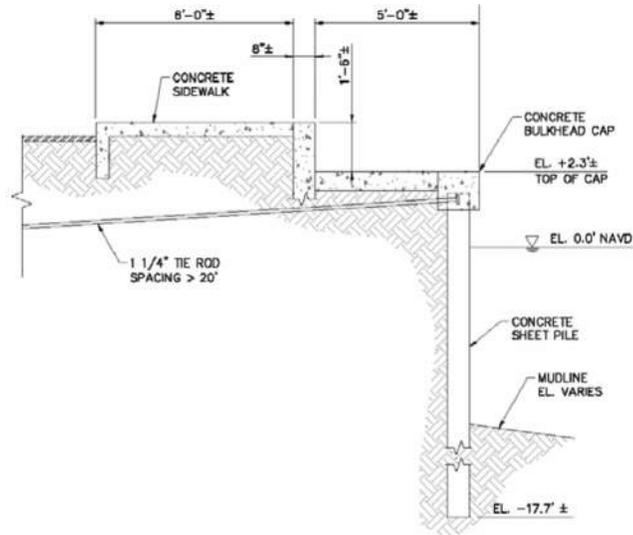
Figure 8: Concrete sheet pile wall detail
(St. Petersburg Bulkheads at Pier Approach, Moffatt & Nichol, 03/30/2018)

Figure 8 shows the believed construction of the western section of the wall. This detail was developed as part of a March 2018 technical memorandum by Moffatt & Nichol and is based on test pits, water jet probes, and additional exploration performed at that time.

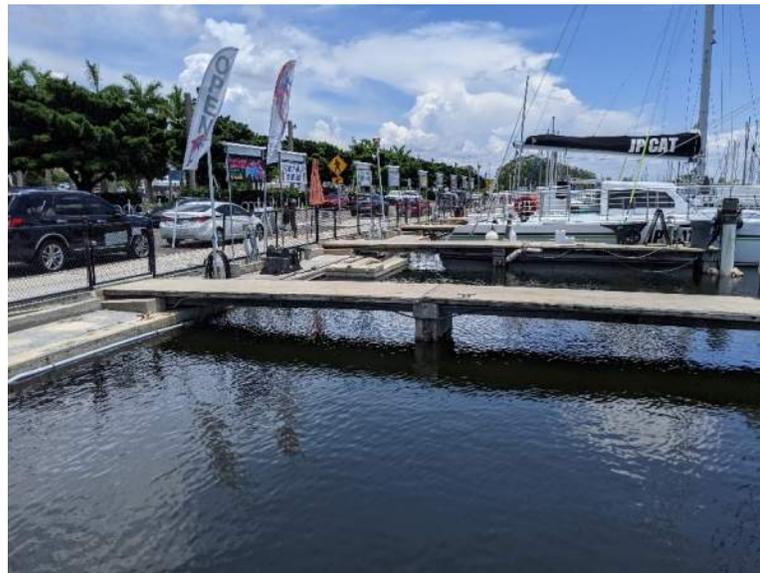
Figure 10: North Docks at the Central Basin (Pier) Wall

There are few physical conflicts present that would prevent construction of the proposed modifications. No overhead obstructions were noted that would prevent driving sheet piles. Portions of the North Docks in proximity to the wall will need to be removed, and any utilities extending from land to the docks will need to be relocated during construction (Figure 10). Pile driving can be accomplished with equipment positioned along 2nd Ave NE, or from barges to keep the pier fully available to the public.

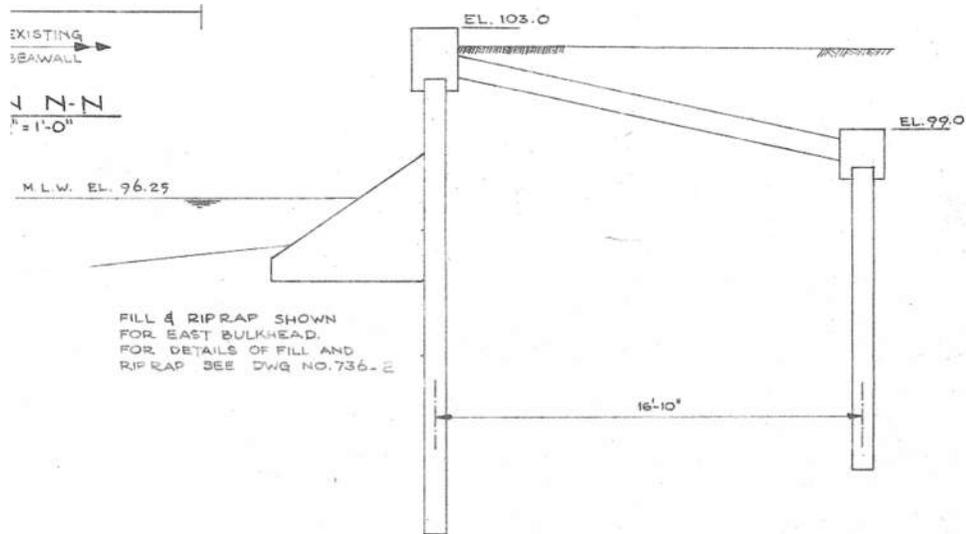
Figure 12: Typical bulkhead section from 1958 plans for Pier section of wall

The West Quay Wall and East Pier areas are both concrete sheet pile bulkhead walls with concrete caps and tie rods or beams extending back to deadmen. Original construction plans are only available for the pier area (Plans for Breakwater and Bulkheads by Parsons, Brinkerhoff, Hall & Macdonald, 1958, see Figure 12). It is believed construction of the West Quay Wall is similar to that of the Central Basin (Pier) concrete sheet pile wall.

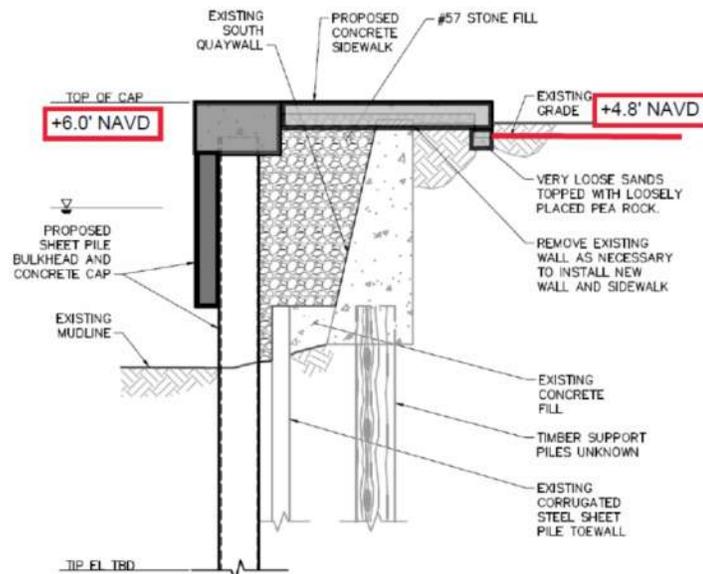
Figure 19: Proposed modifications to concrete seawall at Central Basin (Demens)

The proposed modifications to the concrete seawalls are shown in Figure 19. This detail, provided to GPI by the City, appears to be based on a proposed replacement alternative prepared by Moffatt & Nichol, but the document of origin could not be located. The original detail and the current overlaid concept are essentially identical, showing a new sheet pile wall installed in front of the existing corrugated sheet pile toe-wall. The existing wall is to be abandoned under fill with the top of wall elevation increased by 1.2 ft to EL +6.0'.

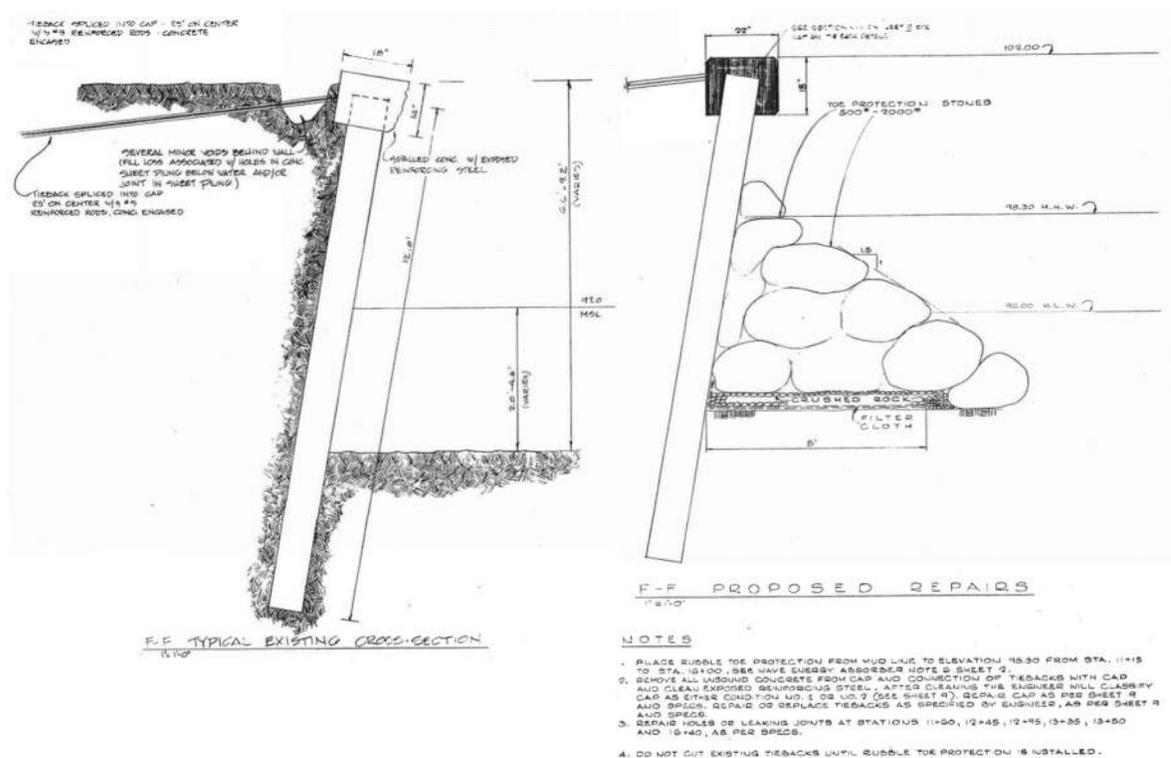
Figure 24: Details for 1976 rehabilitation of South Basin walls

This area consists of concrete sheet piles with concrete caps and tiebacks that extend back to deadmen. Original construction plans are not available, but details for a rehabilitation performed in 1976 were located in a 2005 Preliminary Evaluation Report prepared by the City of St. Petersburg (Figure 24). Based on these details, it appears the sheet piles had rotated and were rehabilitated by reconstructing the concrete caps to be level again and installing large rubble riprap with stones ranging from 500 to 2000 lbs.

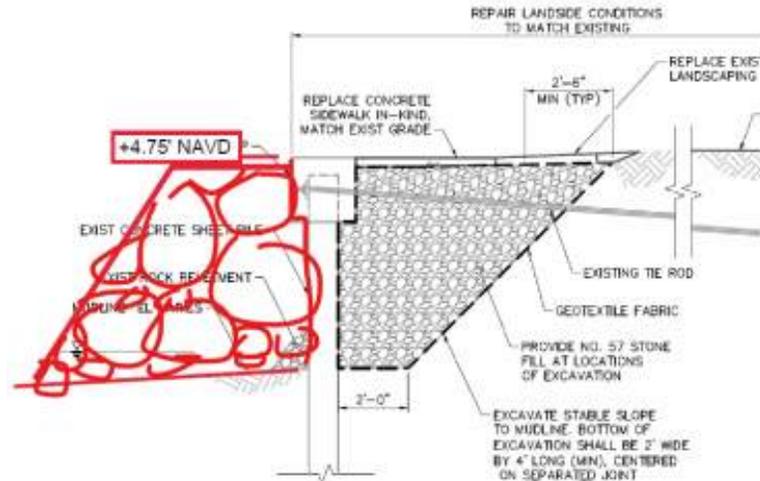
Figure 25: Proposed modifications at South Basin

The proposed modifications to this area are shown in Figure 25. This detail, provided to GPI by the City, appears to be based on a detail in proposed rehabilitation plans prepared by Moffatt & Nichol but deleted in Revision 1 of that document. The original detail and the current concept are nearly identical, showing excavation behind the wall to install geotextile fabric and stone fill. The current concept adds rubble riprap to provide additional protection to the wall.

While the proposed modifications are feasible, they are not recommended. The condition of the concrete sheet piles, both noted in the inspection report and verified during the GPI site visit, show extensive corrosion throughout the sheet piles. Spot repairs along the sheet piles would both be too numerous to be cost effective and generally not desirable due to the "halo effect" described in the Central Basin (West Quay Wall / East Pier) section. Cathodic protection measures to halt the progression of corrosion in the wall are not advisable due to the high cost associated with protecting a wall showing advanced deterioration. It is recommended that the sheet piles wall in this area be replaced.
