# Fishway Assessment and Cost Analysis Report

ROYAL RIVER, YARMOUTH ME

**PREPARED FOR THE NATURE CONSERVANCY  
FINAL – JULY 2017**

**INTER-FLUVE  
P.O. BOX 236  
DAMARISCOTTA, ME 04543**

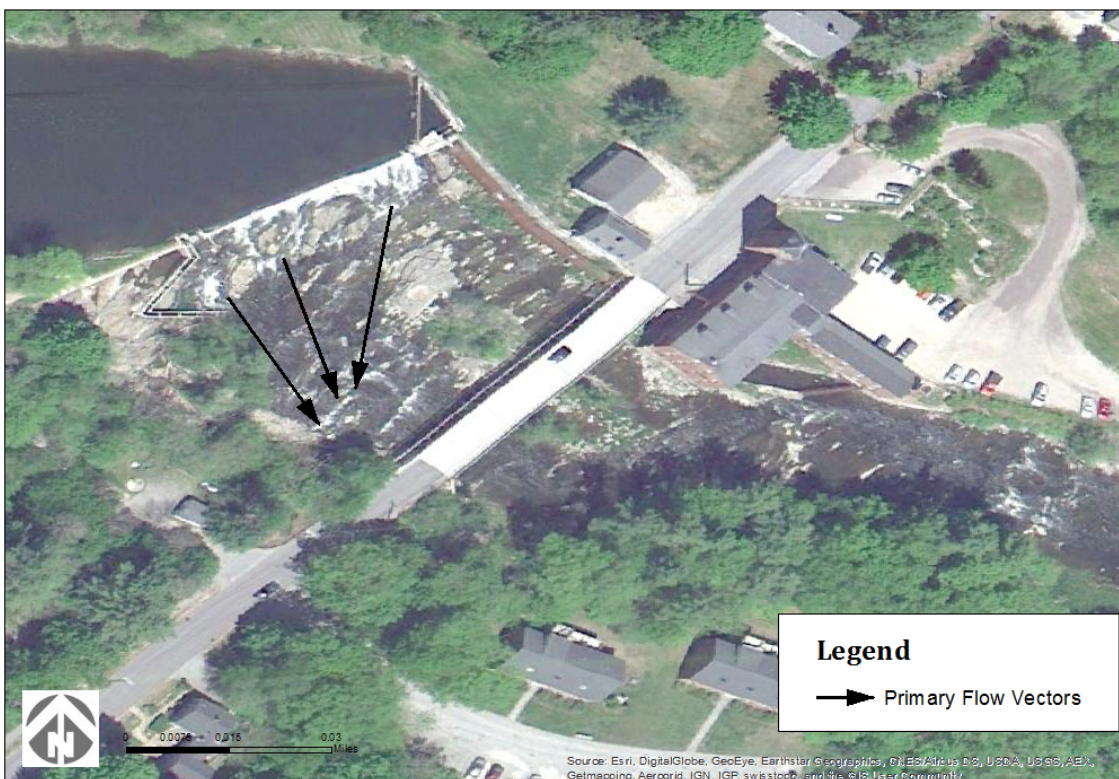
As upstream migrating fish approach the zone of passage, they first encounter the tailrace of the Sparhawk hydroelectric facility (Figure 7). During periods of operation, with maximum diversion capacity of approximately 250 cfs, this outflow could cause a competing signal for upstream passage as it equates to a substantial proportion of the total river flow over much of the fish passage operational range (Table 6 and Figure 6). However, the current operational status and future plans are unknown. At the time of the field assessment, the hydroelectric facility did not appear to be in active generation. If only modest generation were to occur, this competing attraction signal will be less of a concern.

**Figure 8: Site map of the Bridge Street site indicating primary flow vectors. Date of imagery is May 16, 2010. Flow direction is left to right.**

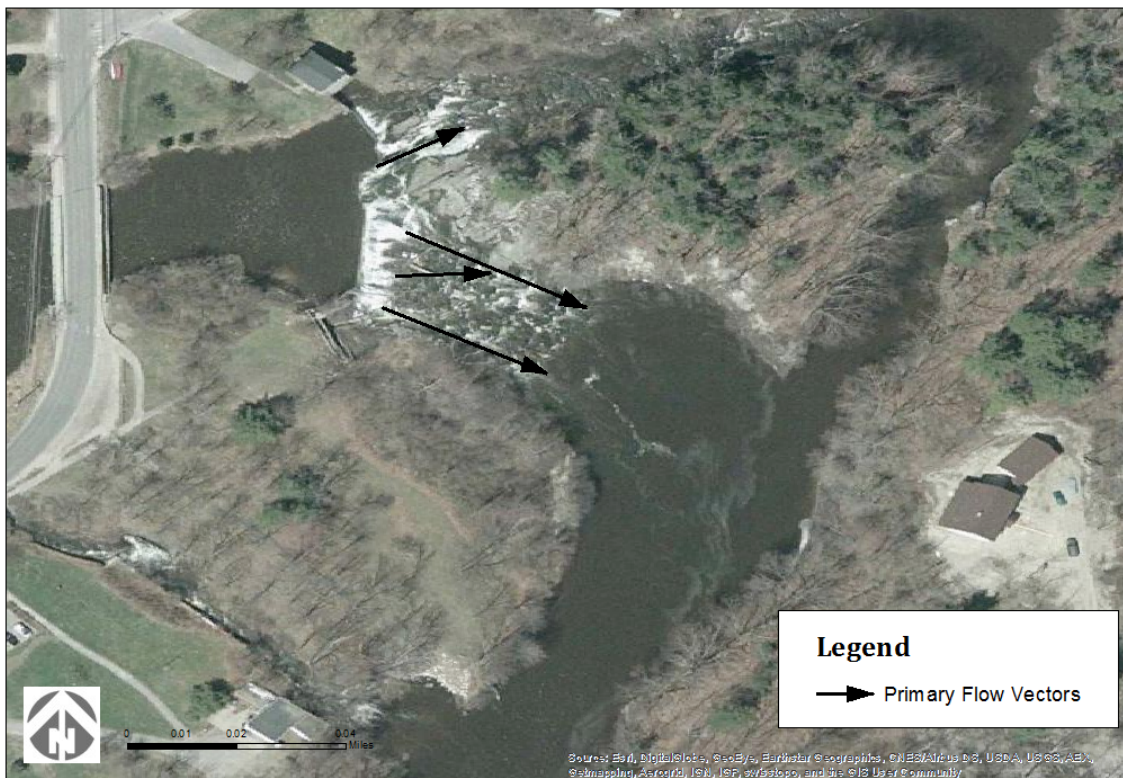
As upstream migrating fish approach the zone of passage, they first encounter the outlet of the foundry channel (Figure 9). Based on review of the aerial photography, the flow out of the foundry channel does not appear to create a substantial attraction cue (Figure 10), although the flow analysis reported in the next section suggests that the channel could convey a substantial proportion of the total flow particularly in the lower half of the fish passage flow range. The foundry channel does not appear to offer a passage pathway at present as the downstream confluence is over a relatively steep confluence fan with minimal depths of flow. In addition, there is a substantial vertical drop greater than 3 feet in height located in the upper 1/3 of the foundry channel where it flows over a former mill foundation or control structure.

outflow from the left (or back) side of Gooch Island also does not appear particularly prominent in the aerial photo record suggesting the primary attraction cue will be to the river right side of the island (Figure 9 and Figure 10).

Upstream migrating fish will then encounter the ledge outcrop approximately 150 feet downstream of the spillway and fishway entrance. Over the aerial photographic record, the predominant flow patterns downstream of the spillway over the ledge outcrop diverge into two primary streams (Figure 10). The first is located at river right extending downstream of the fishway entrance. It appears that ledge may have been removed along this alignment to facilitate use of the fishway. The second primary flow path is adjacent to Gooch Island. Based on the presence of the competing primary flow streams in addition to the dispersed and variable nature of flow over the ledge, far field attraction to the fishway is likely fair to poor over much of the fish passage flow range. Similar to the Bridge St. site, this trend is exacerbated by the relatively modest discharge that is able to be passed through the fishway while still operating in the target flow condition for upstream passage (discussed in more detail below).

**Figure 10: Site map of the East Elm Street site indicating primary flow vectors. Date of imagery is December 31, 2002. Flow direction aligns with flow vectors.**

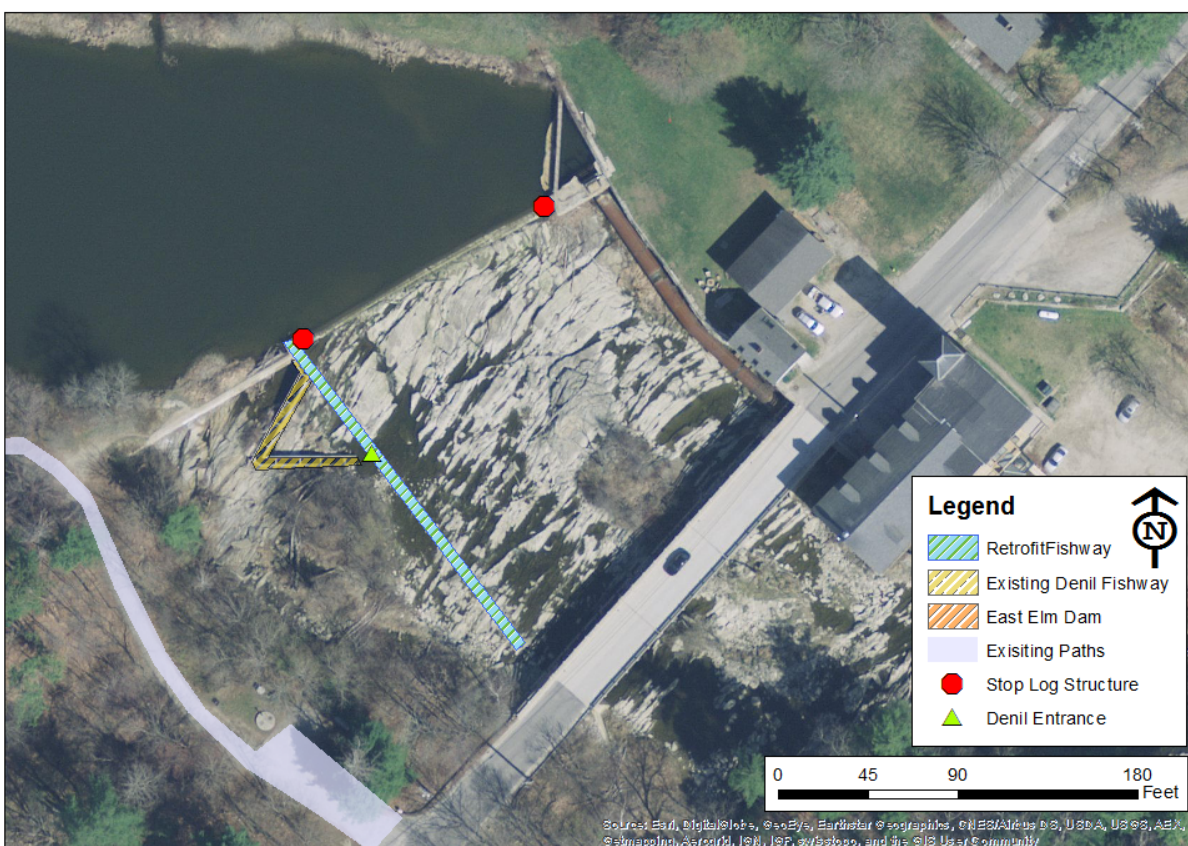
**Figure 11: Possible Bridge Street dam site alignment and dimensions of new Denil fishway to meet USFWS criteria (Table 4).**

The new Denil fishway would follow the design criteria established by the USFWS (2016). Specifications for the new fishway include 4-foot standard width, 1:8 slope, straight alignment, greater depth than the current structure, and increased resting pool length to meet EDF requirements. This alternative would also include installation of an eel ramp to facilitate passage by juvenile eels, selected dam and ledge modifications to facilitate safe downstream passage, and selected ledge modifications in the primary channel leading to the fishway entrance to facilitate upstream migration. The new fishway would be 45 feet longer than the existing fishway. One possible alignment for the new Denil fishway is shown in Figure 11.

In terms of qualitative fish passage potential, because the fishway entrance is substantially downstream of the dam, near-field attraction to the Denil may be challenged. Preliminary hydraulic calculations suggest that up to 4% of the high fish passage flow could be passed through new fishway with mean velocity of approximately 5.3 feet per second as long as the water control structure at the fishway exit remains functional.

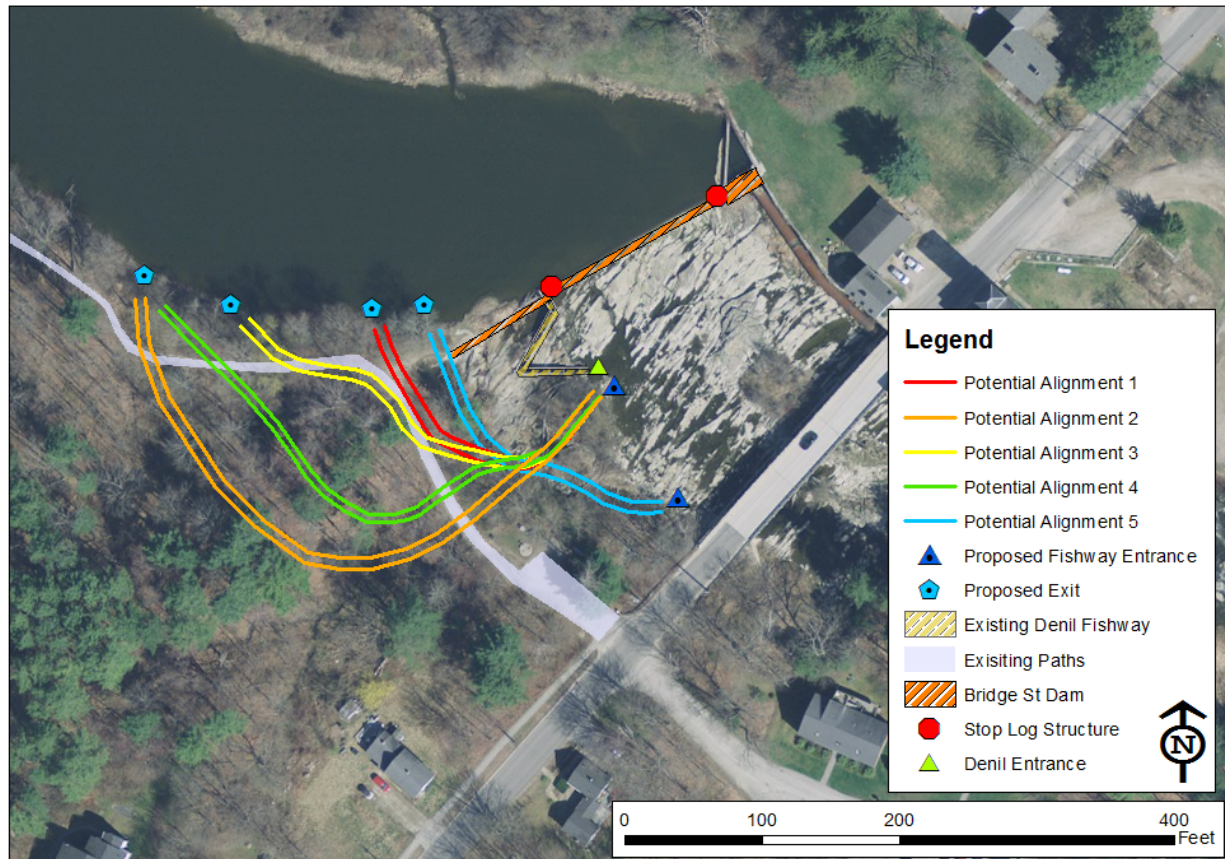
**Figure 12: Potential alignment options for the nature-like fishway alternative at the Bridge Street dam Location. Potential nature-like fishway construction constraints are included, such as pump station and drainage outfall locations.**

Additional design development would be required to optimize the nature-like bypass approach. However, several potential alignments were identified (Figure 12), which range in average channel slope from ~2.5-7% (Table 15). Ideal nature-like average channel gradients fall in the 2% to 3% range or less, with a maximum of up to 5%. Flatter channel slopes will facilitate passage by the broadest range of target species. These potential alignments would accommodate 100% of low fish passage flows (95% exceedance quantile), 60% of median fish passage flows (50% exceedance quantile), and up to 20% of high fish passage flows (5% exceedance quantile). All alignment options would make use of natural channel features such as pools and riffles, step-pools, and resting boulders to dissipate energy and create a diversity of flow patterns that fish would utilize as they ascend the channel, similar to native flow patterns in a natural stream. The differences between the alternative alignments are generally simply related to their overall lengths. With a longer channel alignment, the associated slope will be flatter. With flatter slope, velocities and hydraulic forces are reduced, leading to a higher degree of fish passage performance. The diversity of velocity and depth within the nature-like fishway would result in sufficient opportunity to increase the success rate of upstream passage (Aaerstrup 2003; Calles and Greenberg 2005).

The potential Bridge Street Dam bypass channel would connect into the main channel upstream and downstream of the dam on river right. Several of the alternative alignments would require construction on the Town of Yarmouth parcel as well as an adjoining private parcel adjacent to the right dam abutment. Downstream constraints for the alignment of this alternative include sanitary sewer infrastructure 125 feet downstream of the dam on river right. Several of the alternative alignments shown in Figure 12 cross the existing footpath adjacent to the river, which would require reconfiguration of a short stretch of the path, and possible addition of a footbridge. For the purposes of the cost analysis, a 481-foot-long nature-like bypass channel was assumed, which represents the lowest slope option listed in Table 15. This is a conservative assumption, as this also results in the longest length of channel construction and hence the greatest estimated construction cost among the alternative alignments shown.

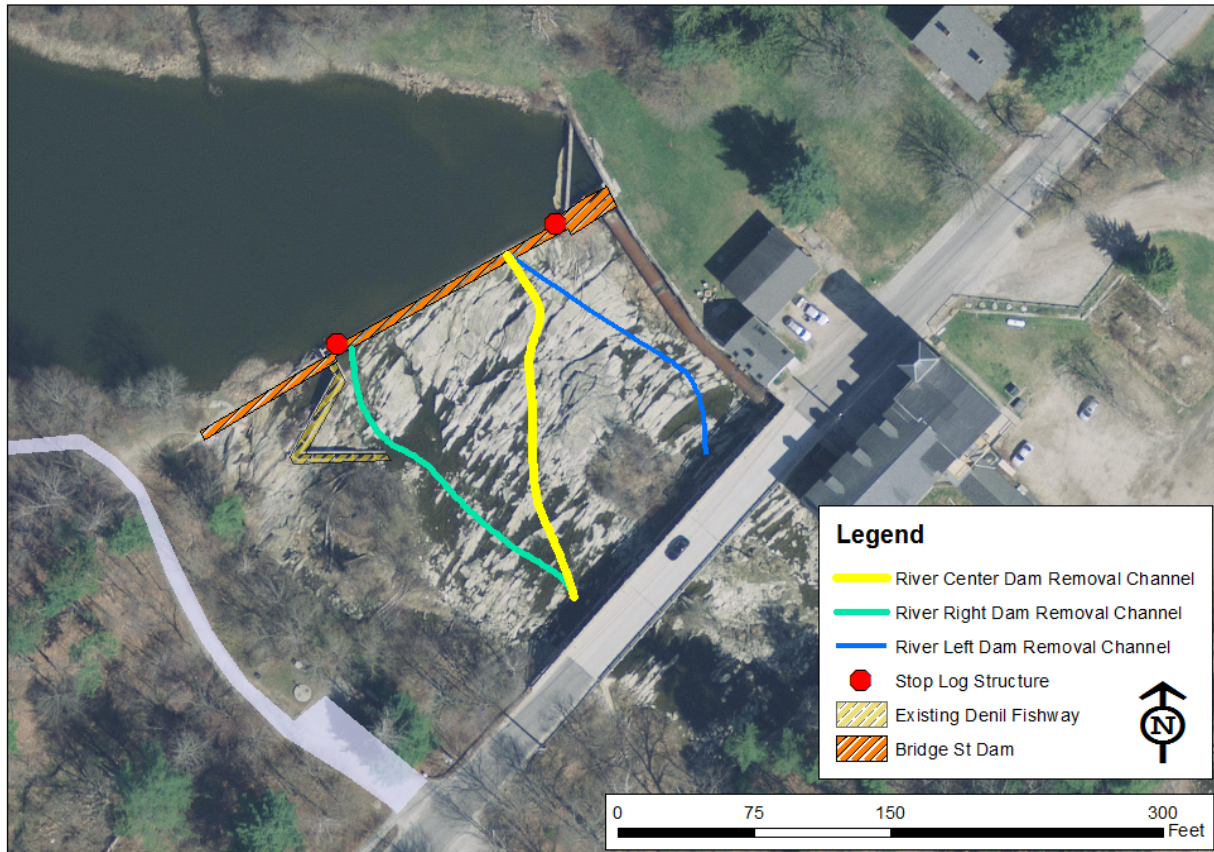
Figure 13: Probable post-dam-removal fish passage channels at the Bridge Street Dam site.

Based on the current observable site condition, probable post-dam removal fish passage channels are indicated in Figure 13. These alignments were estimated based on comparisons of bedrock elevations, field observations, and aerial photograph analyses, and constitute the likely primary flow paths if the spillway were to be removed. Slopes and lengths of these channels are provided in Table 16. The average channel gradients along these alignments are relatively steep. It is anticipated that the diversity of flow patterns along the ledge outcrop would provide a variety of opportunities for passage by native fish, similar to that which occurs in numerous rivers in similar settings along the Maine Coast. However, it was also assumed that select enhancement of passage conditions through ledge modification may be required associated with dam removal. Optimization of the passage design associated with dam removal would need to be advanced in subsequent project phases.

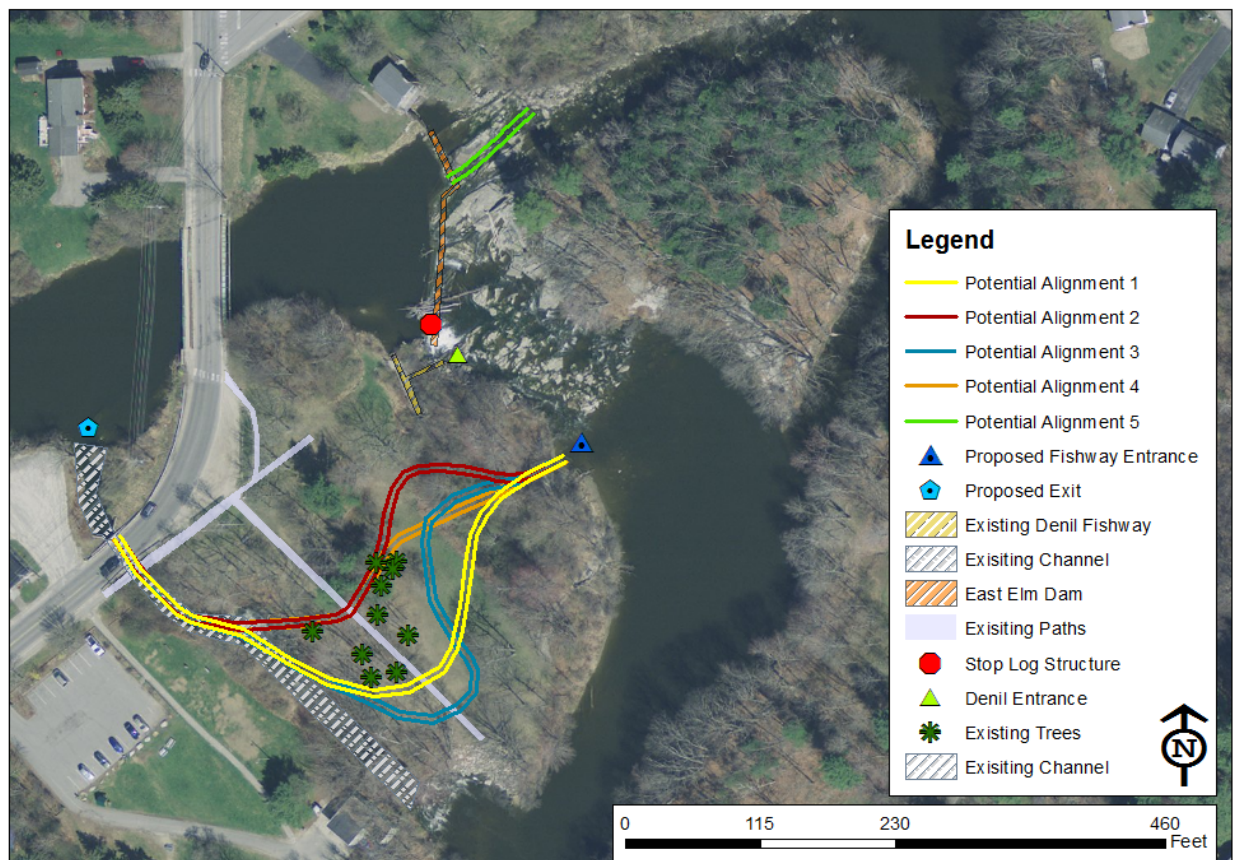
**Figure 15: Potential alignment options for the nature-like fishway alternative at the East Elm Street dam site.**

As with the Bridge Street site, additional design development would be required to optimize the nature-like bypass approach. However, several potential alignments were identified (Figure 15), which range in average channel slope from ~2.5-3.7% (Table 17). The alternative alignment 5 takes advantage of an existing seam in the ledge outcrop near the left end of the spillway, and would require additional investigation of the potential for ledge outcrops upstream of the dam spillway to fully establish its feasibility. This alignment would route passage flows around the back side of Gooch's Island, which would likely provide adequate attraction signal at low passage flows, but may be more limited at high fish passage flows.

The remainder of the alternate alignments shown in Figure 15 would make use of the upstream inlet to the existing foundry channel. These alignments split from the foundry channel downstream of the historical spillway in the foundry channel, bending towards the main river channel across the park, with a fishway entrance at the terminus of the ledge outcrop in the existing main channel pool.

Except for alignment 5, all of the alignments shown in Figure 15 would require construction on the adjacent parcel owned by the Town of Yarmouth. The same alignments cross the existing footpath between the foundry channel and the main river channel. This would require reconfiguration of a short stretch of the path, and possible addition of a footbridge. For the purposes of the cost analysis, a 512-foot-long new segment of channel was assumed. Added to the existing length of the foundry channel that would be utilized, this results in an assumed 652-foot-long nature-like bypass alignment, which represents the lowest slope option listed in Table 17. This is a conservative assumption, as this also results in the longest length of channel construction and hence the greatest estimated construction cost among the alternative alignments shown.

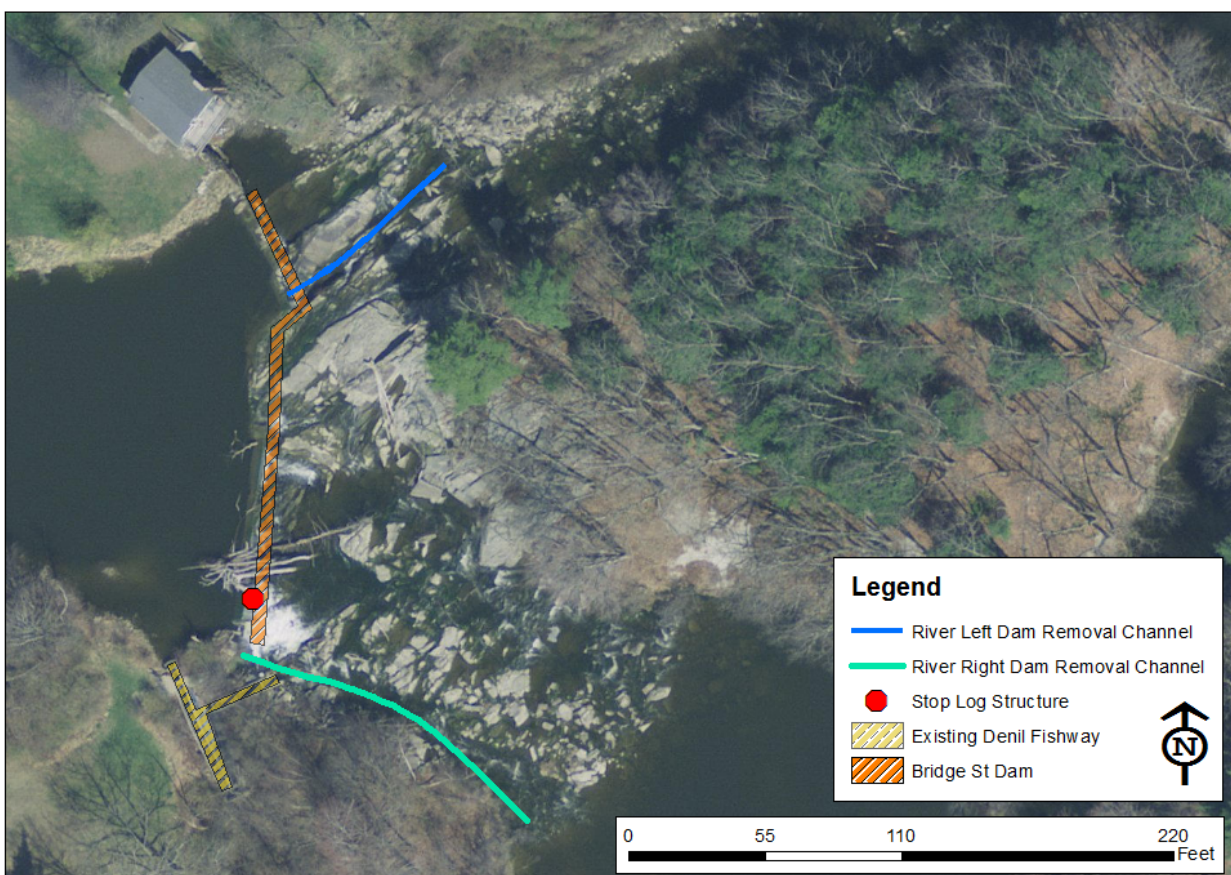
Figure 16: Probable post-dam-removal fish passage channels at the East Elm Street dam site.

elevations, field observations, and aerial photograph analyses, and constitute the likely primary flow paths if the spillway were to be removed. Slopes and lengths of these channels are provided in Table 18. As with the Bridge Street dam removal alternative, the average channel gradients along these alignments are relatively steep. It is anticipated that the diversity of flow patterns along the ledge outcrop would provide a variety of opportunities for passage by native fish, similar to that which occurs in numerous rivers in similar settings along the Maine Coast. However, it was also assumed that select enhancement of passage conditions through ledge modification may be required associated with dam removal. Optimization of the passage design associated with dam removal would need to be advanced in subsequent project phases.

See Section 5.1 for additional assumptions in the cost analysis related to mitigation of infrastructure impacts and sediment management. Sediment management associated with removal of East Elm Street dam in particular is a potentially major cost factor.
