Cross Lake Channel Rock Assessment
Lake Okeechobee Waterway
Route 1

Martin and Palm Beach Counties
Florida

Final Report

December 2021

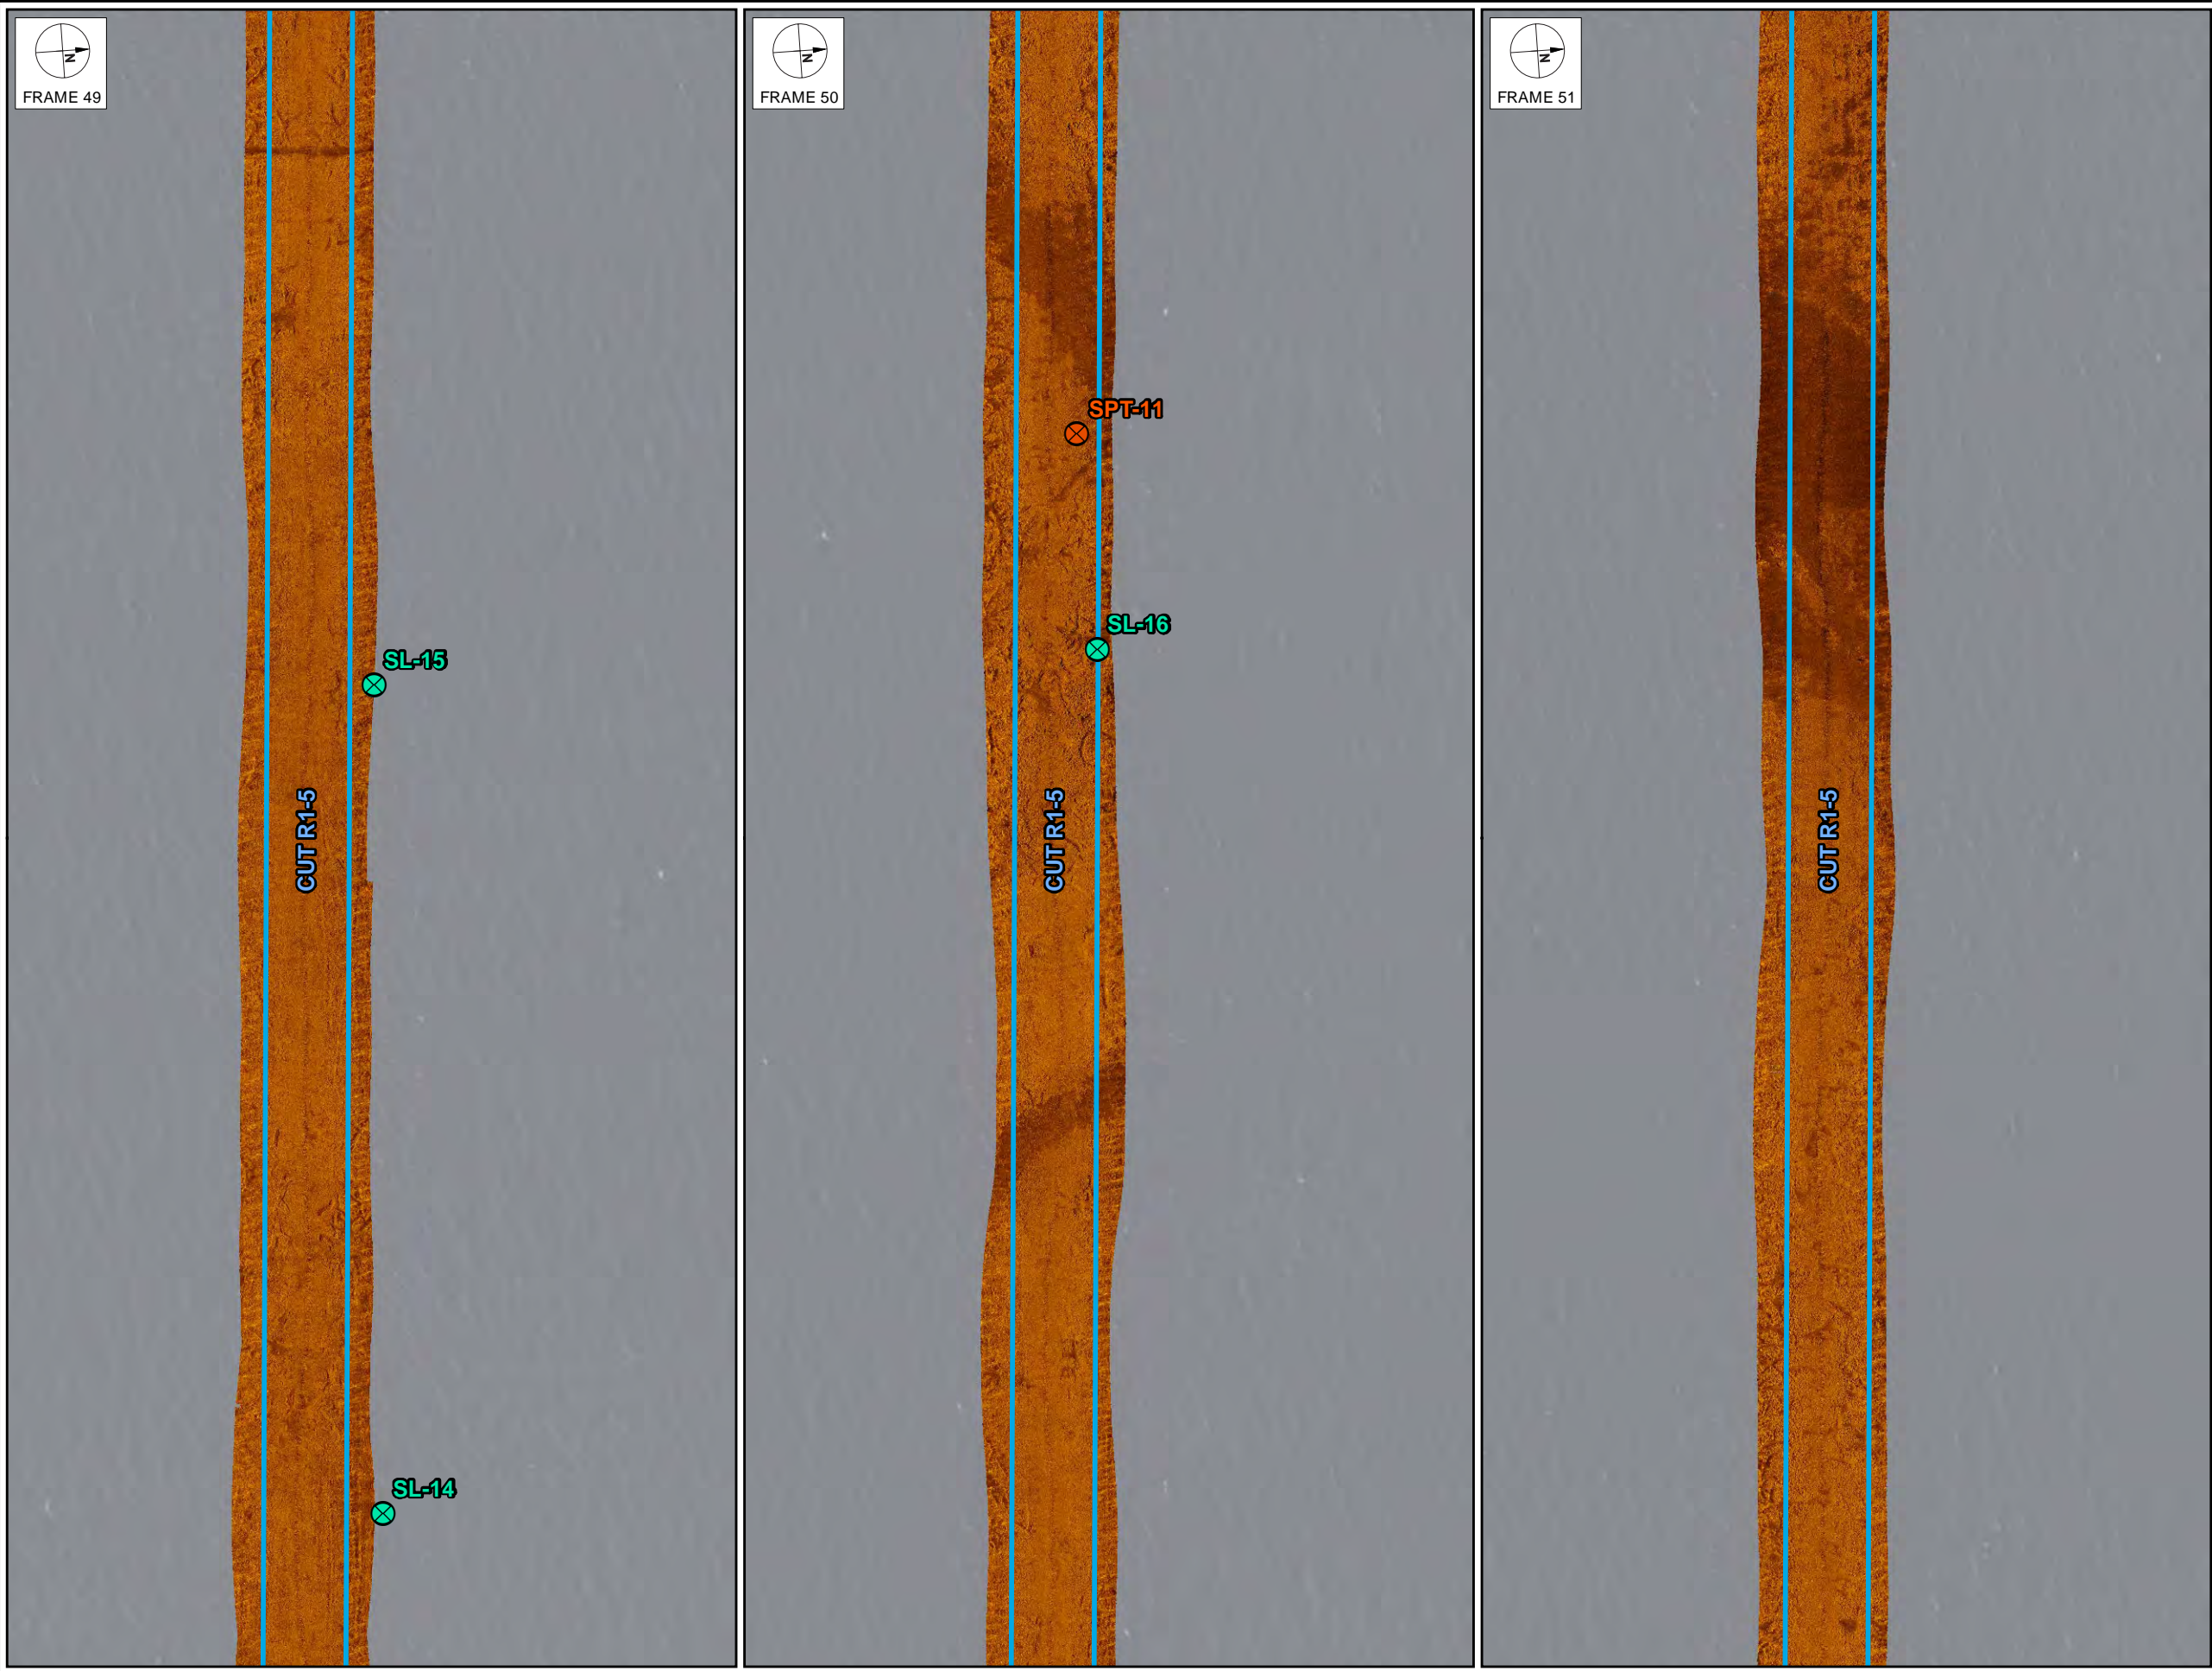
FLORIDA INLAND
NAVIGATION DISTRICT
LAKE OKEECHOBEE
ROUTE 1 CHANNEL
ROCK ASSESSMENT
SIDE SCAN SURVEY IMAGES

To obtain a representation of shoal composition throughout the OWW Route 1 Channel, Taylor Engineering reviewed the side scan images, SPT boring data, and survey data. Taylor Engineering interpreted side scan imagery based on the strength of the return signal to evaluate the channel bottom surface geology. Brighter colors (stronger signals) indicate harder, rocky surfaces, while darker colors (weaker signals) indicate softer, loose sediment surfaces. The side scan analysis revealed two main bottom types: exposed rock and unconsolidated sediment. Taylor Engineering then compared the side scan imagery to the boring logs and sediment grab samples to ground truth the side scan channel-bottom interpretation. Boring data indicated the exposed rocky surfaces are composed of limestone, while unconsolidated sediments vary between altering amounts of silt, sand, and shell. **Appendix D** provides a geologic map of the shoals within the Route 1 Channel (above -10-ft Lake Okeechobee Datum) created using the side scan imagery and boring log interpretation where red indicates limestone rock and yellow indicates unconsolidated sediment.

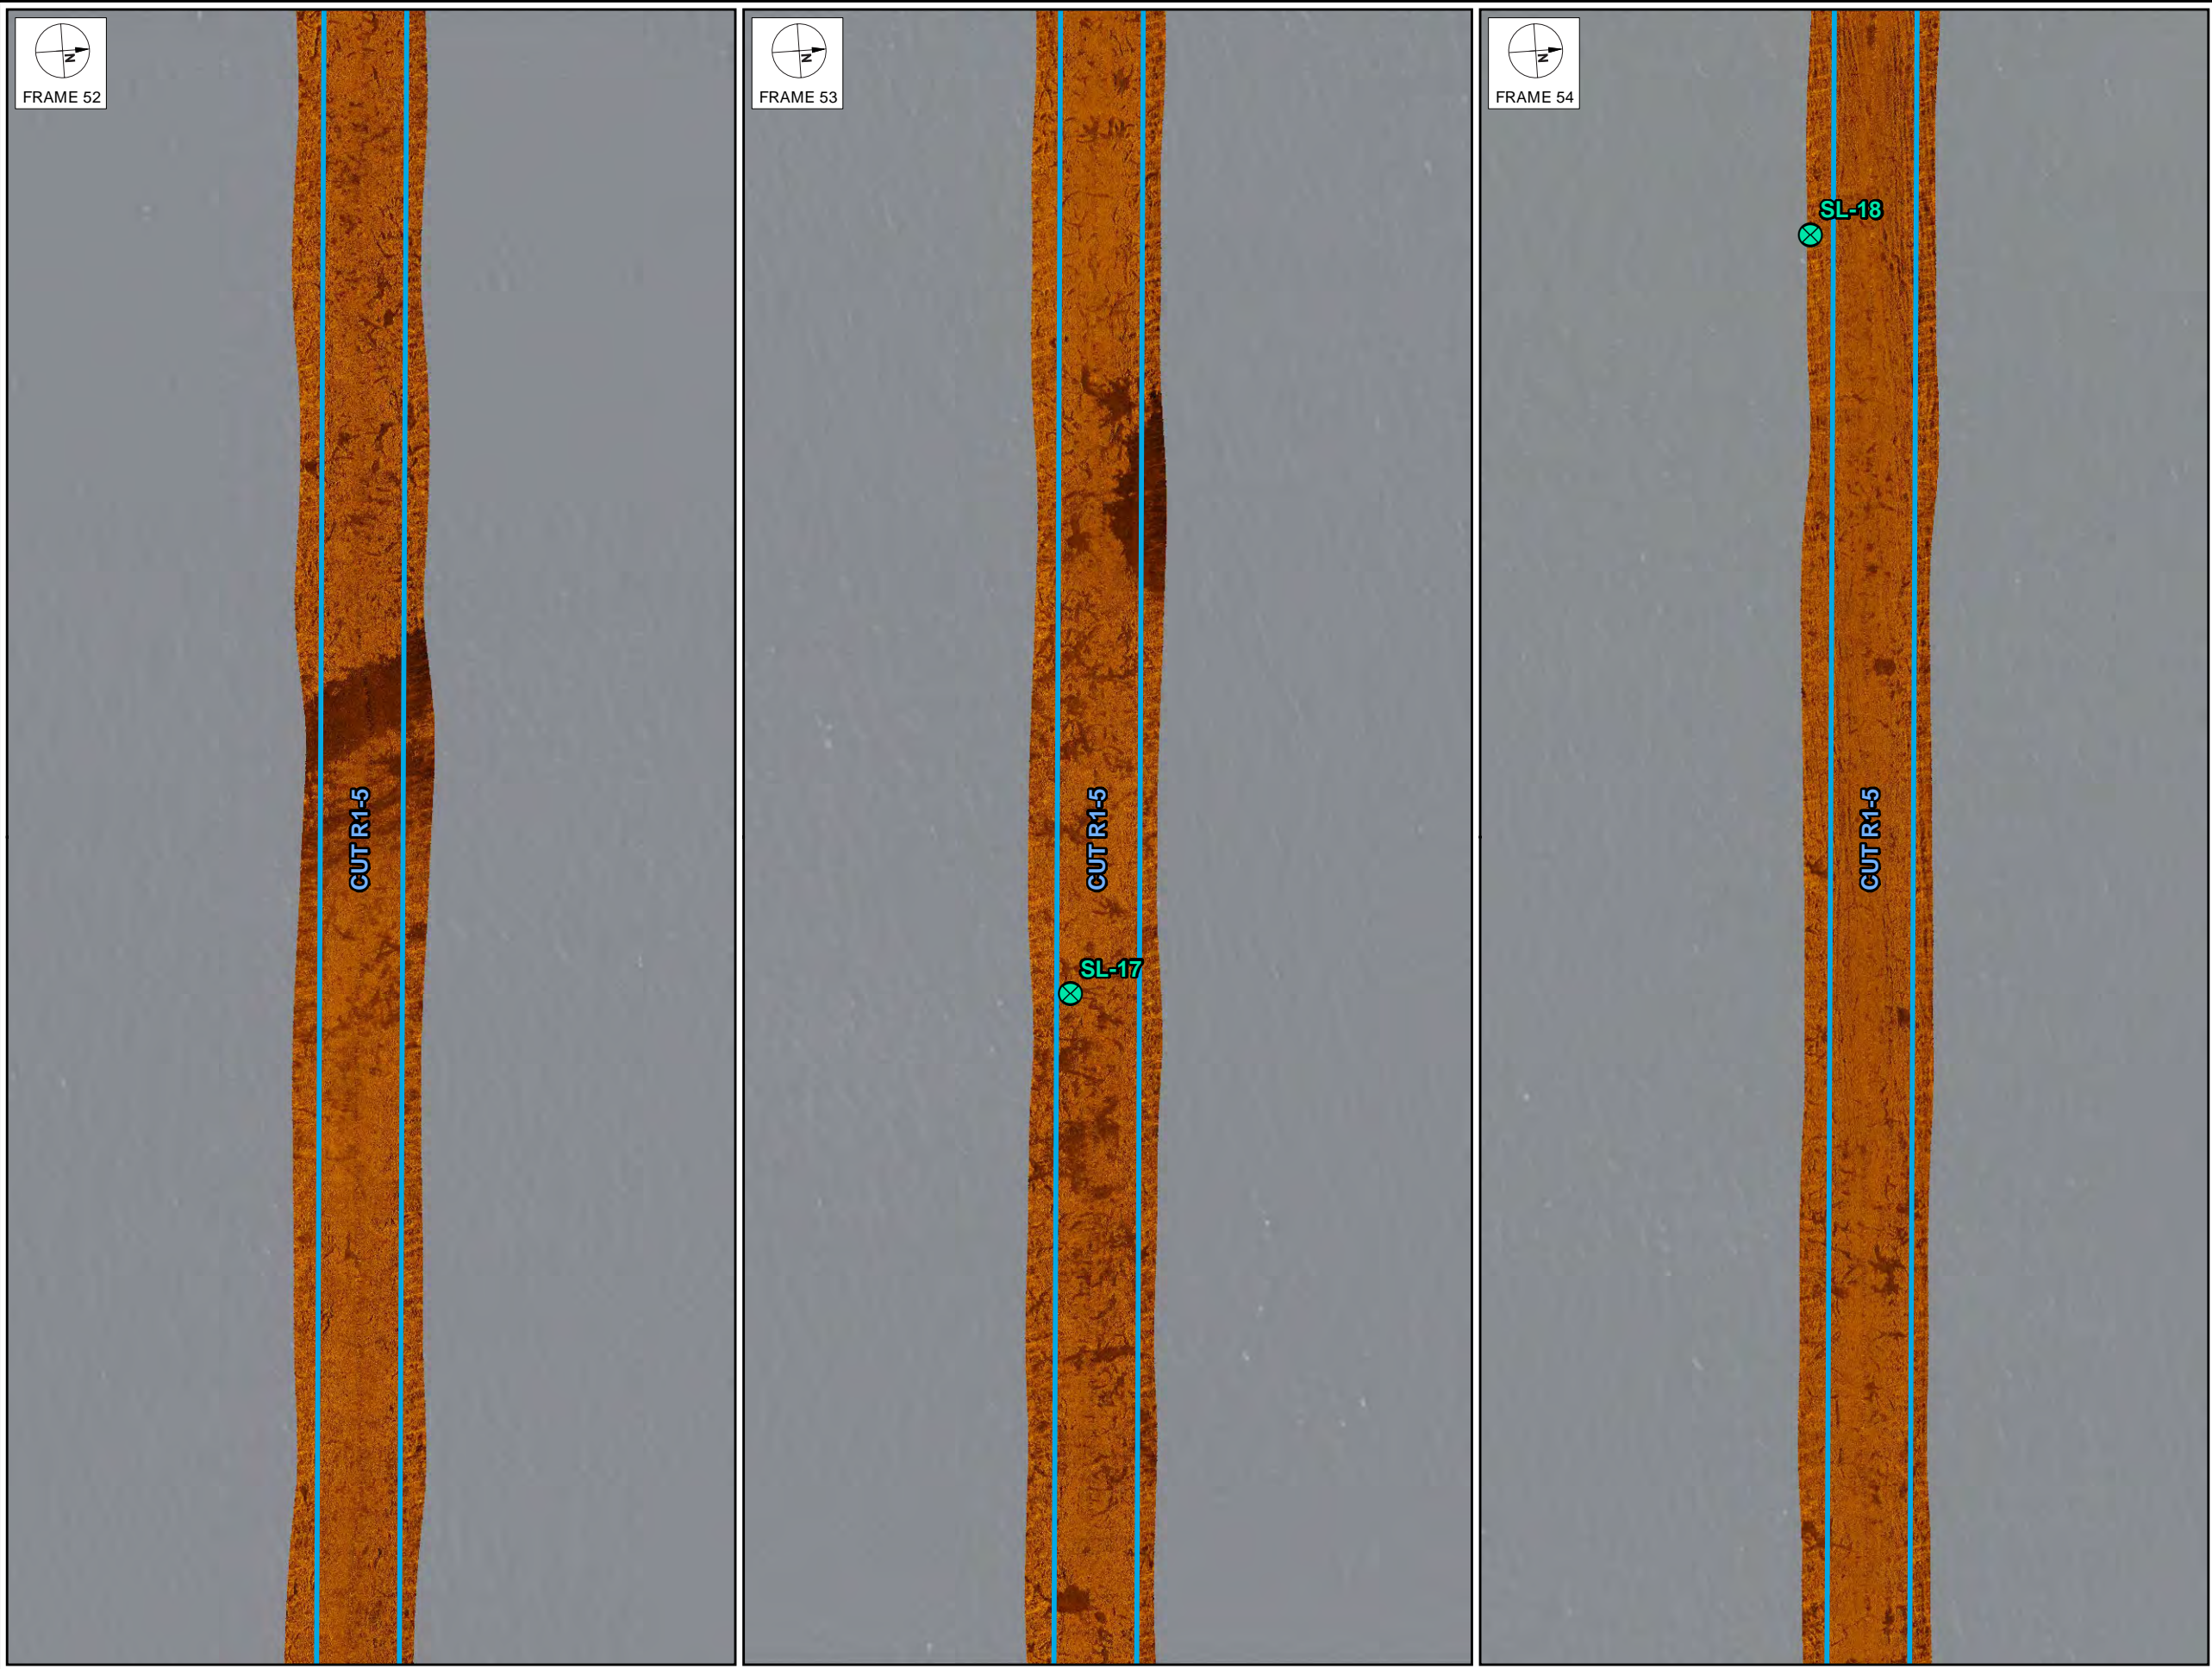
FLORIDA INLAND
NAVIGATION DISTRICT
LAKE OKEECHOBEE
ROUTE 1 CHANNEL
ROCK ASSESSMENT
SIDE SCAN SURVEY IMAGES

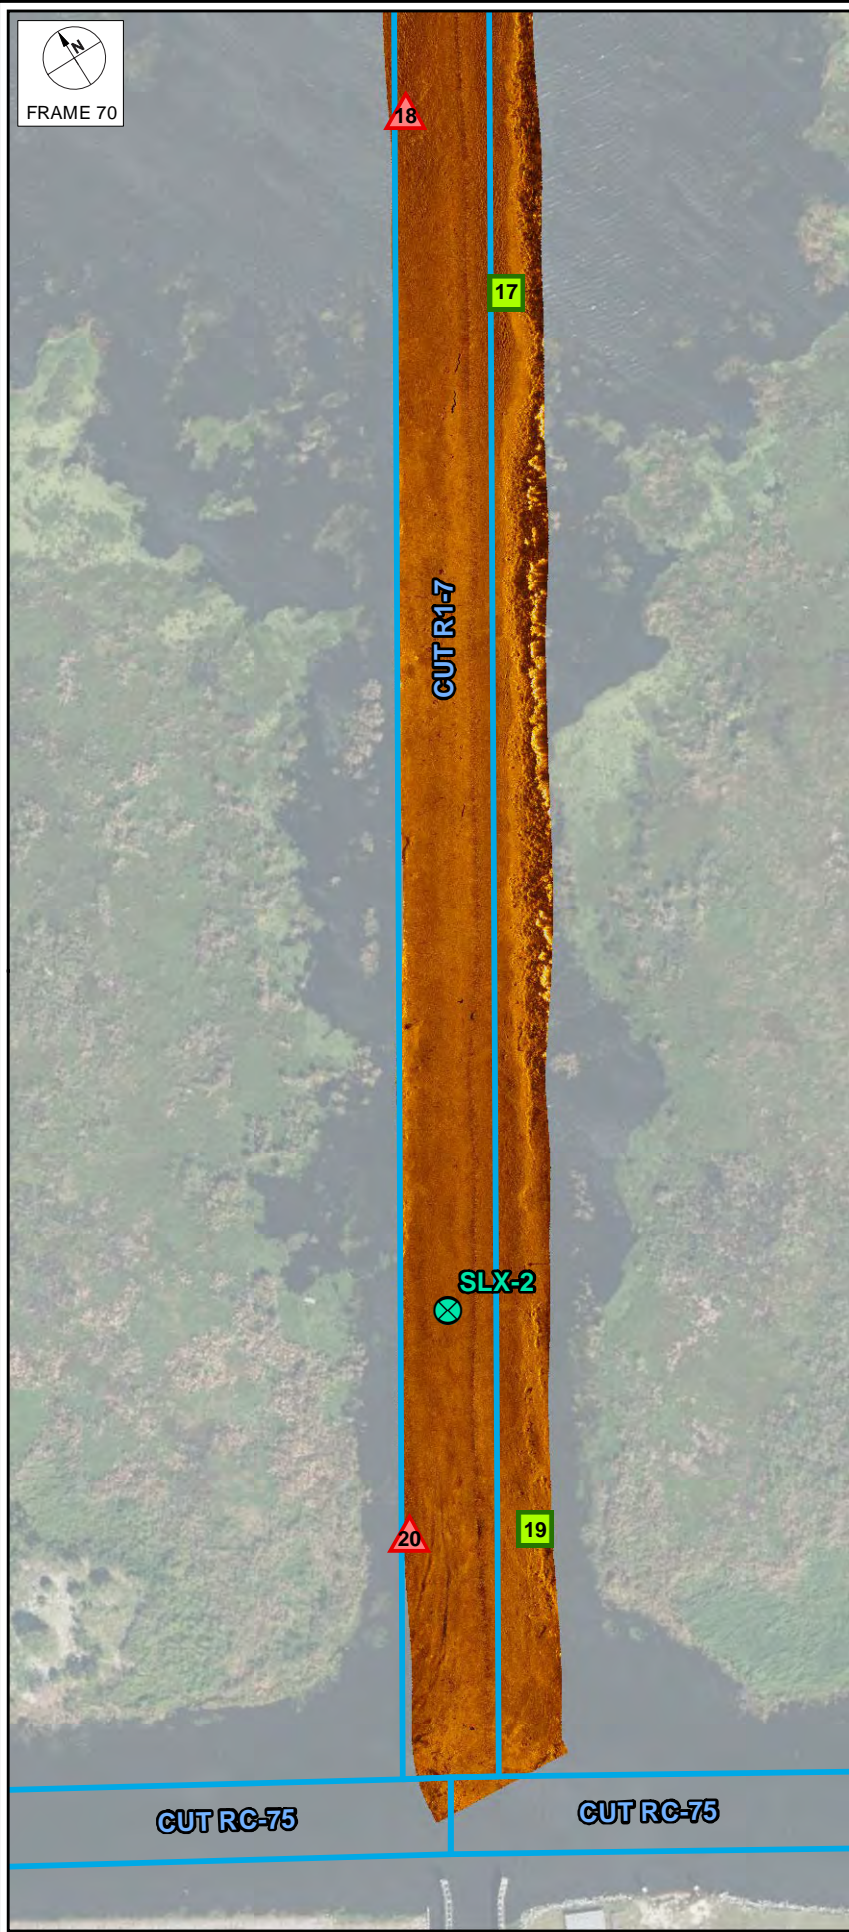
FLORIDA INLAND
NAVIGATION DISTRICT
LAKE OKEECHOBEE
ROUTE 1 CHANNEL
ROCK ASSESSMENT
SIDE SCAN SURVEY IMAGES

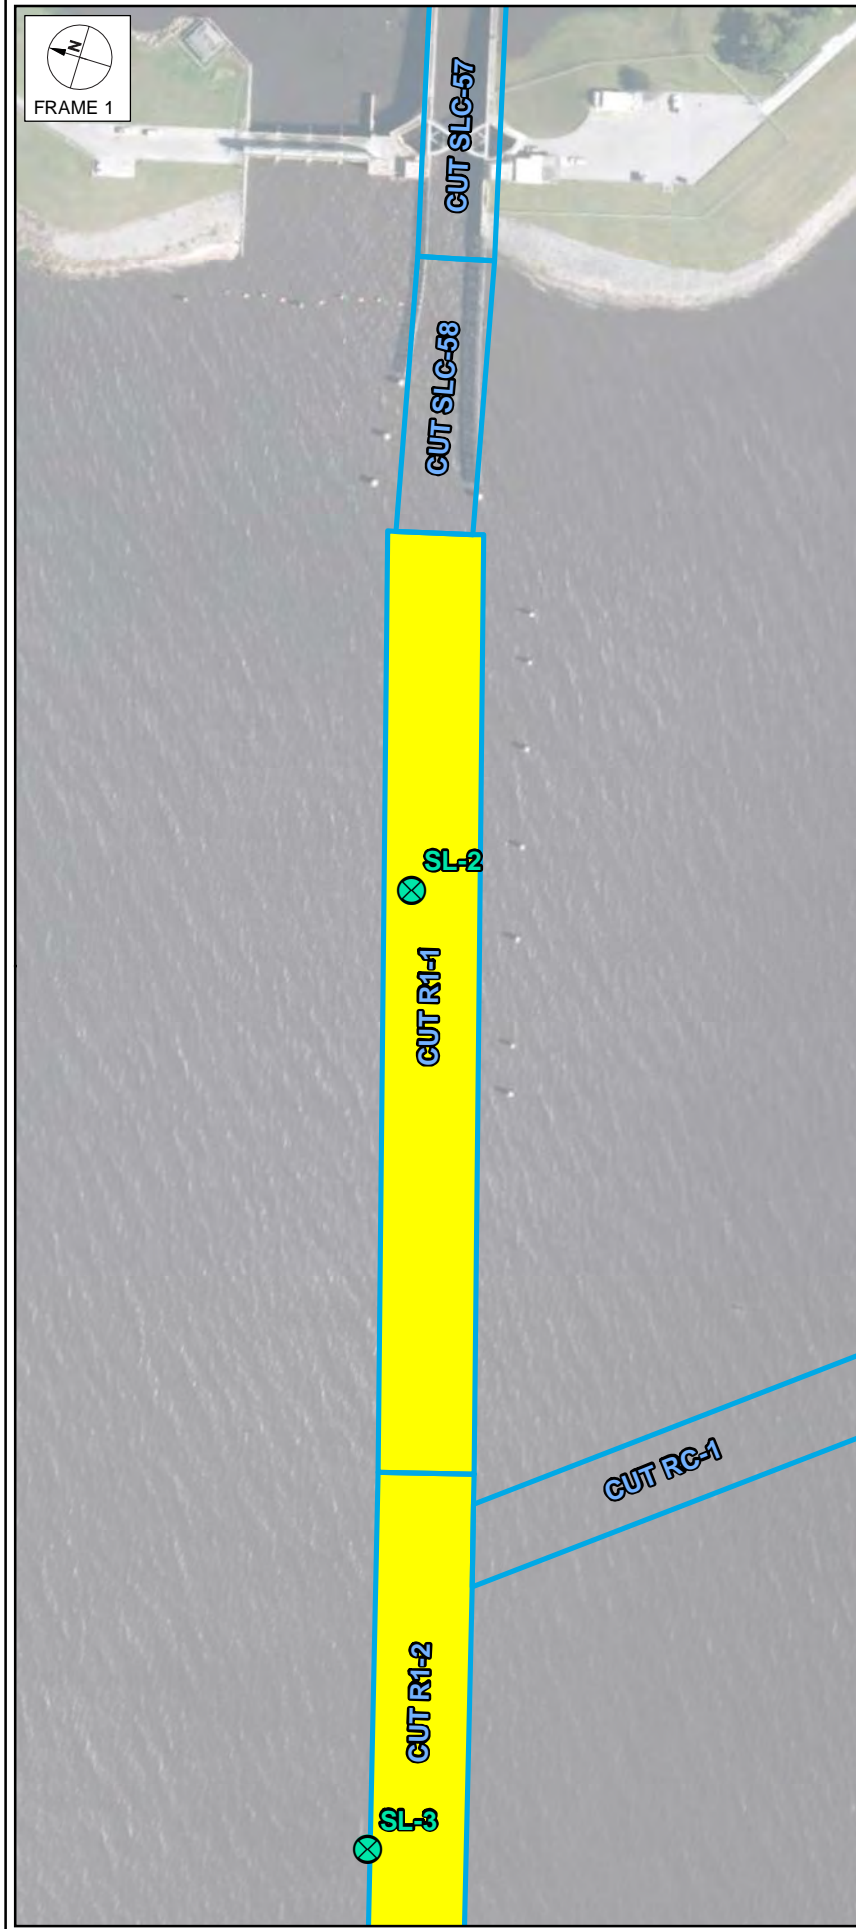
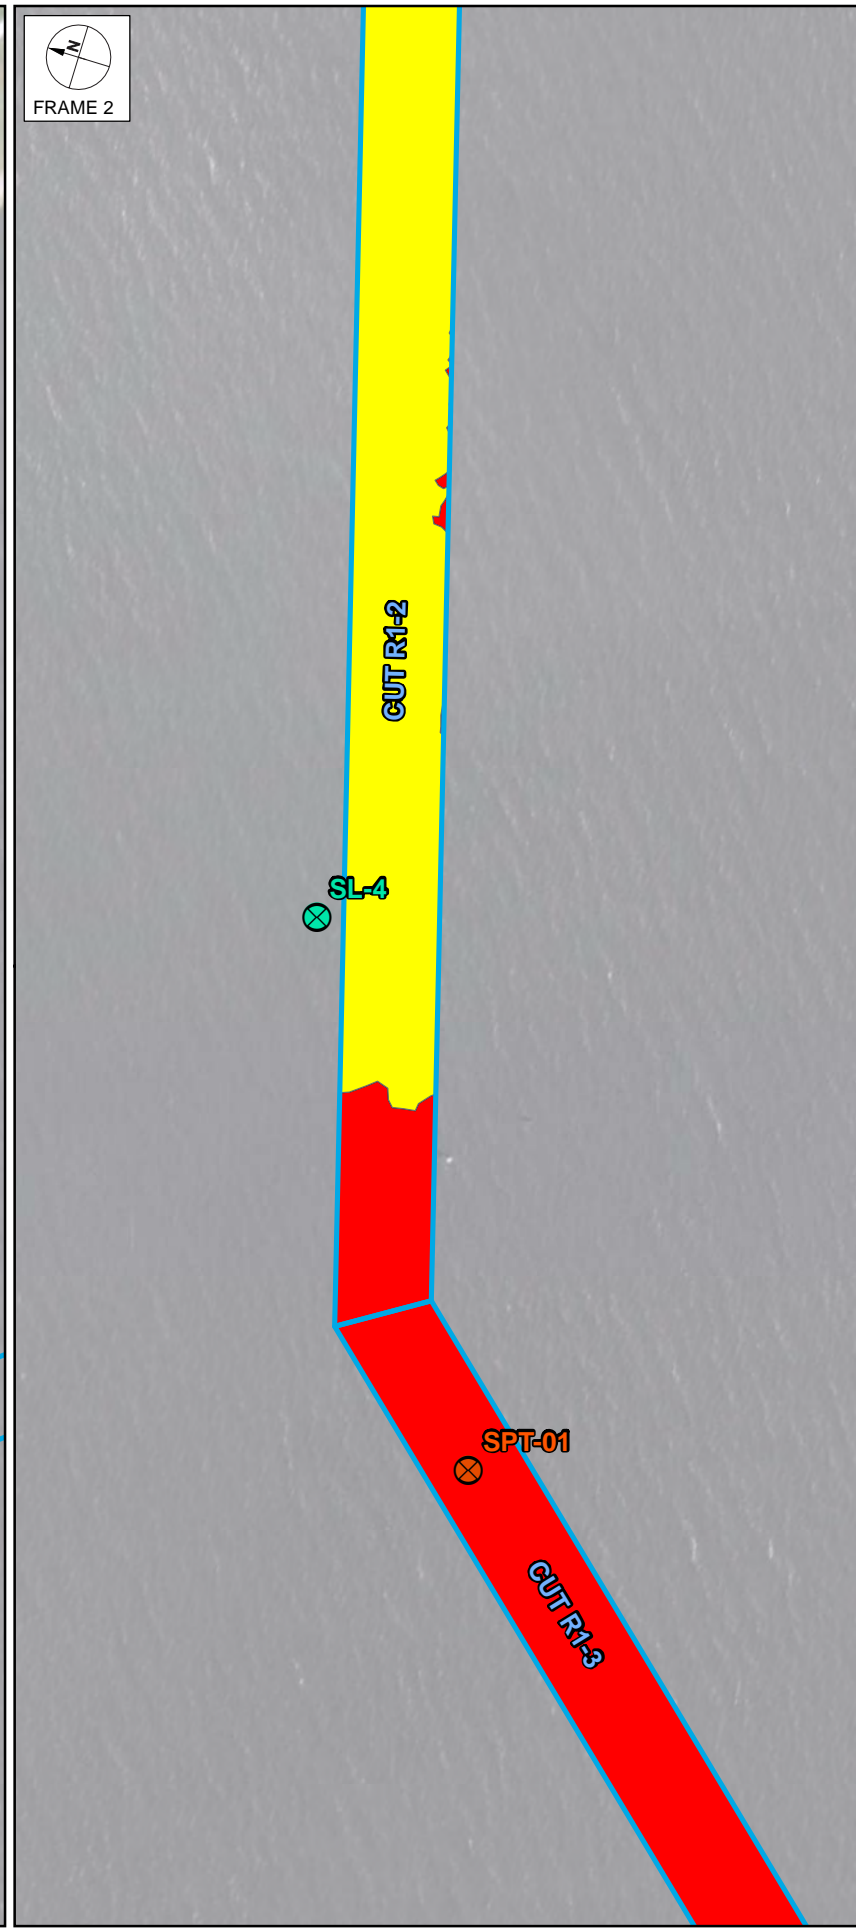
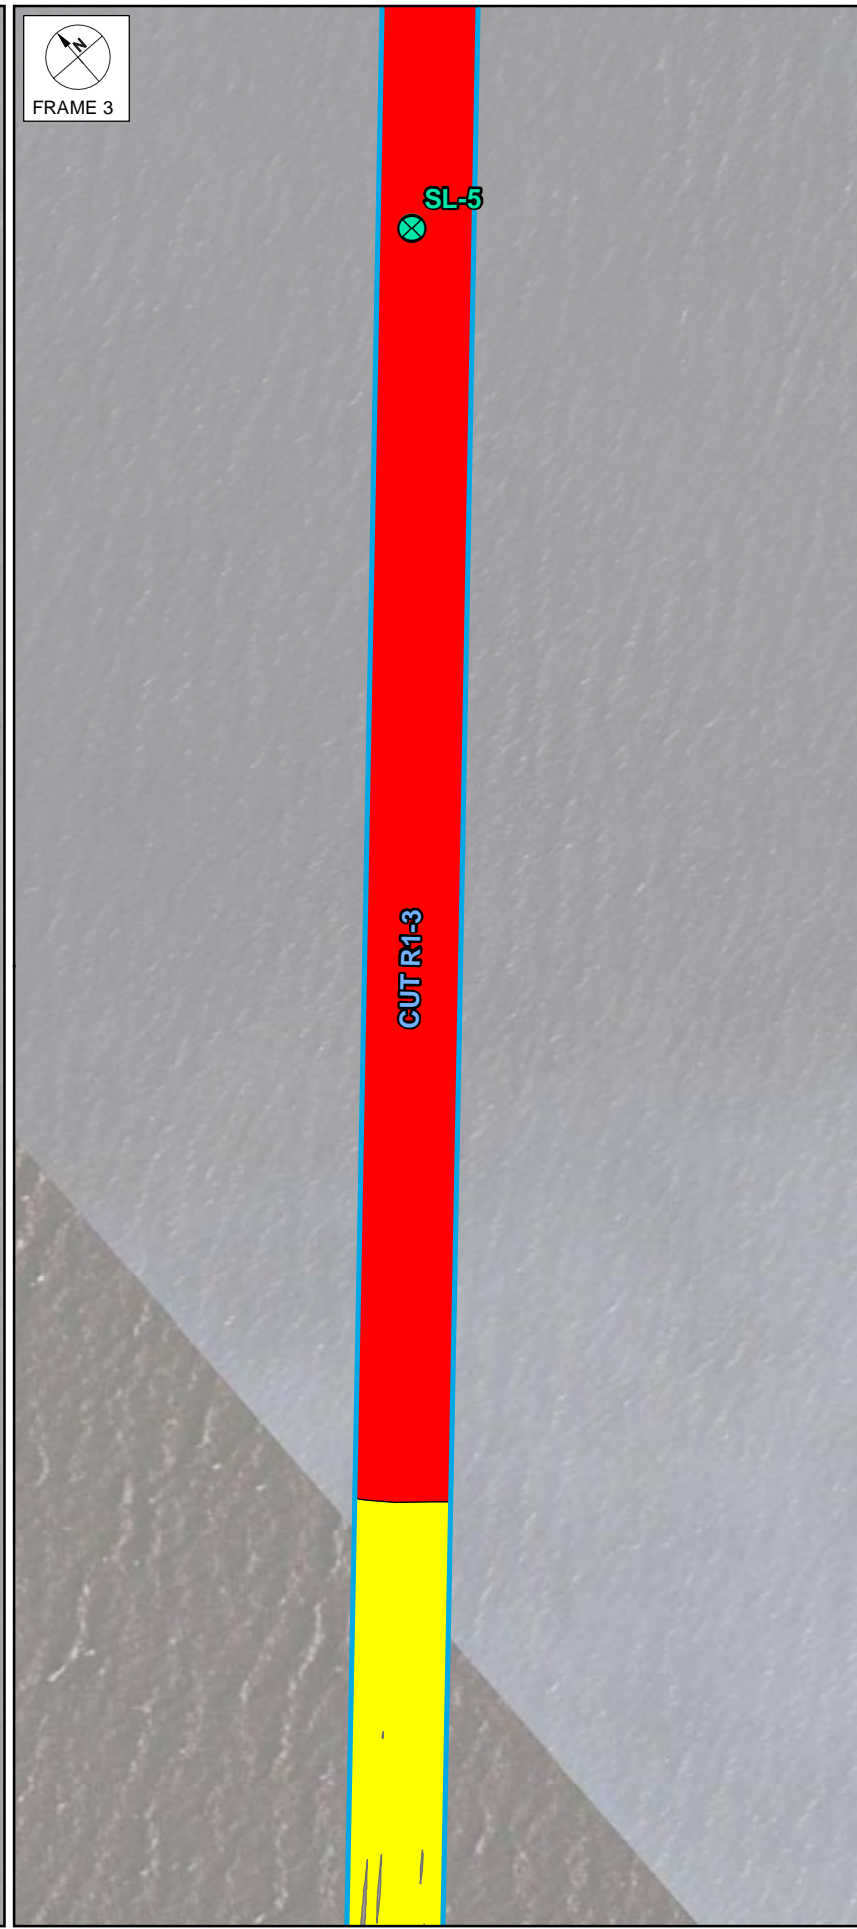
Geologic Map of Channel Bottom

FLORIDA INLAND
NAVIGATION DISTRICT
LAKE OKEECHOBEE
ROUTE 1 CHANNEL
SHOAL COMPOSITION

- Limestone Rock
- Unconsolidated Sediment

*Shoaling above -10-ft LOD

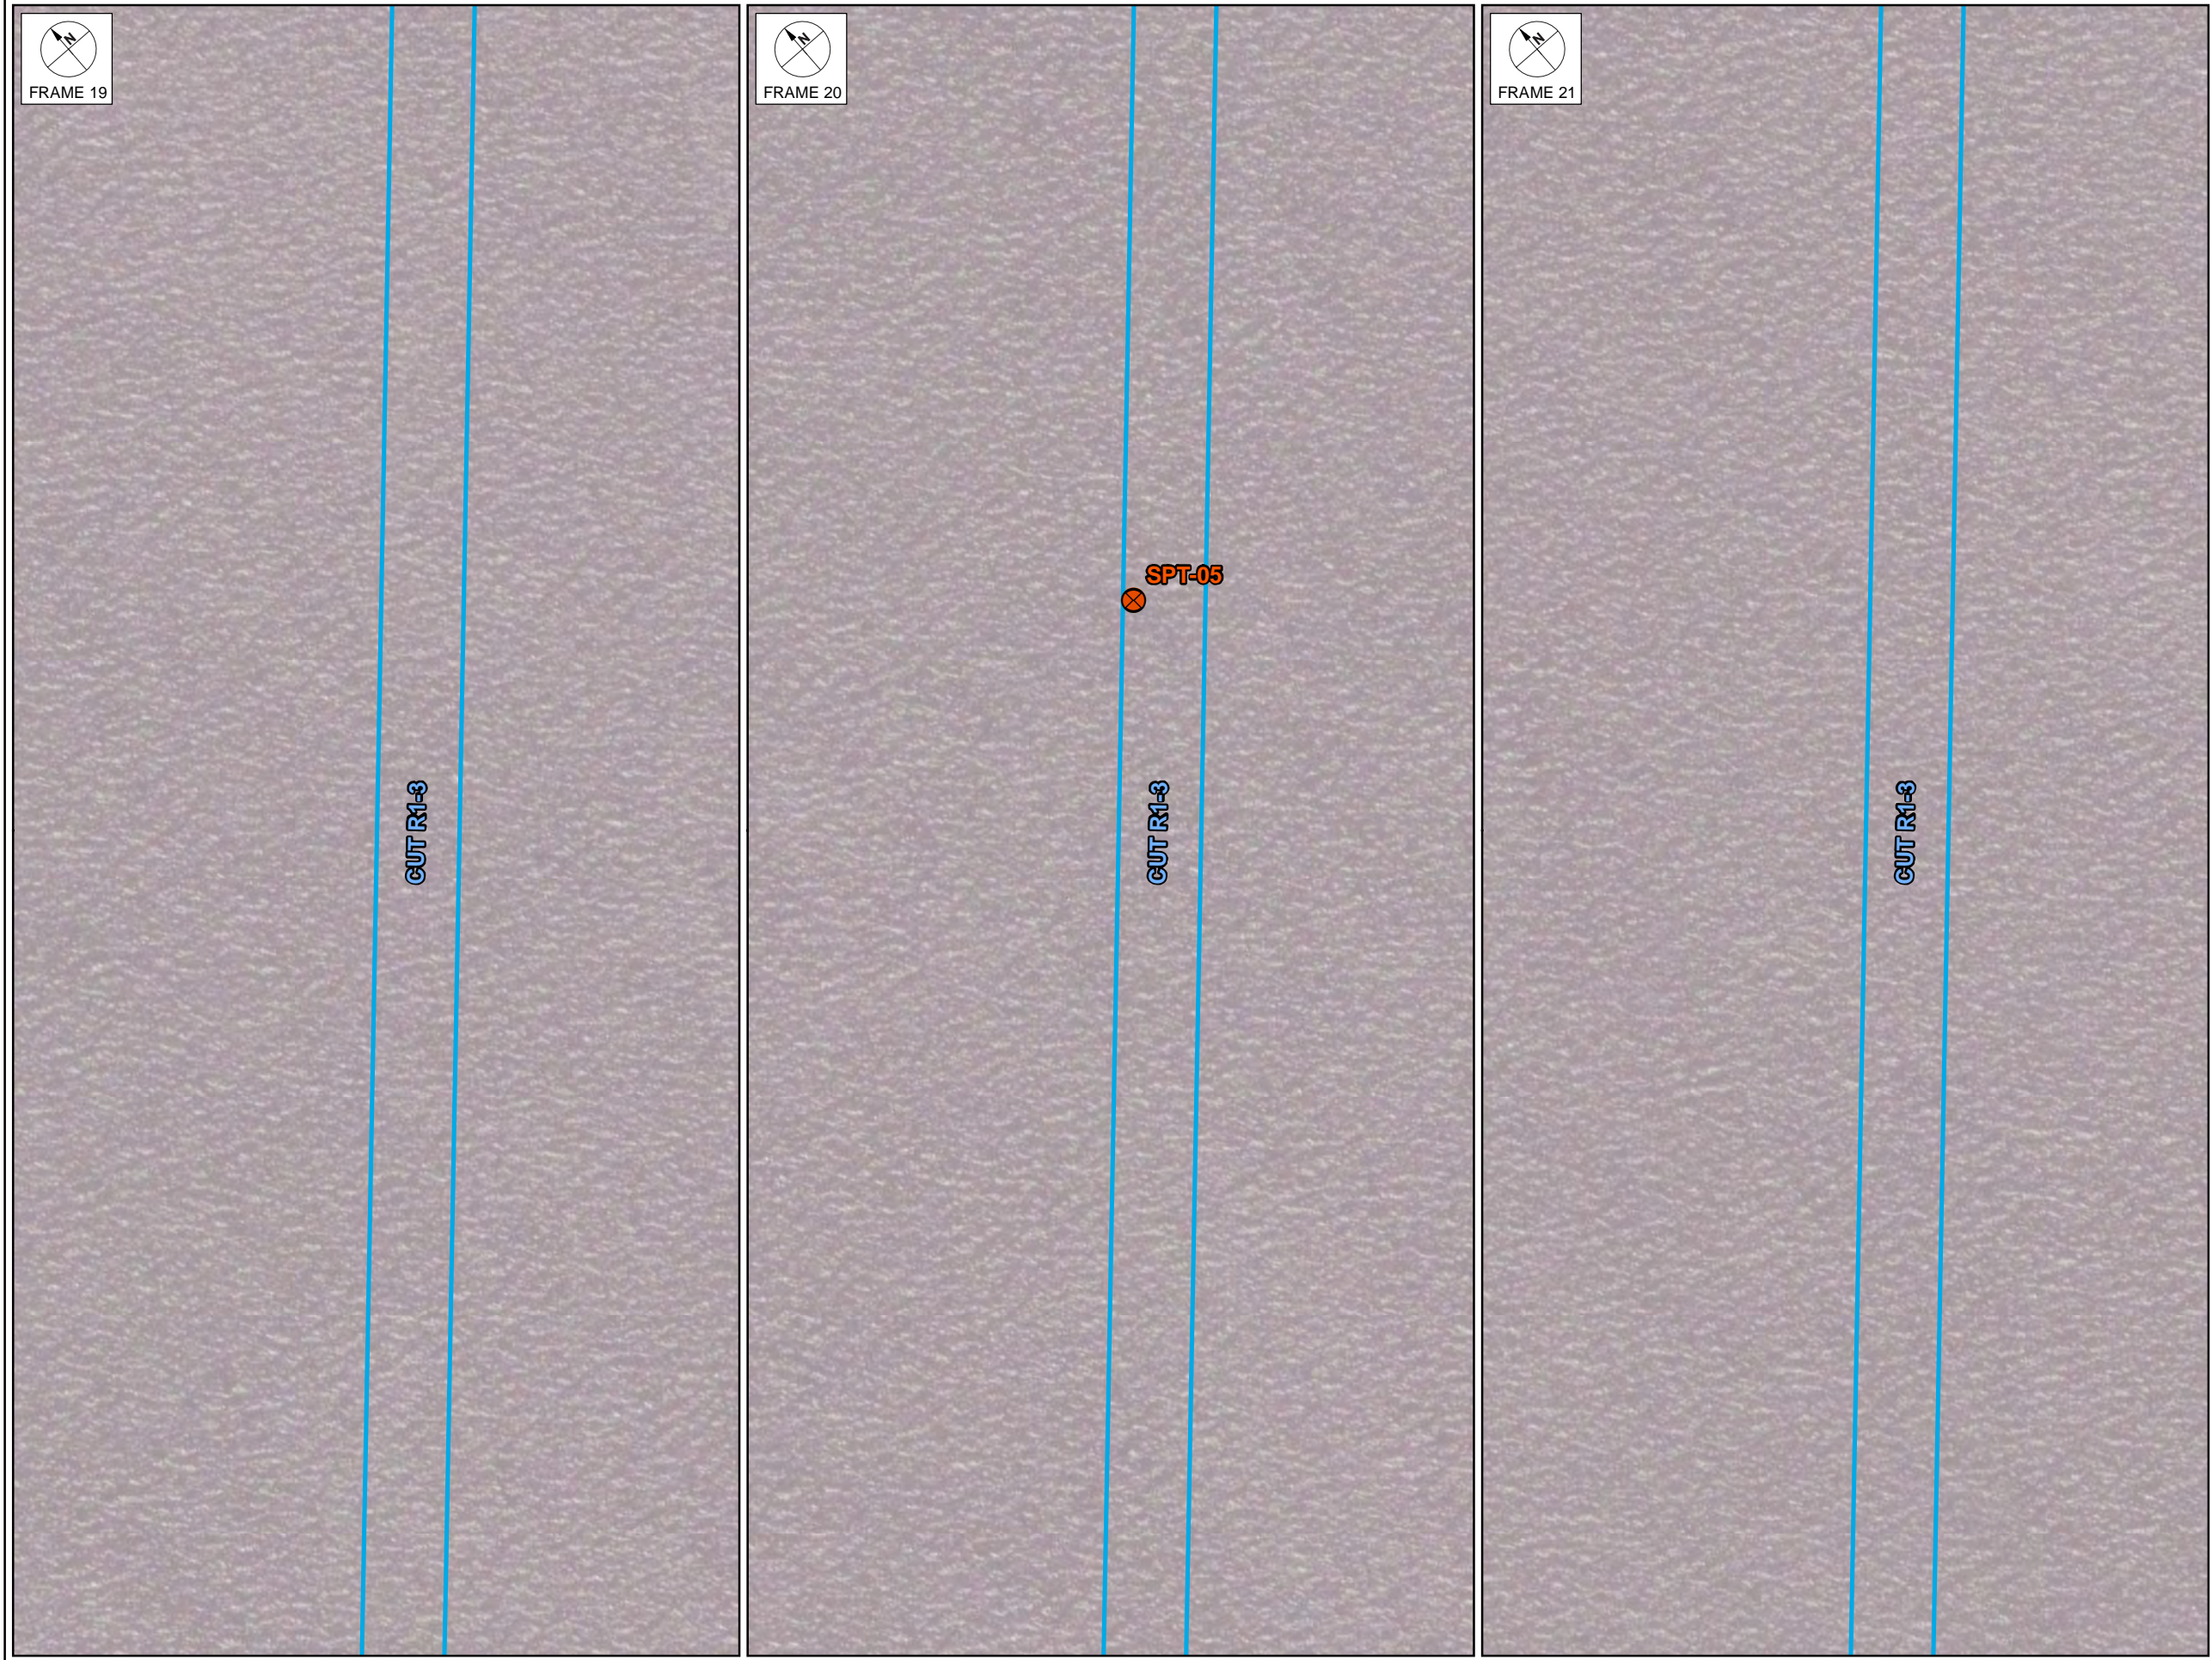
FLORIDA INLAND
NAVIGATION DISTRICT
LAKE OKEECHOBEE
ROUTE 1 CHANNEL
SHOAL COMPOSITION

Unconsolidated Sediment

*Shoaling above -10-ft LOD

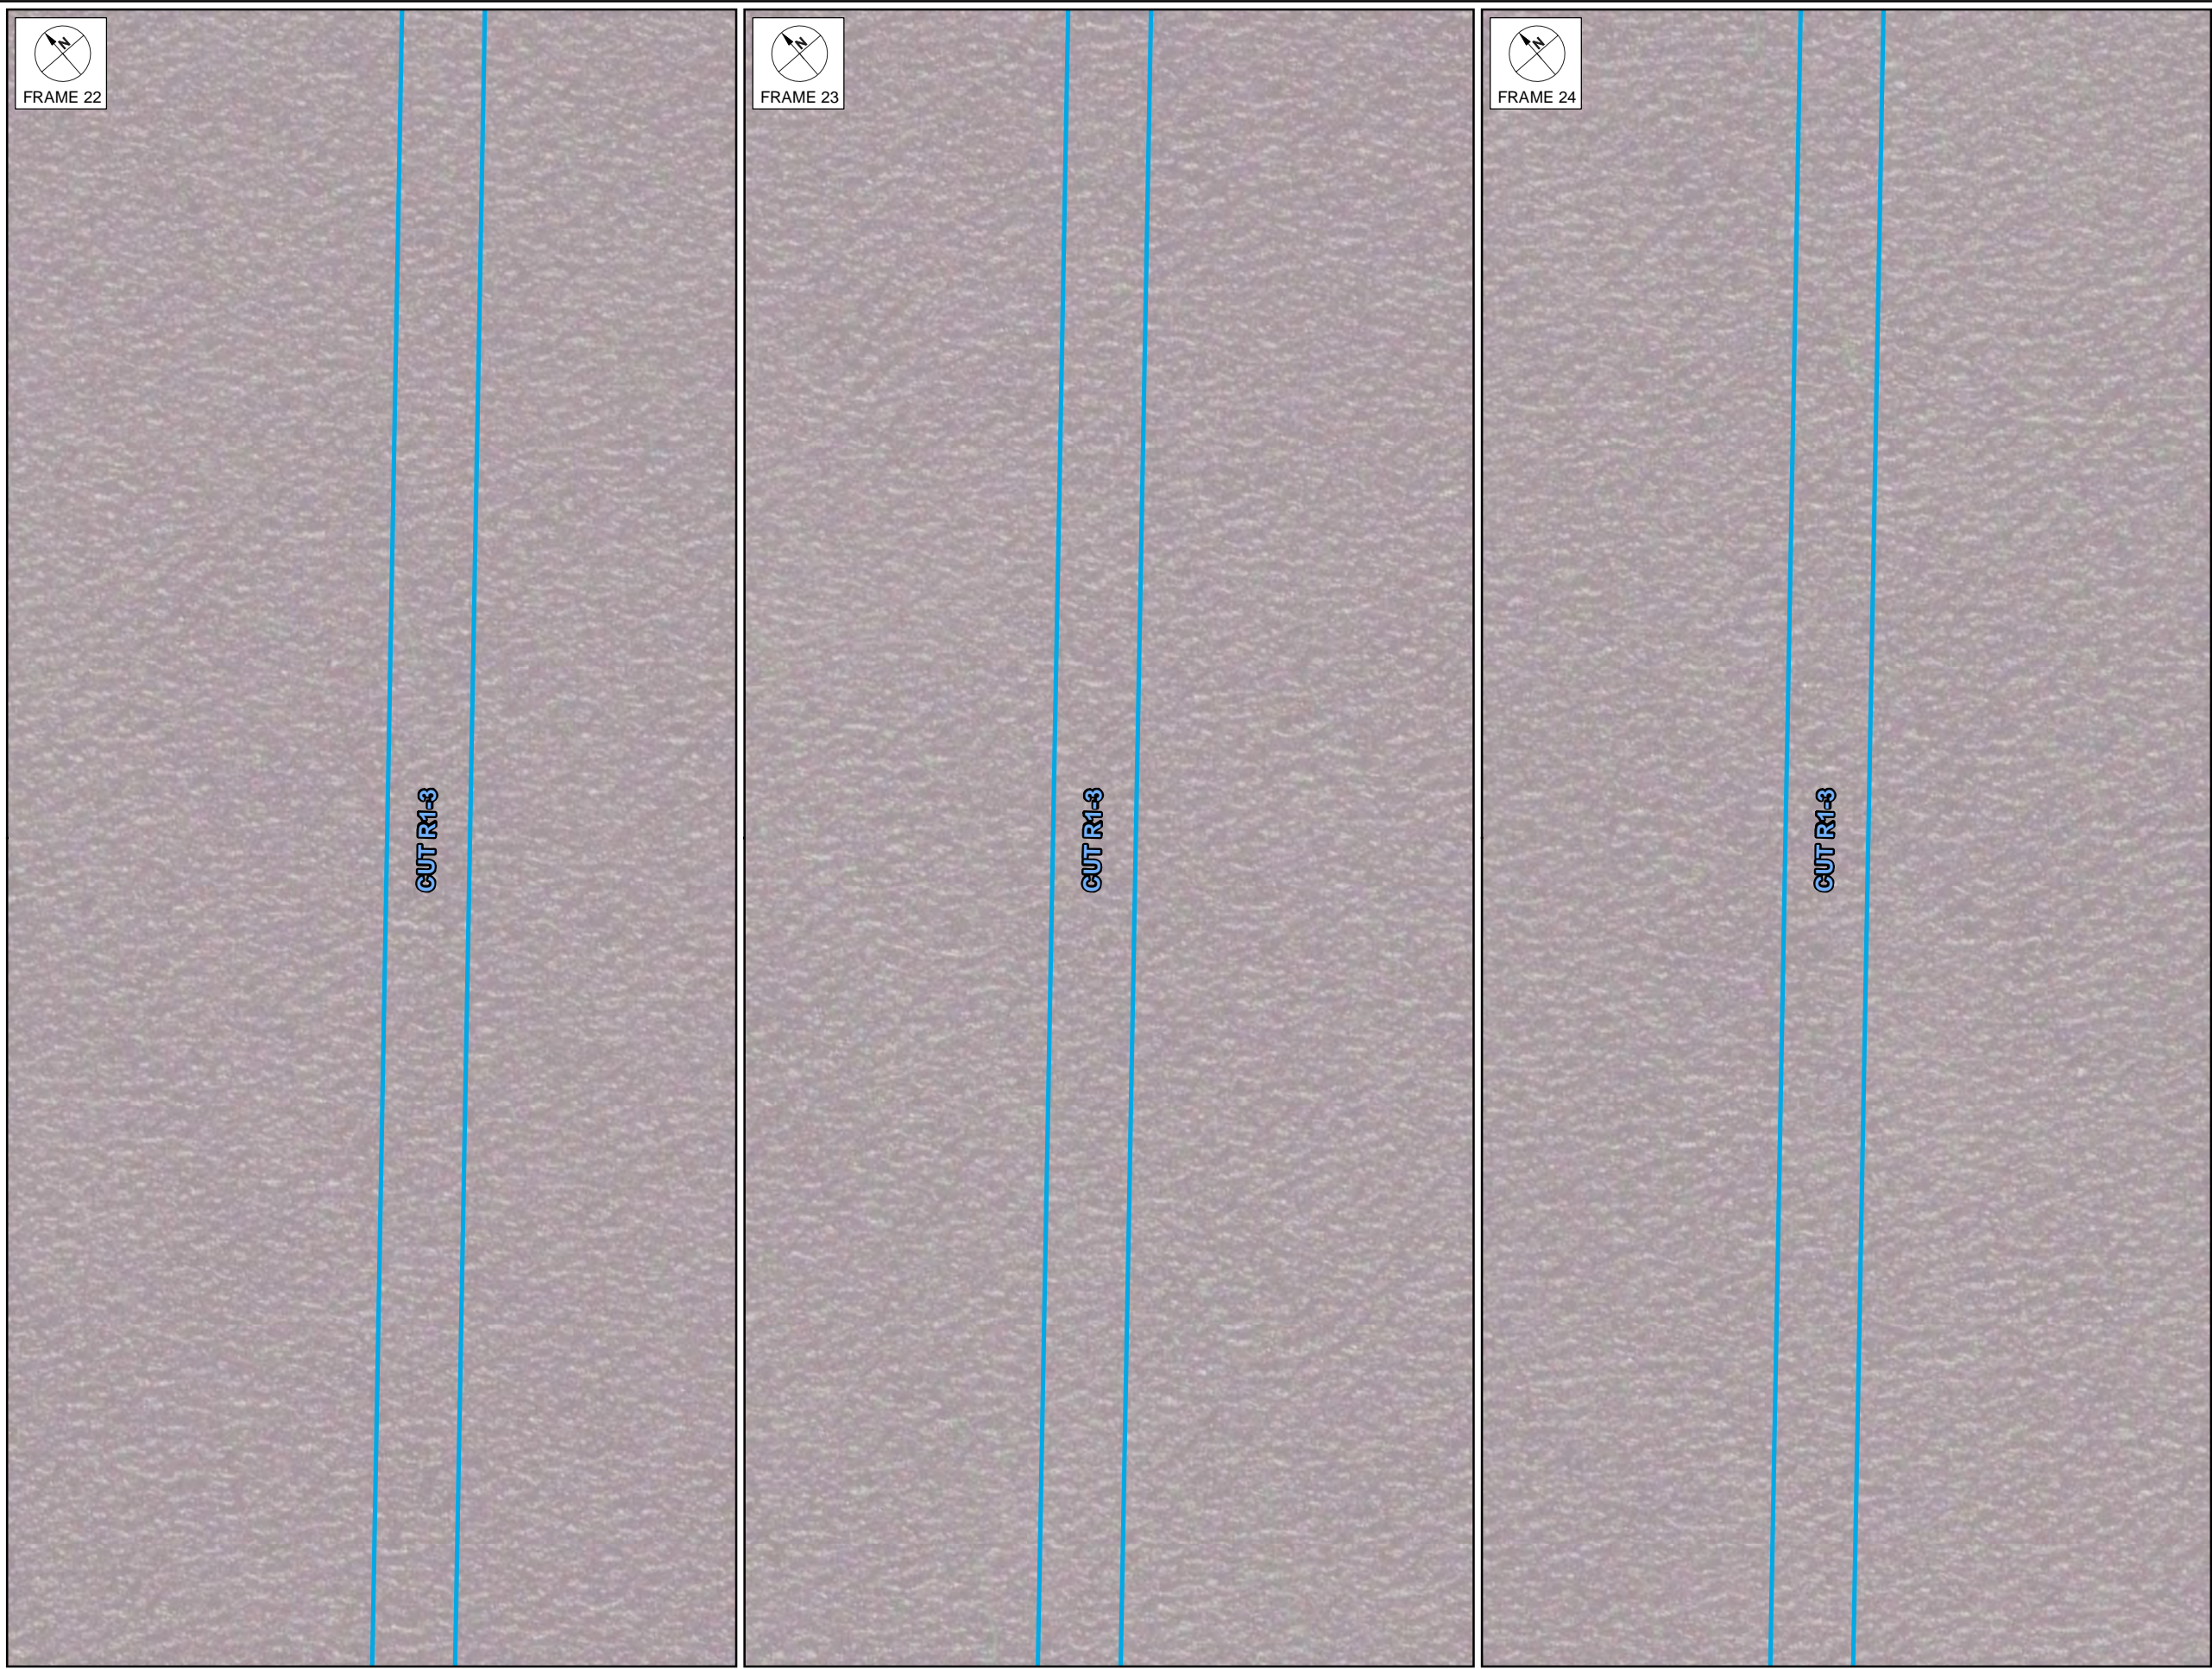
FLORIDA INLAND
NAVIGATION DISTRICT
LAKE OKEECHOBEE
ROUTE 1 CHANNEL
SHOAL COMPOSITION

*Shoaling above -10-ft LOD
