Cross Lake Channel Rock Assessment
Lake Okeechobee Waterway
Route 1

Martin and Palm Beach Counties
Florida

Final Report

December 2021

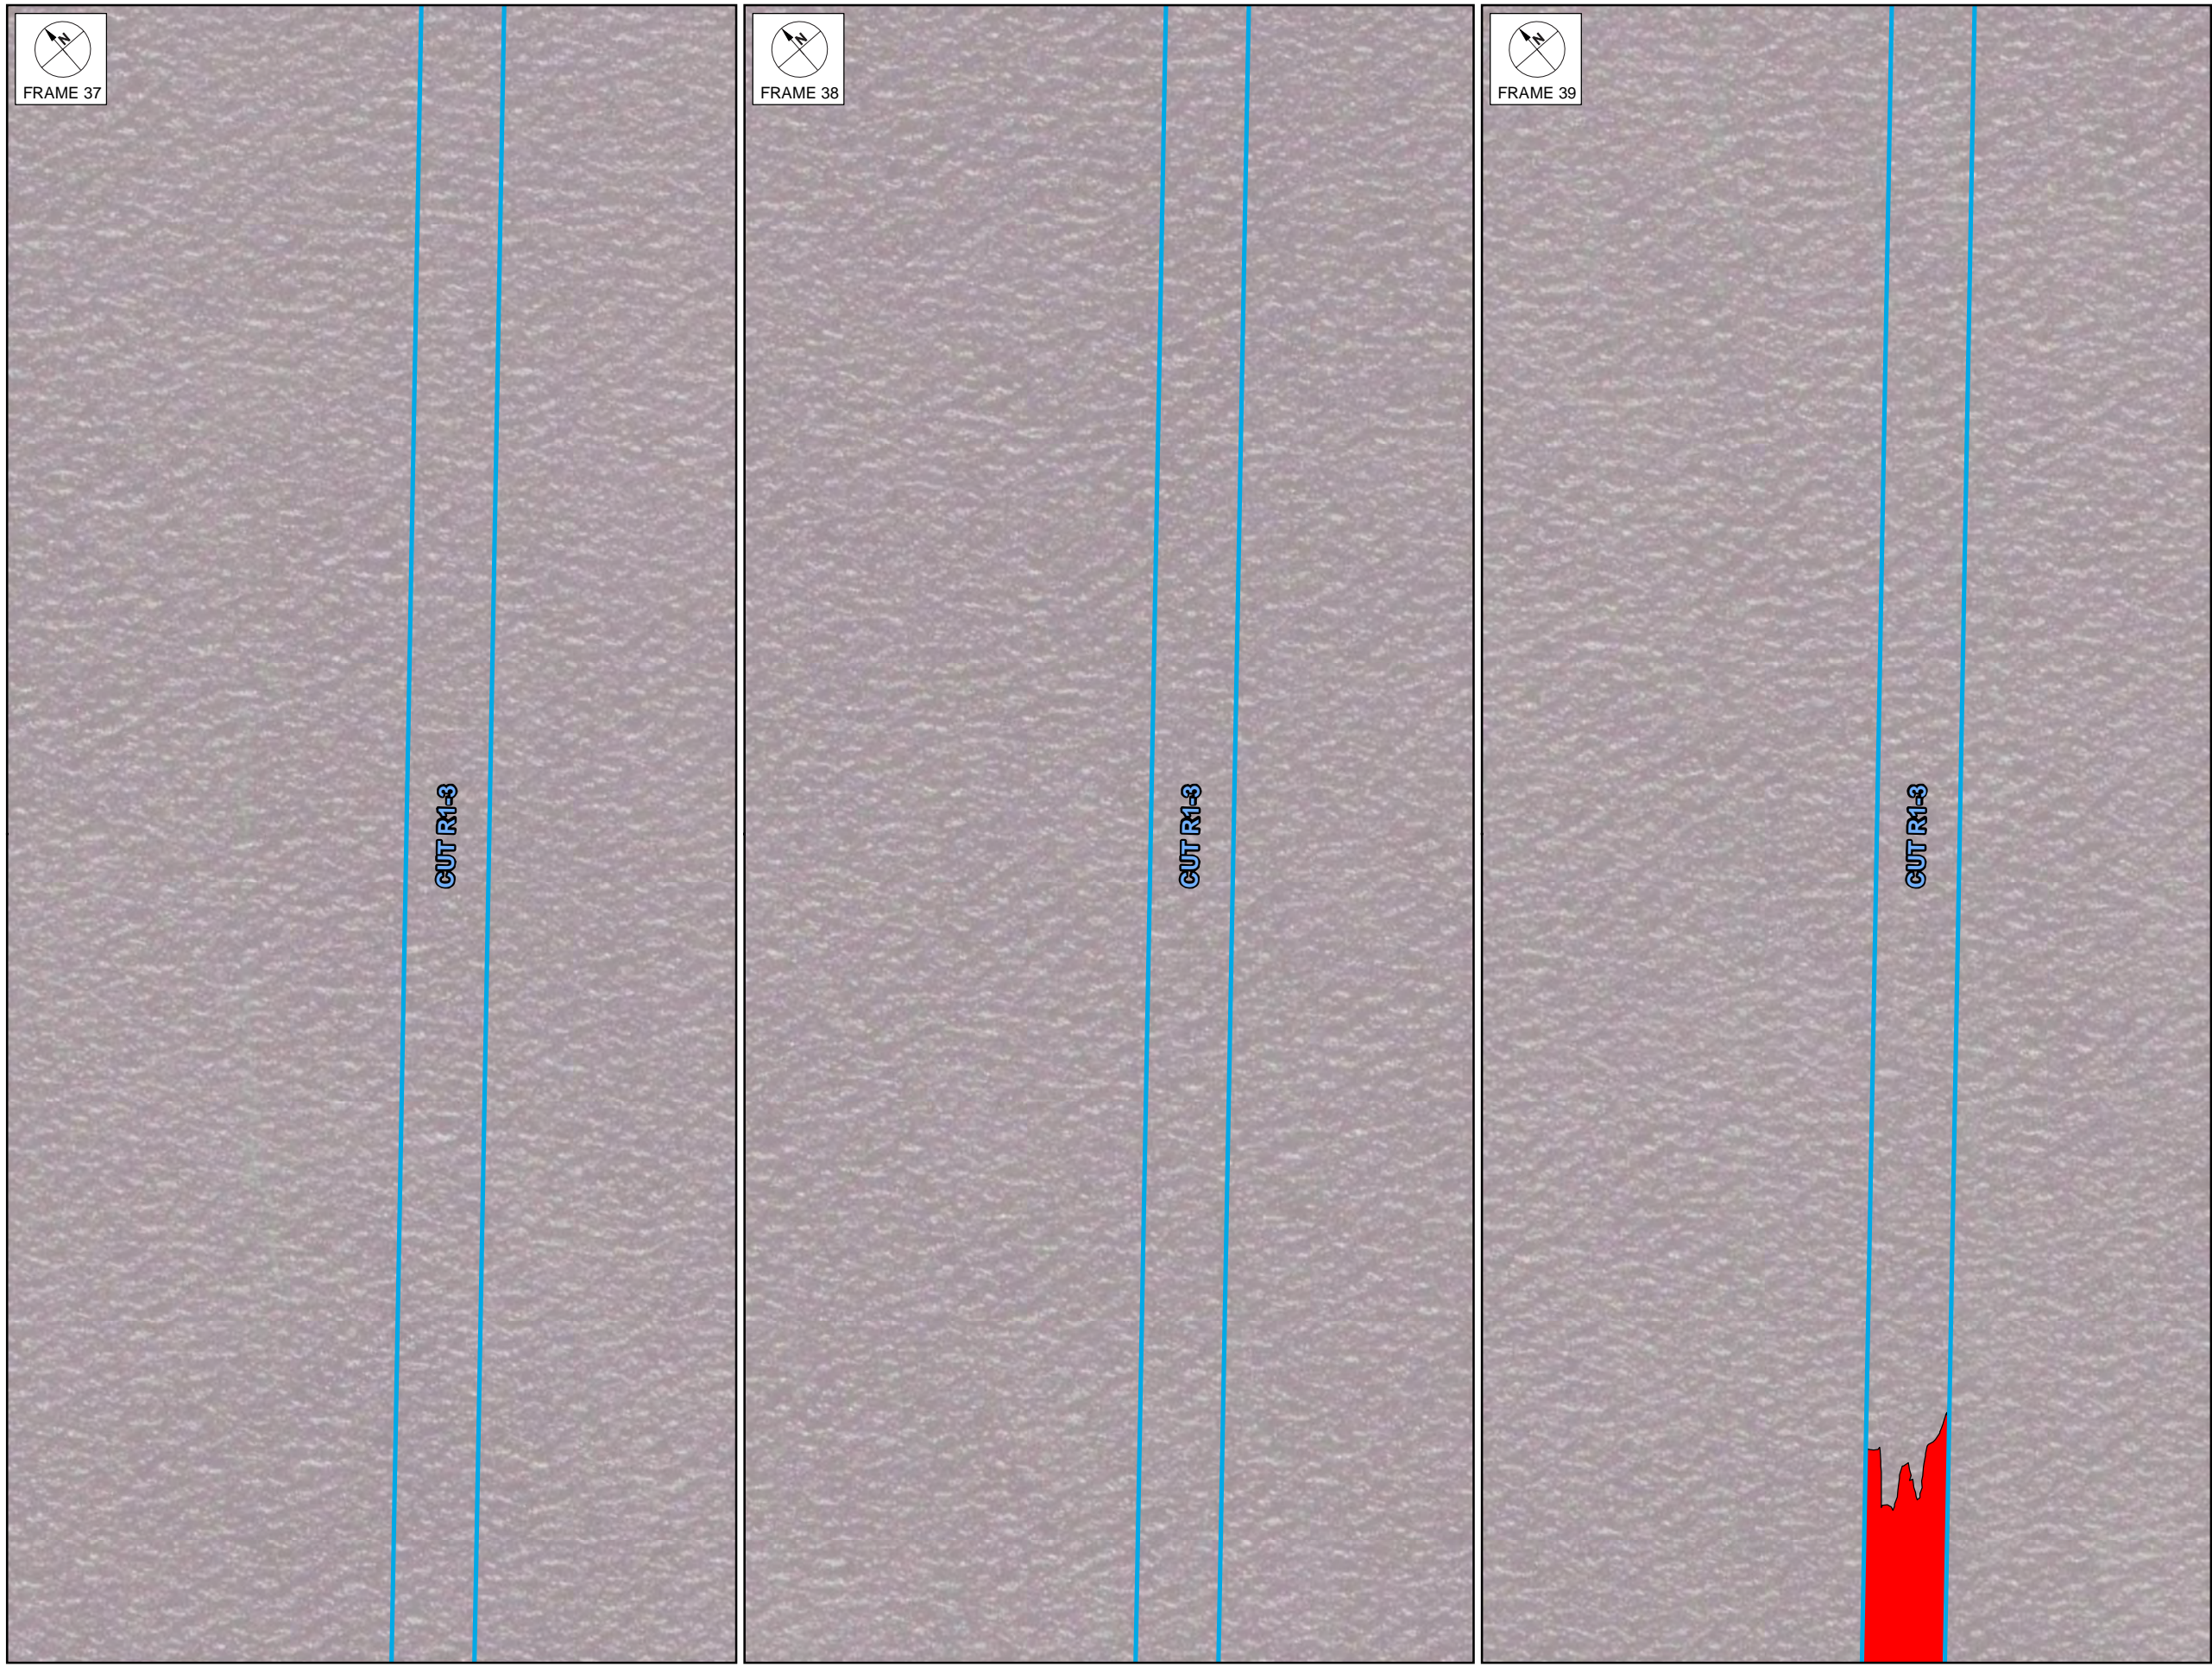
FLORIDA INLAND
NAVIGATION DISTRICT
LAKE OKEECHOBEE
ROUTE 1 CHANNEL
SHOAL COMPOSITION

*Shoaling above -10-ft LOD

To obtain a representation of shoal composition throughout the OWW Route 1 Channel, Taylor Engineering reviewed the side scan images, SPT boring data, and survey data. Taylor Engineering interpreted side scan imagery based on the strength of the return signal to evaluate the channel bottom surface geology. Brighter colors (stronger signals) indicate harder, rocky surfaces, while darker colors (weaker signals) indicate softer, loose sediment surfaces. The side scan analysis revealed two main bottom types: exposed rock and unconsolidated sediment. Taylor Engineering then compared the side scan imagery to the boring logs and sediment grab samples to ground truth the side scan channel-bottom interpretation. Boring data indicated the exposed rocky surfaces are composed of limestone, while unconsolidated sediments vary between altering amounts of silt, sand, and shell. **Appendix D** provides a geologic map of the shoals within the Route 1 Channel (above -10-ft Lake Okeechobee Datum) created using the side scan imagery and boring log interpretation where red indicates limestone rock and yellow indicates unconsolidated sediment.

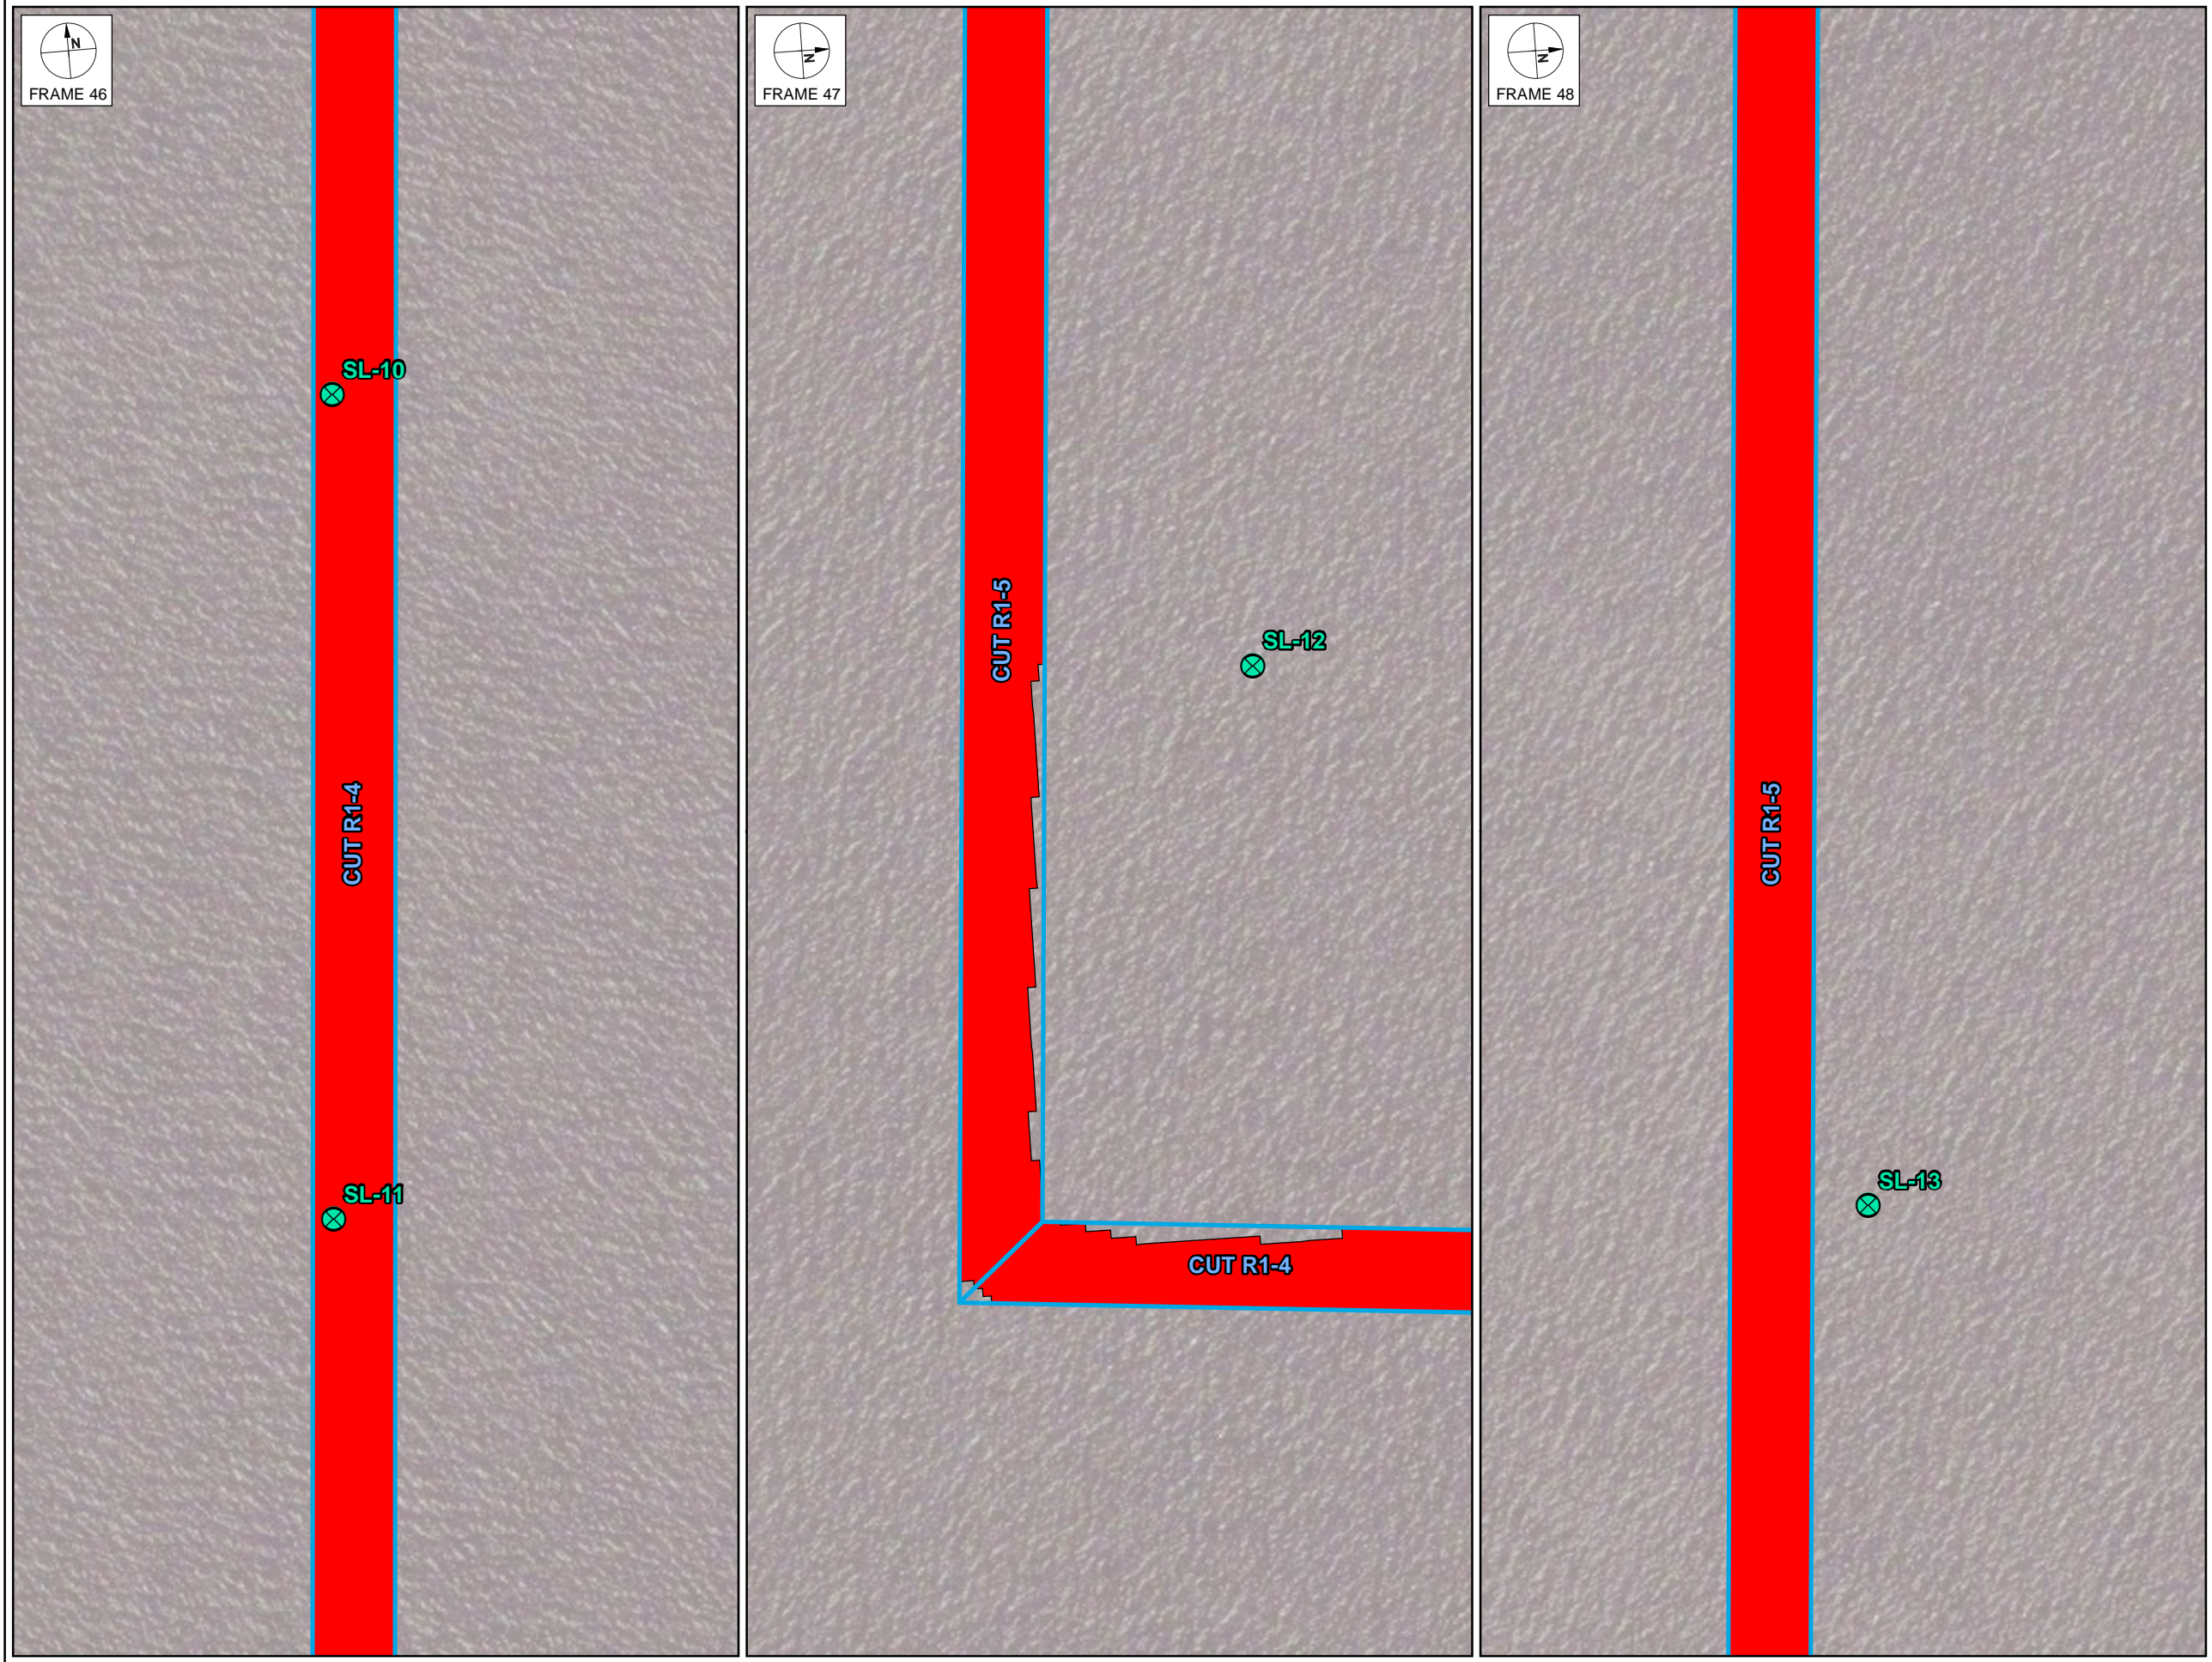
FLORIDA INLAND
NAVIGATION DISTRICT
LAKE OKEECHOBEE
ROUTE 1 CHANNEL
SHOAL COMPOSITION

*Shoaling above -10-ft LOD

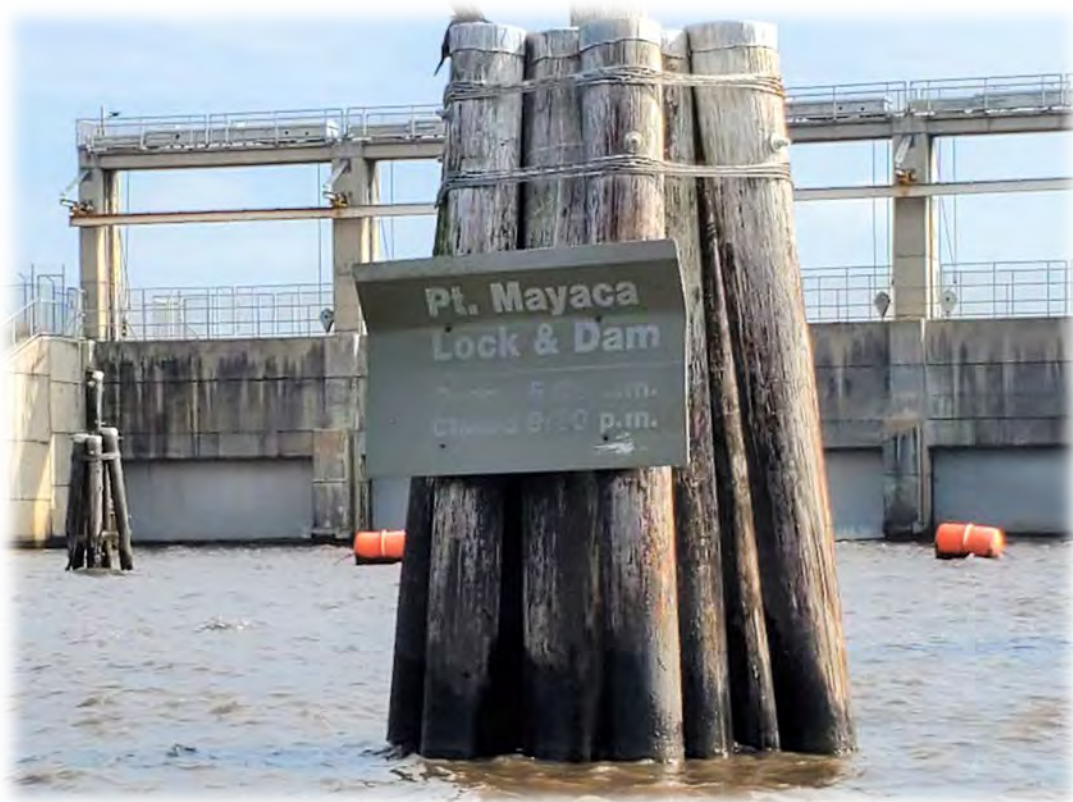
Okeechobee Route 1 Navigation Aid Location

| Photograph (Attachment B) | Aid to Navigation | Type | Material | Observation | Recommendation |
|---|---|---|---|--|--|
| Page 1 | Port Mayaca Lock Entrance South Side; Pt. Mayaca Lock & Dam Open 6:00 AM Closed 9:00 PM | Daybeacon | Timber Dolphin Pile | Daymark damaged and faded | Replace Daymark |

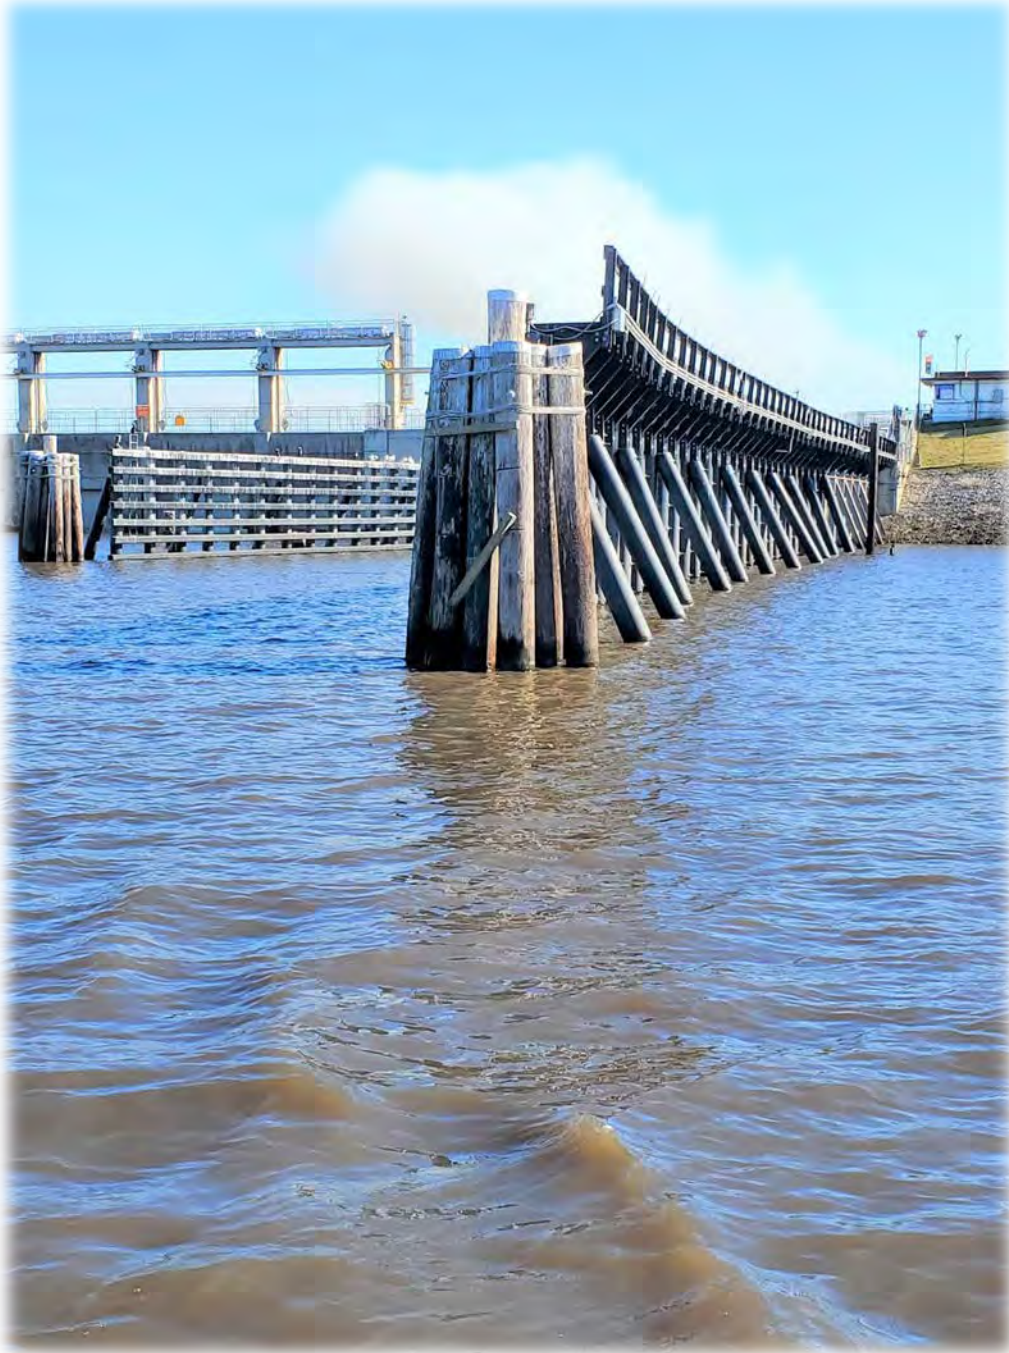
Okeechobee Route 1 Navigation Aid Location

| Photograph (Attachment B) | Aid to Navigation | Type | Material | Observation | Recommendation |
|---|---|---|---|--|--|
| Page 2 | Port Mayaca Lock Entrance North Side Sign; Pt. Mayaca Lock & Dam Open 6:00 AM Closed 9:00 PM | Daybeacon | Timber Dolphin Pile | Daymark missing / Destroyed | Replace Daymark |

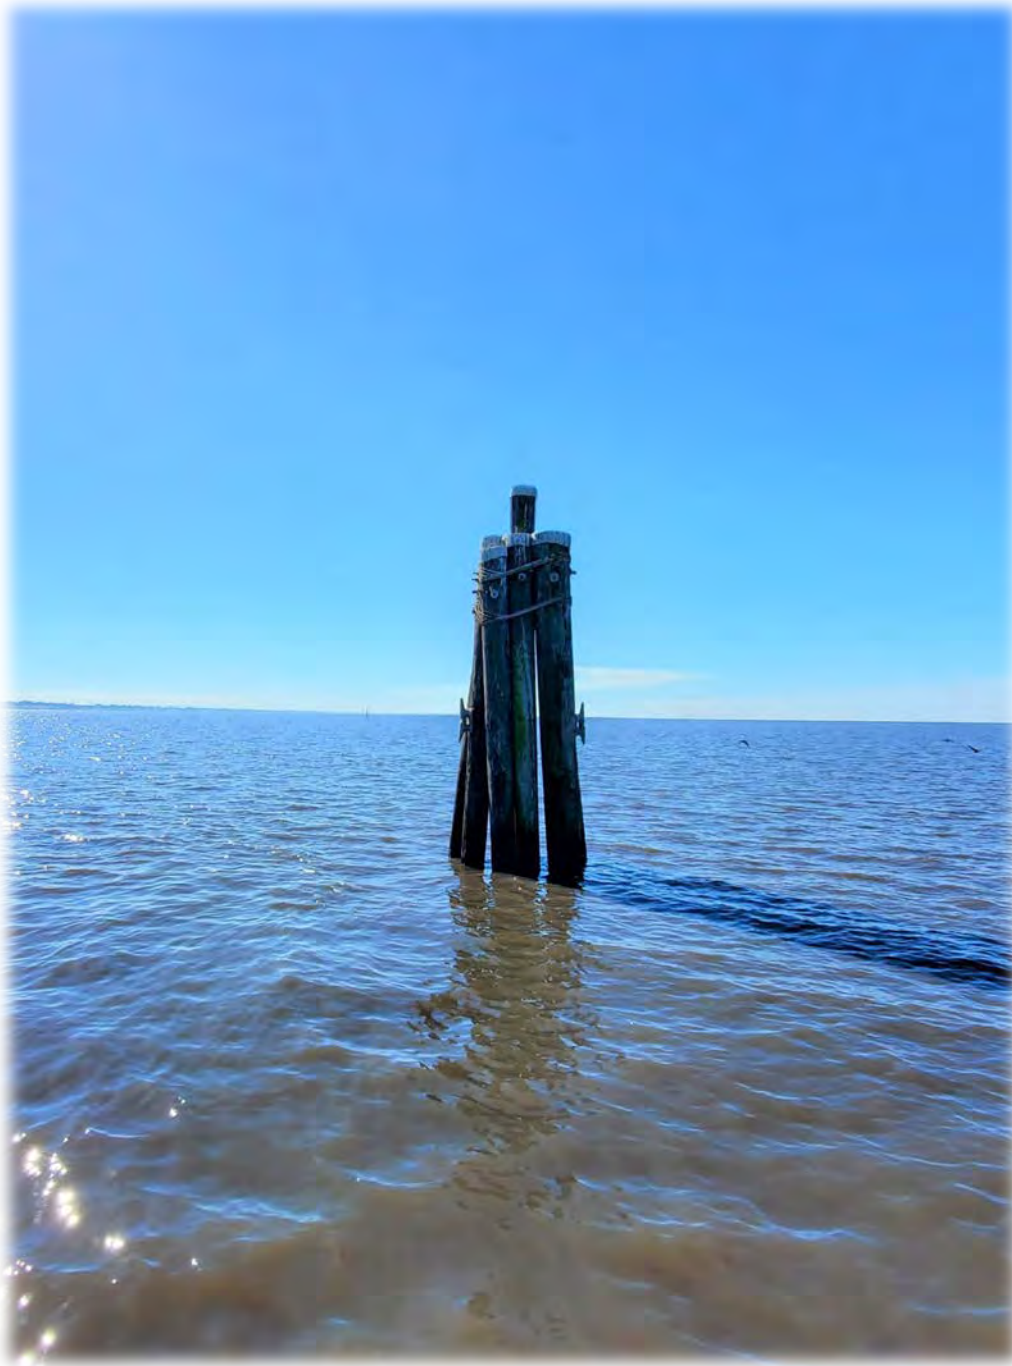
Okeechobee Route 1 Navigation Aid Location

| Photograph (Attachment B) | Aid to Navigation | Type | Material | Observation | Recommendation |
|---|---|---|---|--|--|
| Page 3 | Dolphin pile (non-ATON) | Dolphin | Timber Dolphin Pile | Loose cable wrap, pile deterioration, pile configuration atypical | Structural inspection |

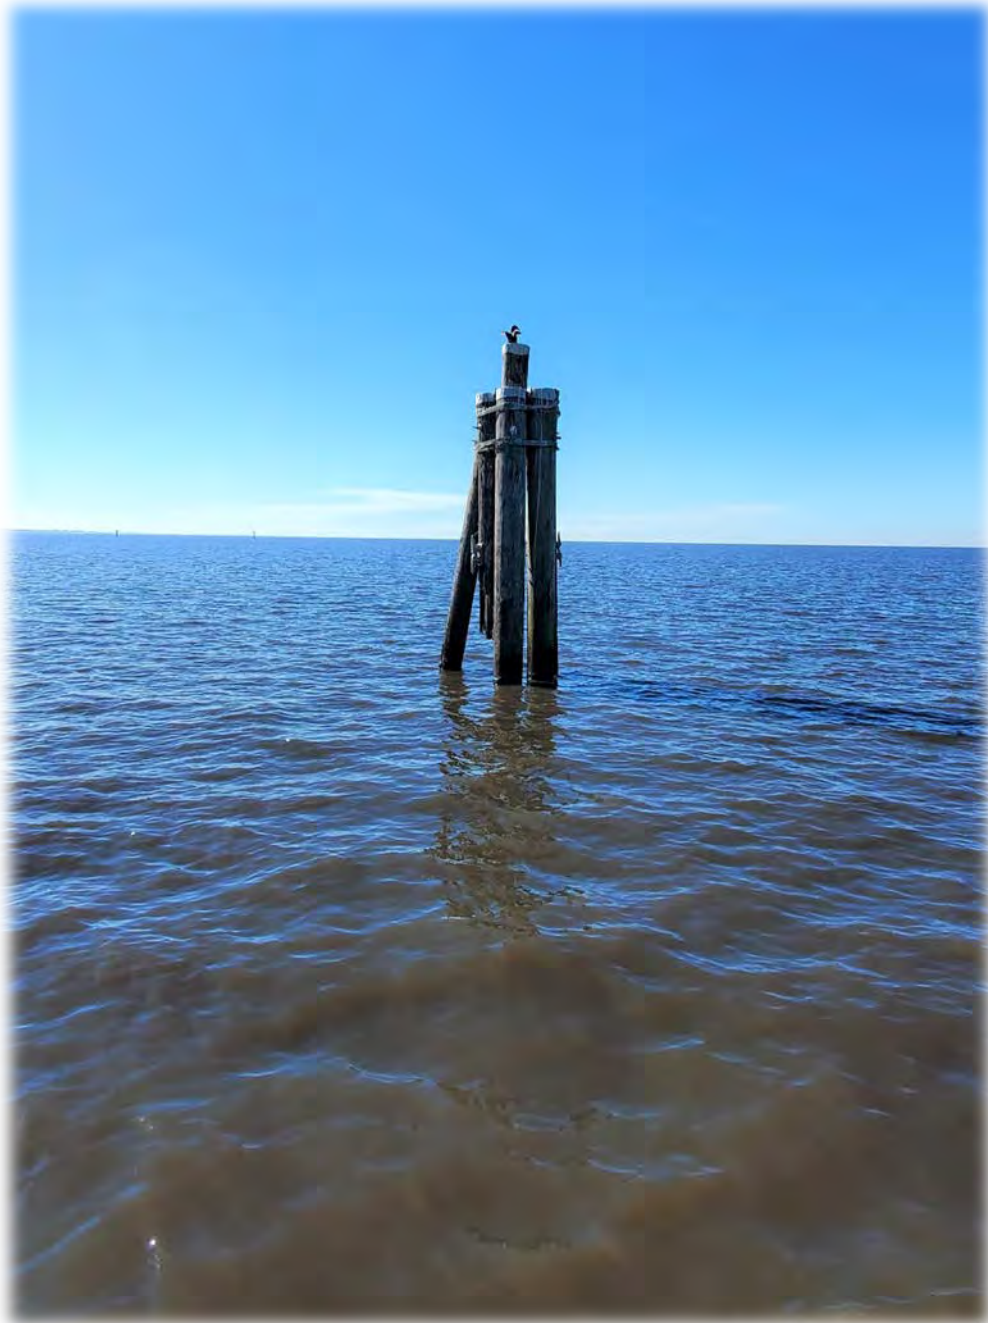
Okeechobee Route 1 Navigation Aid Location

| Photograph (Attachment B) | Aid to Navigation | Type | Material | Observation | Recommendation |
|---|---|---|---|--|--|
| Page 4 | Dolphin pile (non-ATON) | Dolphin | Timber Dolphin Pile | Broken pile, pile deterioration | Structural inspection |
