TOWN OF MIDDLEBURY POLICE DEPARTMENT

Energy Conservation Measures / Community Room Upgrades

JANUARY 24, 2019

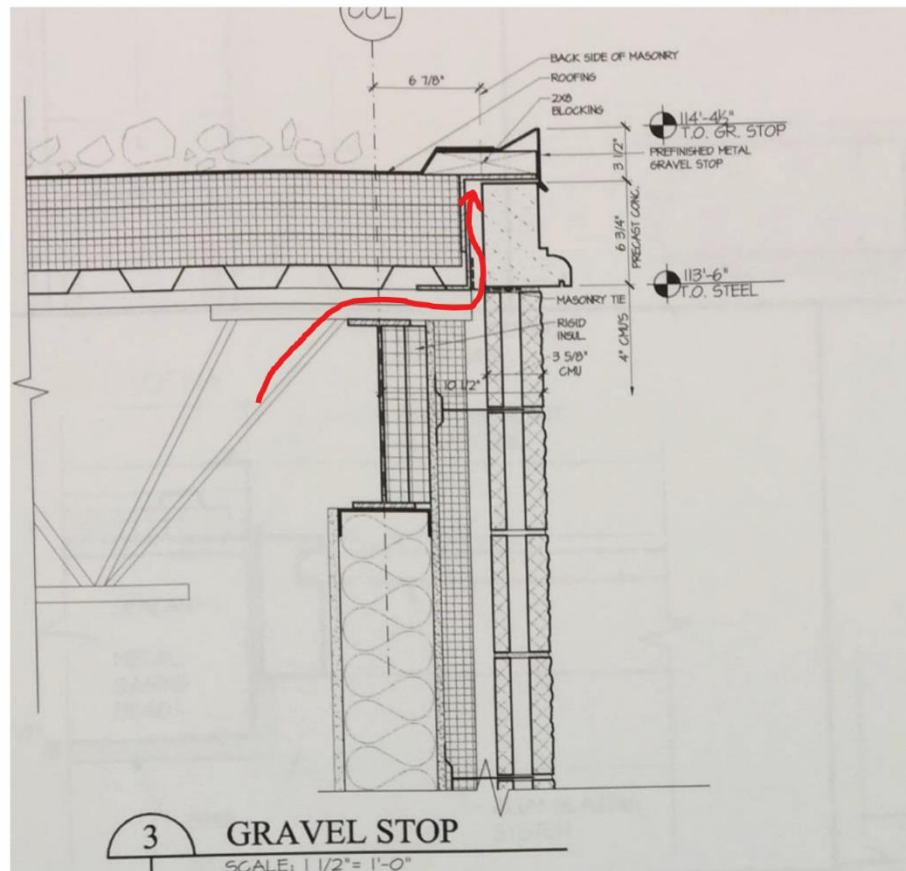
ZERO by DEGREES Diagram indicating path of warm air through existing wall to roof construction

Warm air is easily able to migrate between the metal roof deck and the top of the steel beam via the pathway show, beyond any air barrier materials. Depending on the wall configuration, interior drywall or interior CMU are typically the materials acting the most like an air barrier.

Air leakage is occurring in both directions between the metal roof deck and steel beams below, where the deck meets exterior walls. Intermittently, bar joists complicate this detail, where they sit on supporting steel I-beams. See **Zero by Degrees diagram, Pg 4.**

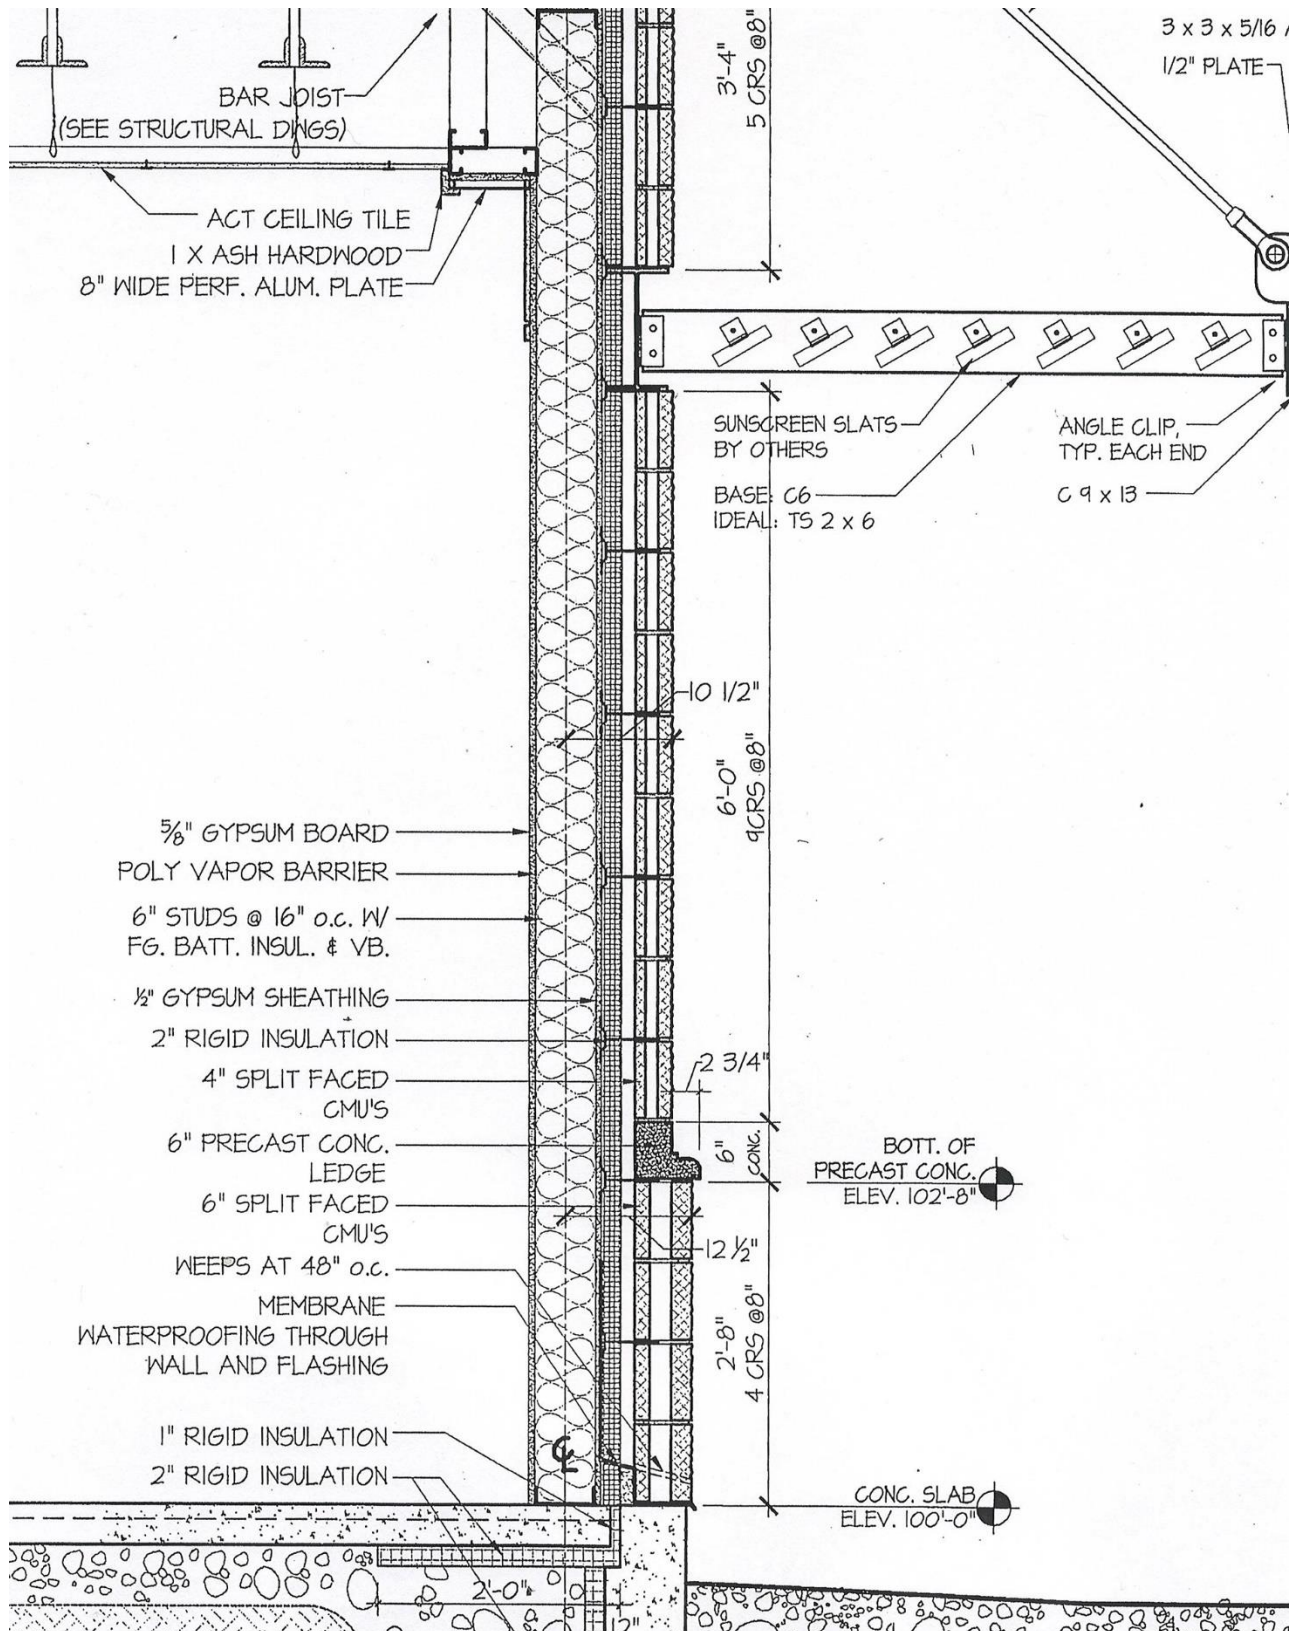
BREAD LOAF CORPORATION As-Built Drawings: Typical Wall Section at Steel Screens

(2) The wall system infill for the existing storefront shall deviate from the existing wall section designed by Bread Loaf Corporation in the following ways:

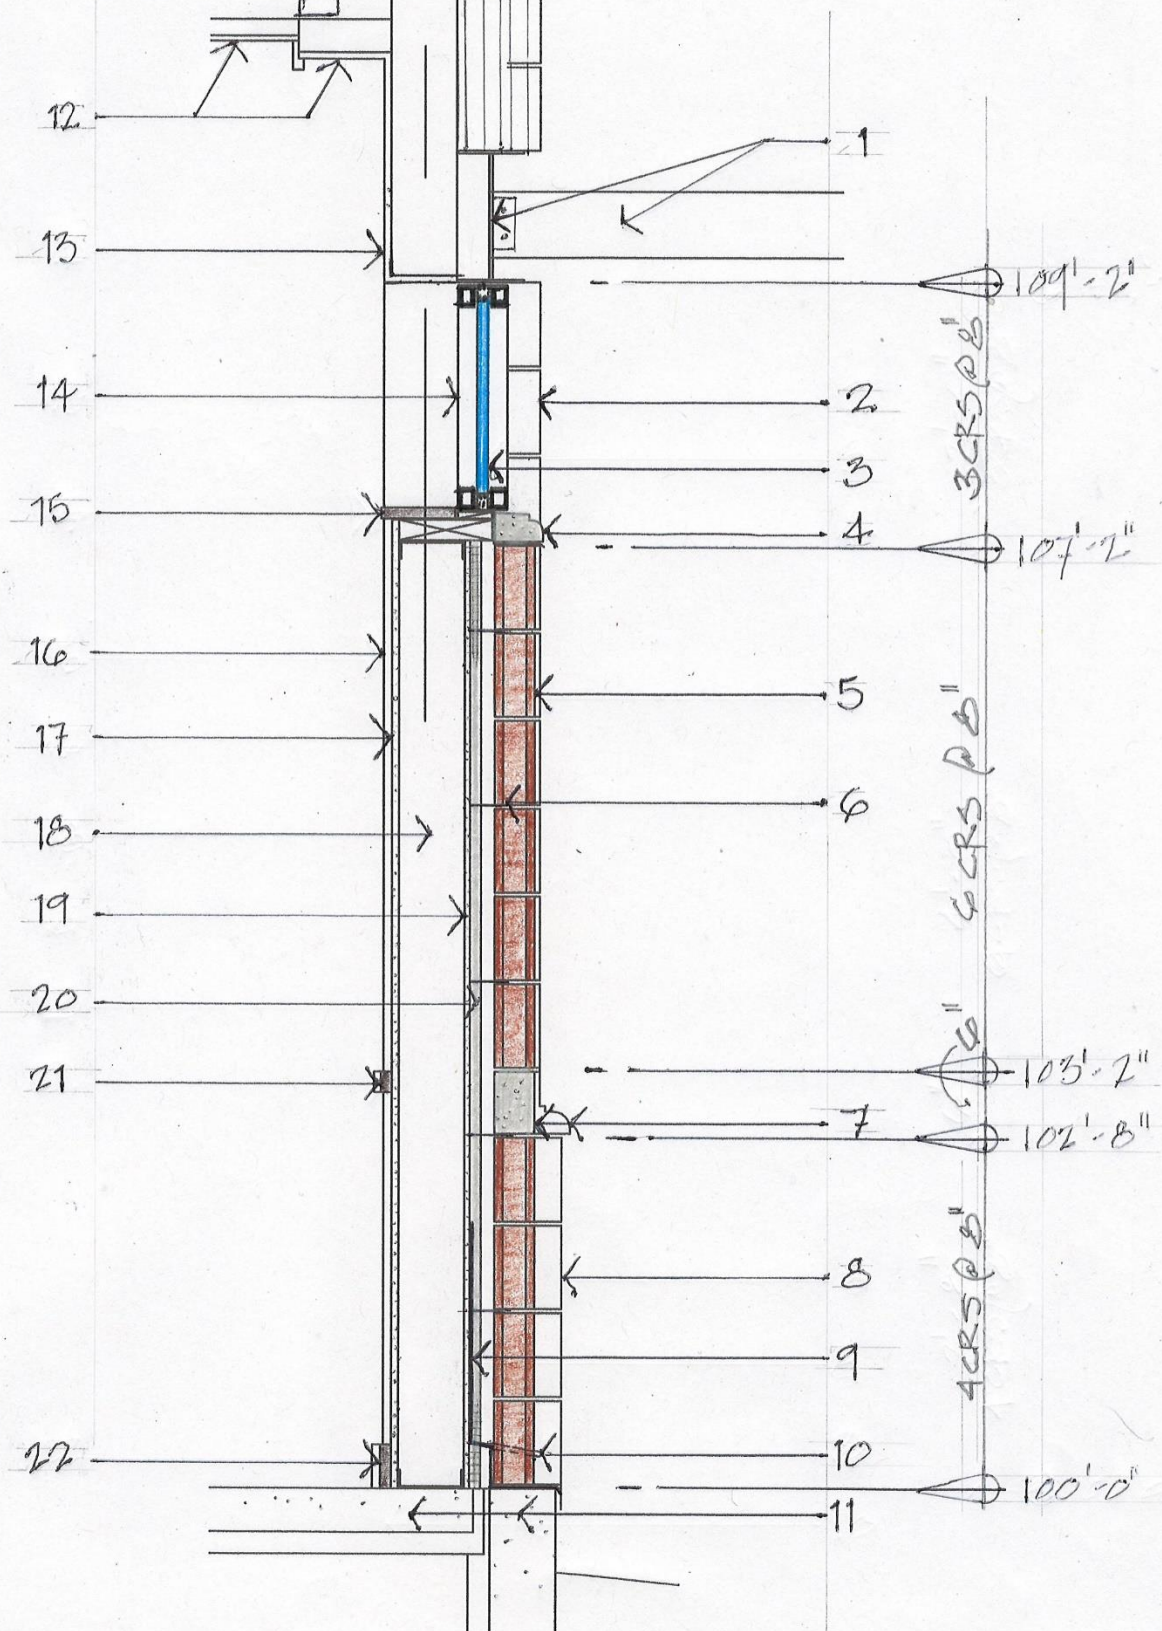
PROPOSED DRAWING - WALL SECTIONS at Storefront Glazing Infills

PROPOSED NOTES – re WALL SECTION at Storefront Glazing Infills

- 1 Existing painted steel beam and sunscreen canopy, suspended from 1" threaded rods**
- 2 Face of 4" split faced CMUs beyond**
- 3 1" insulated low-E glazing**

- 4 Pitched precast concrete sill - mimic section at existing window units: 2 5/8" high x 4 3/8" deep, drip cut on underside, project 3/4" from face of CMU plane below**

- 11 Existing concrete floor slab and foundation wall**
- 12 Existing acoustical tile ceiling and 8" wide perforated aluminum plate at perimeter**
- 13 Plane of existing gypsum wall board beyond – gyp board return to storefront section**

- 14 Proposed thermally-broken Tubelite TU24000 Series Non-Impact Storefront. Dual pour - debridge thermal barrier 2" x 4 1/2" section, color to match existing. Masonry opening = 12' wide x 1'-9 3/8" high. Field verify.**

- 19 Frame wall shall be sheathed on the exterior plane with fiberglass mat-faced gypsum sheathing (DensGlas or equal). Building wrap and weep details are to match the original design as shown in the existing wall section.
- 20 1" XPS rigid insulation – maintain air space to back of CMUs
- 21 Ash chair rail 7/8" x 1 7/8" with top at +38" aff. Align with and return to existing beyond.
- 22 Ash base 1" x 4". Align with and return to existing beyond.

See Specification Note (2) on page 4, and Pages 5-11 for wall sections, elevations, details, and photographs.

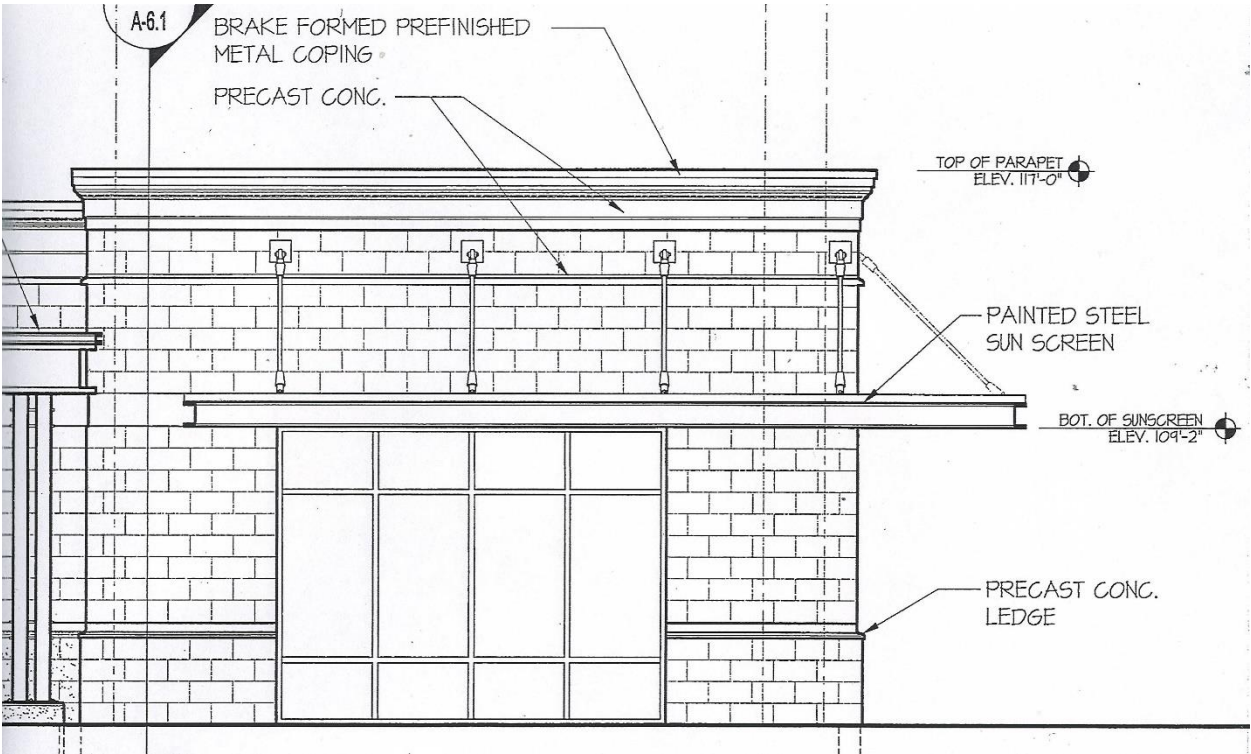
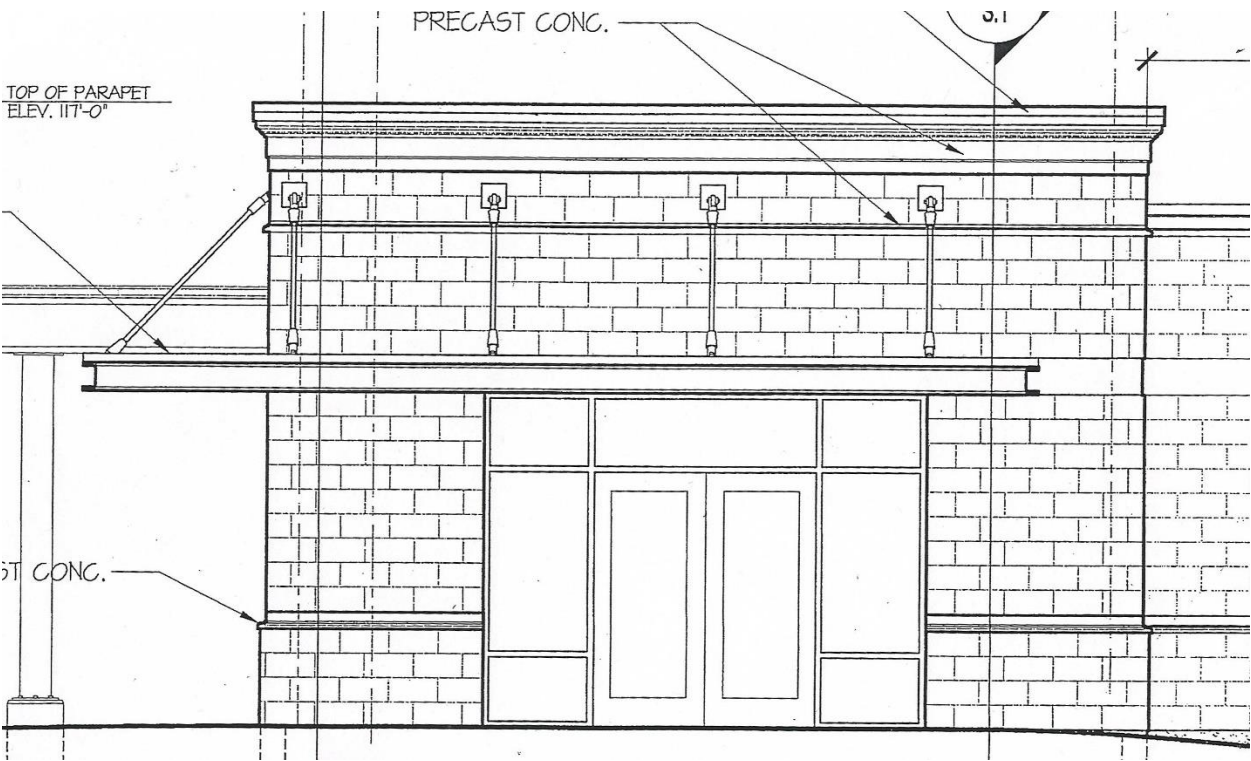
BREAD LOAF CORPORATION As-Built Drawings: Partial South / East Elevations at Community Room

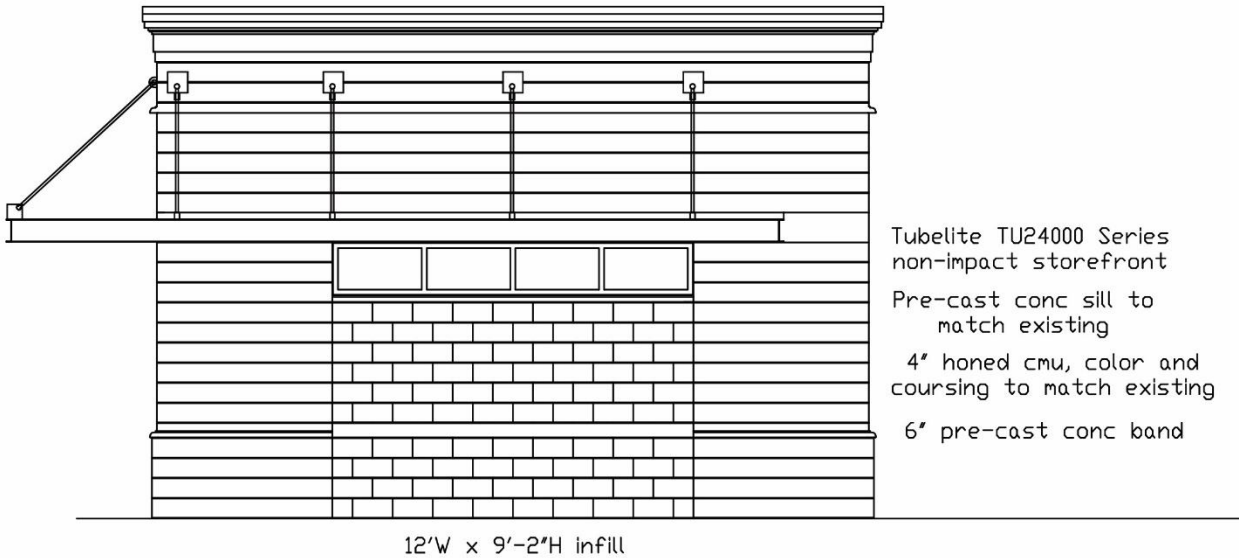
PROPOSED Partial Elevation at Storefront Glazing Infills

proposed partial east elevation
south infill similar

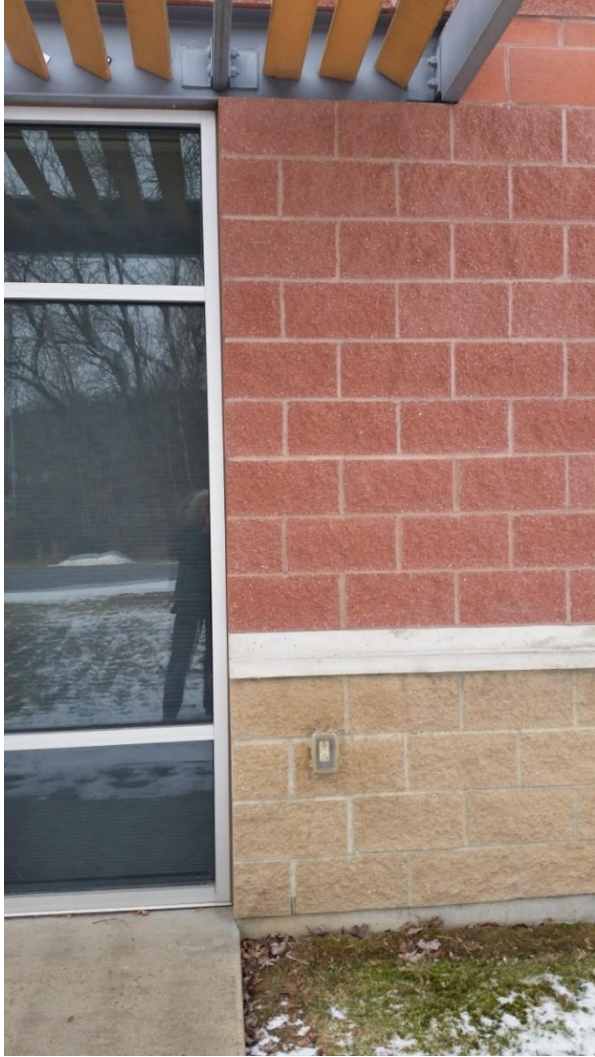
Existing East Elevation Details

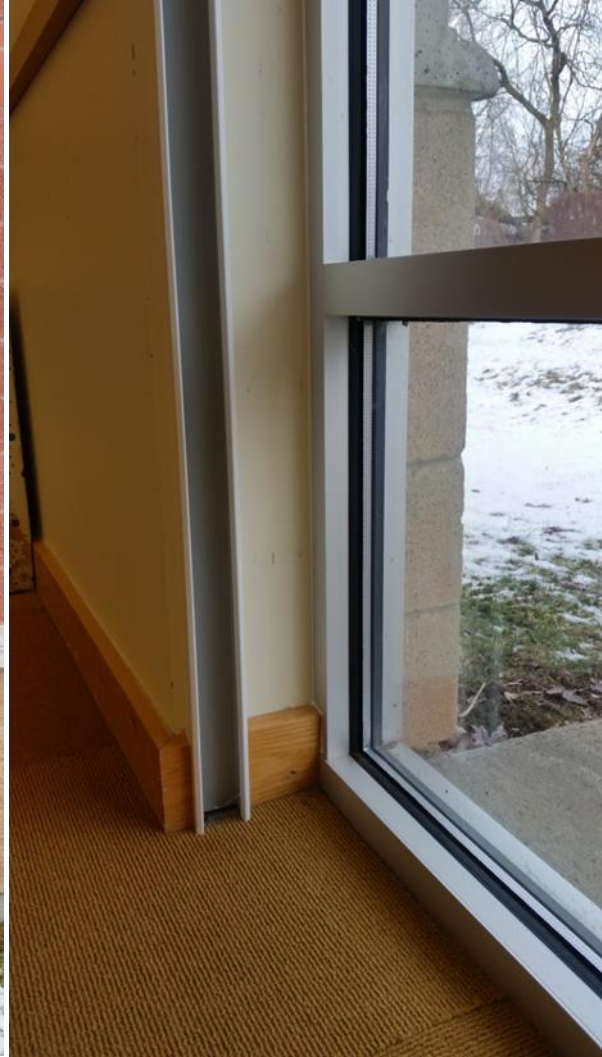
Interior view at same location

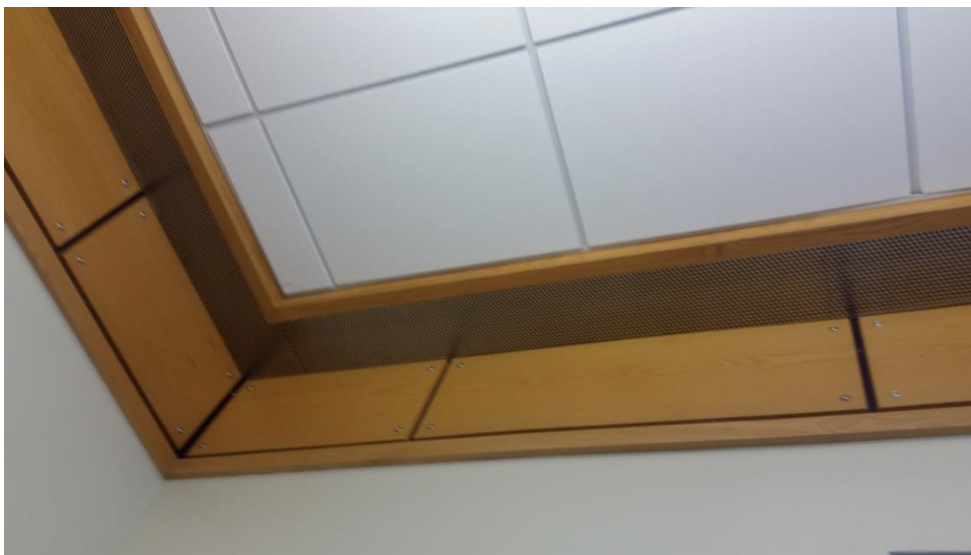
Ceiling Soffit Detail
