Municipal-Regional Planning Commission
Meeting Agenda

RE: Oak Creek Phase Two Acceptance Request

Acceptance Punchlist
Atoka Subdivision
Oak Creek Phase 2

FROM: *Layne Dawson, PE*
INSPECTION DATE: *May 29, 2020*
RE-Inspection Date October 6th, 2021
REPORT DATE: *June 1, 2020*
Revised Report Date: 10-21-2021

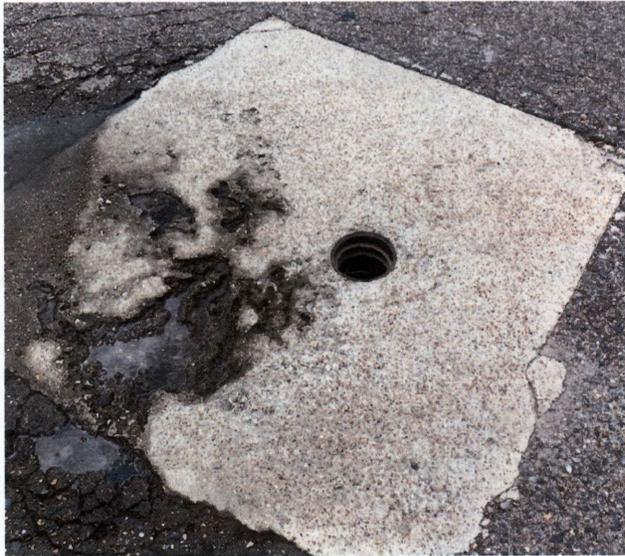
Missing 3" SS valve lid. Two locations: Sta. 9+24 Chinkapin Drive and Sta. 8+45 Sweetgum Lane.

Valve is still missing at this location also the concrete has worsened and needs to be repaired.

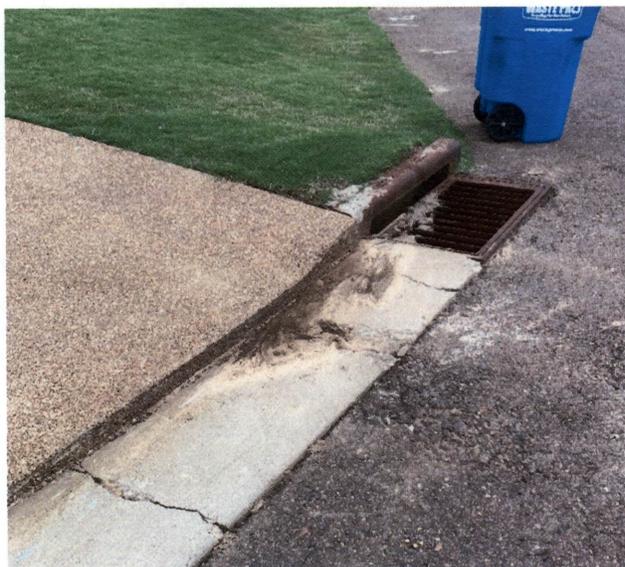
Broken gutter in front of inlet grate. The gutter is not just broken but sunk, causing a depression just before inlet. This is in front of a driveway on Cherrybark Drive, Sta. 23+00 Lt.

This area has been repaired, and this comment is closed.

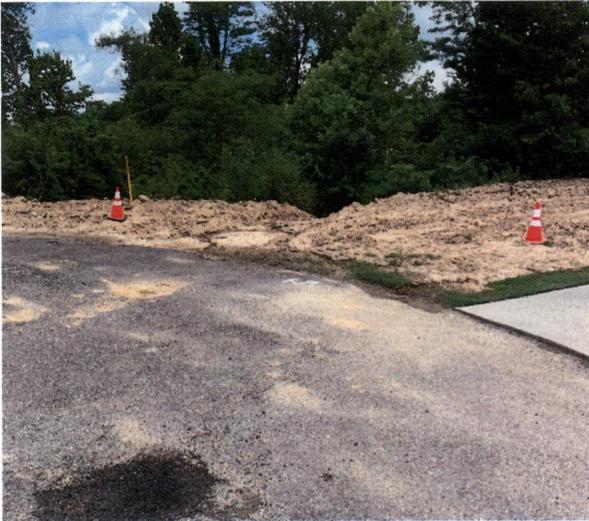
Erosion control measures need to be placed. Looks like there was recent work in this area on gas lines. Permanent erosion control should be used before there is a washout into to creek. This is at the end of Cherrybark Drive.

This area has been stabilized. This comment regarding the erosion control and stabilization is closed.

Comment #2 at this location: The constructed infrastructure at this location does not match the approved construction plans or the final plat. This needs to be resolved before final subdivision acceptance can take place.

Additionally, the constructed infrastructure at the end of E. Cherrybark Drive in front of lots 86 and 87 do not match the August 1, 2016, recorded final plan. The deviation in constructed infrastructure from the final recorded plan will need resolution prior to acceptance by the town.

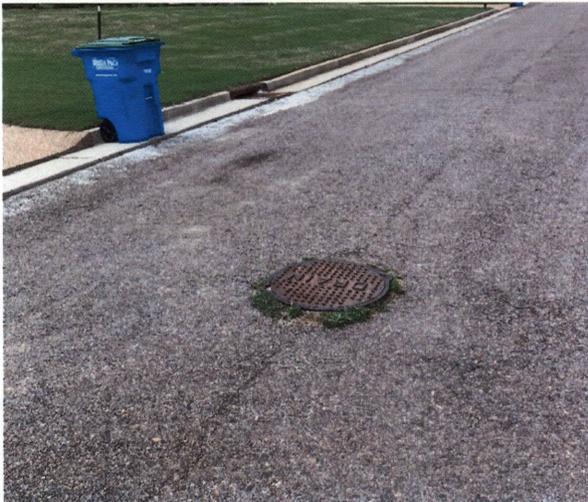
Sediment and vegetation need to be removed before paving surface lift of asphalt. Gutters should have a clean joint edge for full depth pavement lift. (Typical)

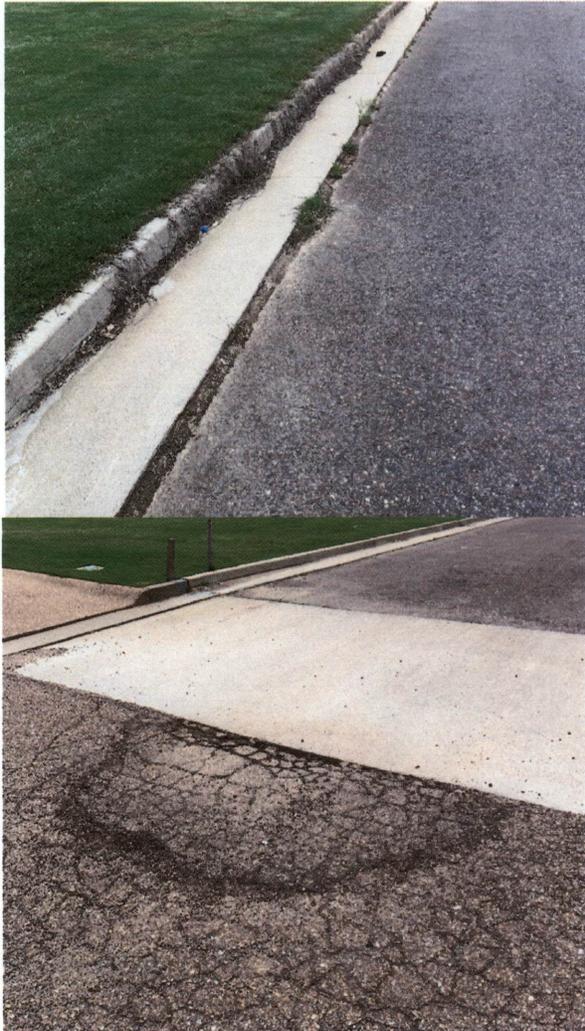
Asphalt failure. Looks like this area has already been patched and surface lift has already been placed. Asphalt should be removed full depth and replaced if this section hasn't already been accepted. Since this section has the final lift of asphalt it may be part of the previous phase. Chinkapin Drive Sta. 11+15

This asphalt is in Oak Creek Phase 1 not phase 2. Therefore, this comment is closed.

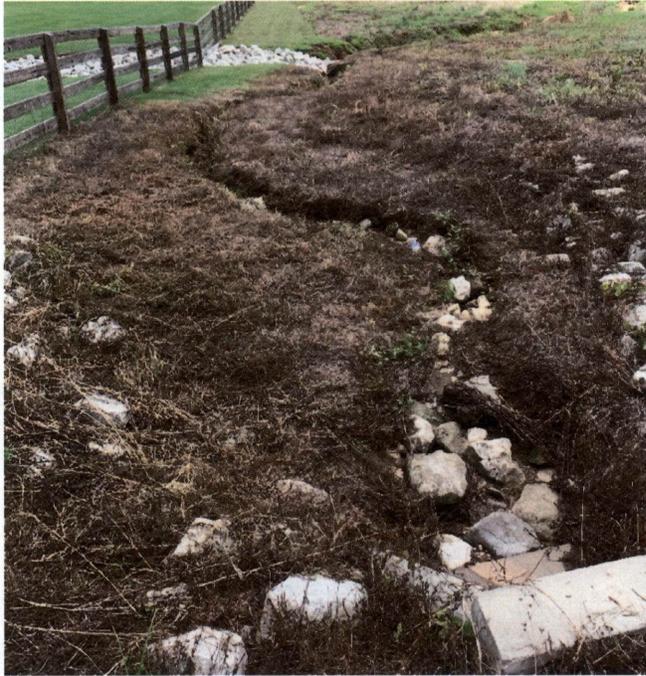
Erosion from outlet to existing ditch line. Outlet and rip-rap have been placed per plans, but the ditch created by this outlet looks like it may cut into Lot 99 if measures are not taken to keep the ditch from wandering. HW 97, Chinkapin Drive Sta. 20+50, Offset 230' Rt.

This headwall has been converted to a drain manhole. It is greatly improved but still has erosion that needs to be addressed. There are pictures below to illustrate what is there. This comment is not closed yet.

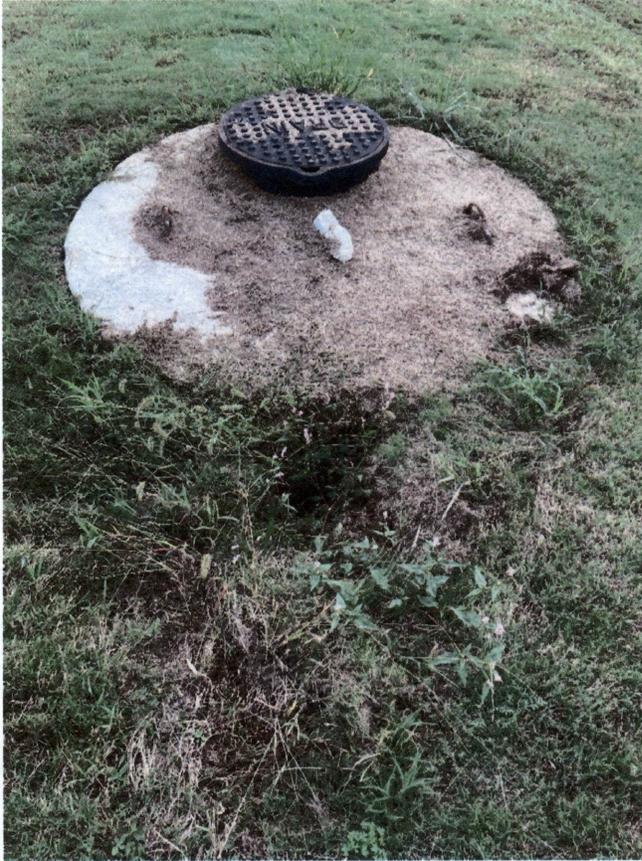
This is the current configuration of the above picture. It looks much better. However, the hole shown would indicate a hole in the manhole that water is entering in, and causing the loss of material that created this hole. The hole in the manhole needs to be repaired then the hole in the soil filled and seeded.

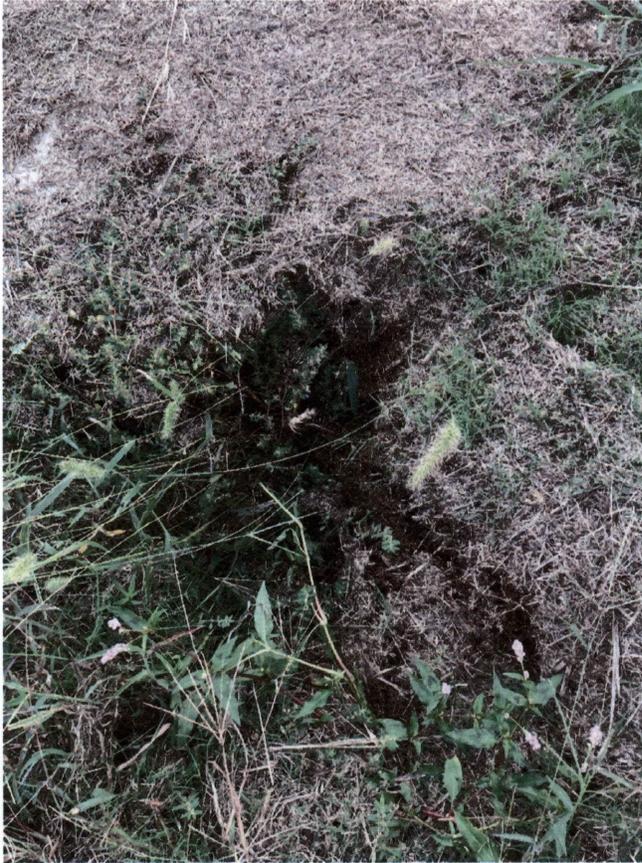
This photo shows erosion around the drain manhole shown above. All erosion should be repaired and permanently stabilized.

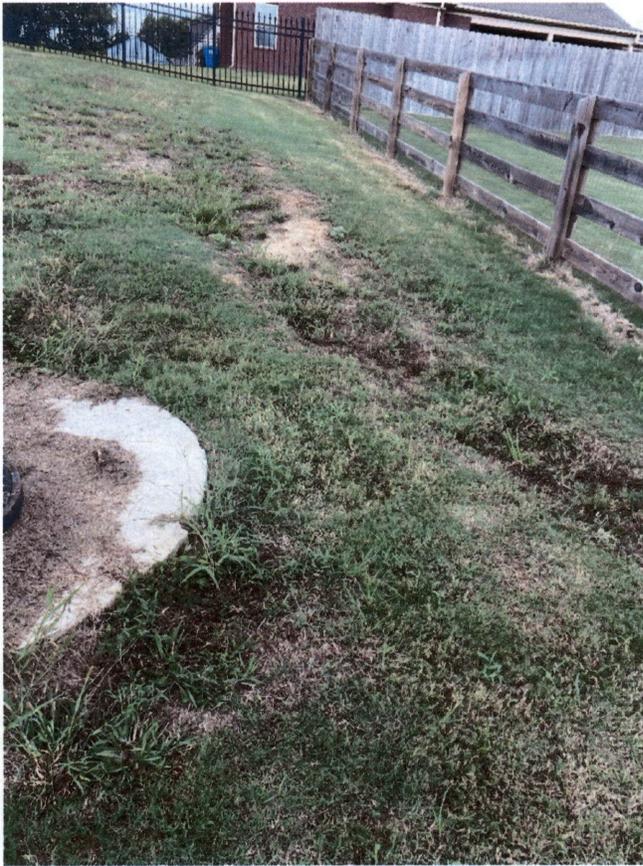
This photo shows erosion near the drain manhole above. All erosion should be repaired and permanently stabilized.

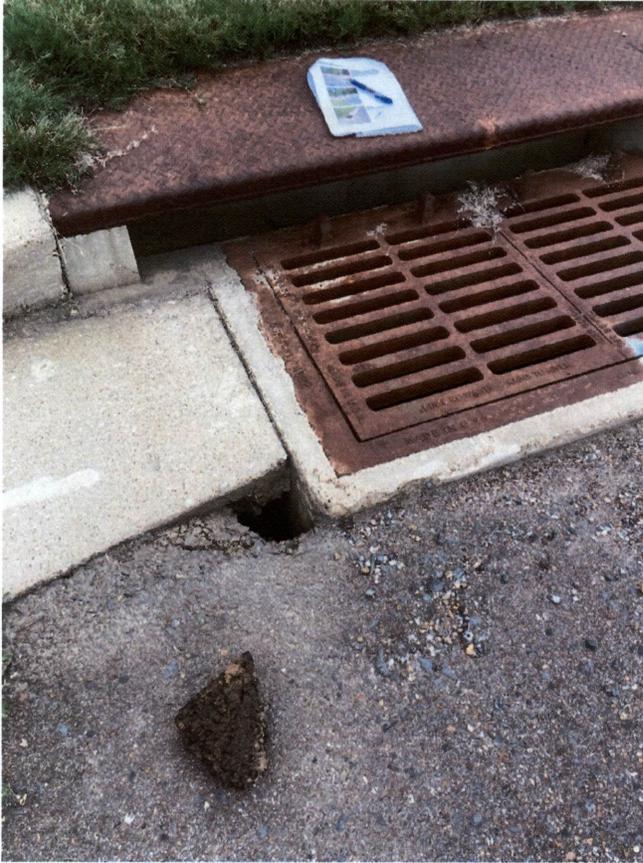
This inlet is on the east side of the cove at the east end of Sweetgum Lane. The hole in the picture is deep and extends under the curb and asphalt on the side and in front of the inlet. It appears that the water is getting into a hole other than the grate on top. This hole will need to be filled and the curb and asphalt repaired.
