City of Greenfield ADA Self-Evaluation and Transition Plan

Active, Aware, Accessible

June 2018

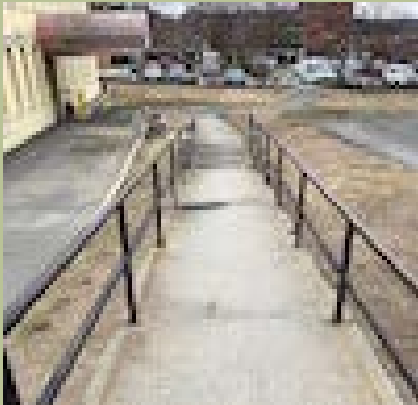
The library's accessible entrance ramp has cracks and crevices. Route from parking to entrance crosses an emergency vehicles lane.

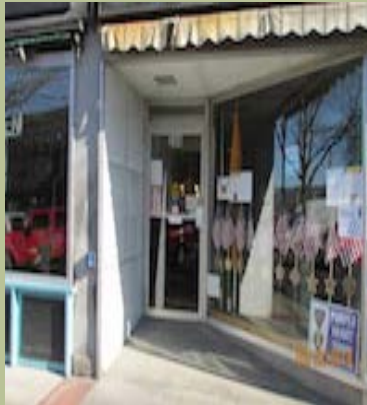
Accessible route from parking to entrance at the Veteran's Center has large crevices and is uneven.

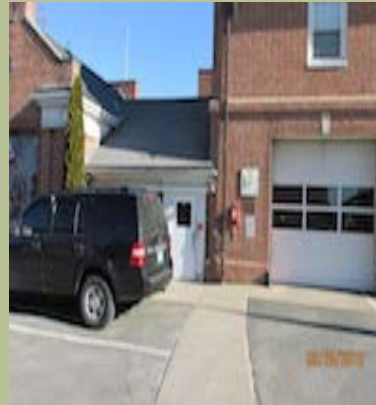
There is not an accessible route to the entrance of the fire station from accessible parking.

Fire Station (See pg. 24 for summary of evaluation)					
Location	Barrier	Suggested Action	Cost Estimate	Priority*	Timeframe
Approach & Entrance	Exterior Accessible Route	Design Accessible Route	\$15,000.00	3	3 years
Access to Goods and Services	Interior Accessible Route	Redesign entrance to Fire Station	\$30,000.00	3	4 years
Toilet Rooms	Accessible Route	Design Accessible Route	\$10,000.00	3	5 years
*1 = Safety Hazard 2 = Major Barrier 3 = Moderate Barrier 4 = Negligible Impact

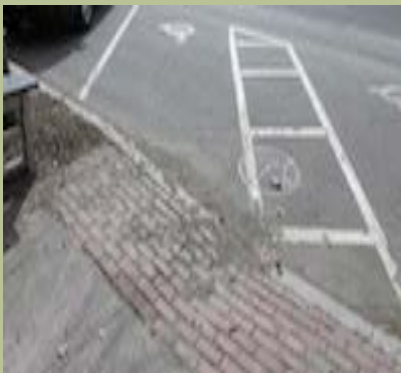
Accessible route from on-street parking location in front of 114 Main Street is uneven and not stable.

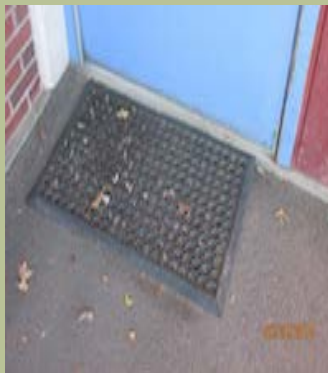
Route to City Offices entrance is uneven, damaged, and door is not ADA compliant.

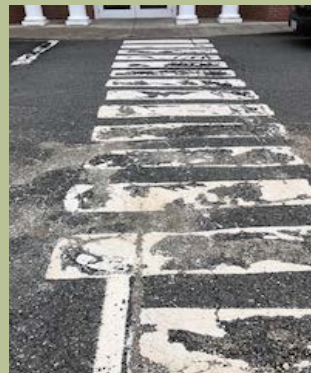
The surface of the route to Federal Street entrance is not stable or accessible.

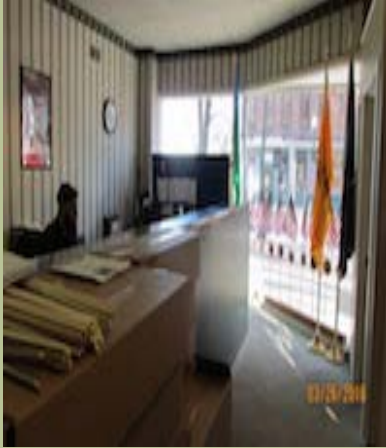
There is no interior accessible route upon entrance to the Veteran's Center.

Veteran's Center		(See pg. 23 for summary of evaluation)			
Location	Barrier	Suggested Action	Cost Estimate	Priority*	Timeframe
Approach & Entrance	Entrance	Provide unobstructed accessible route	\$500.00	2	1 year
Access to Goods and Services	Sales and Service Counters	Provide counter area for accessibility	\$1,000.00	2	1 year

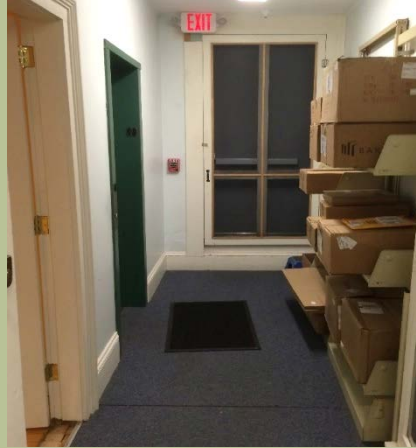
Accessible route to the elevator in library has obstructions.

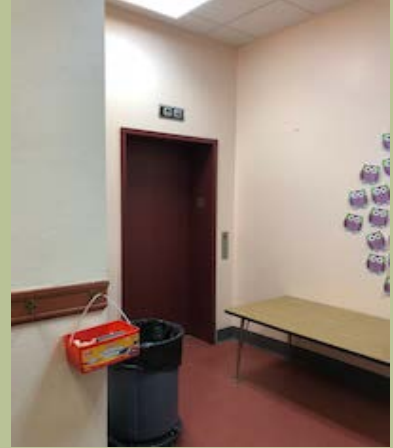
Long table and trash can is an obstruction to access the elevator at the Federal Street Elementary School.

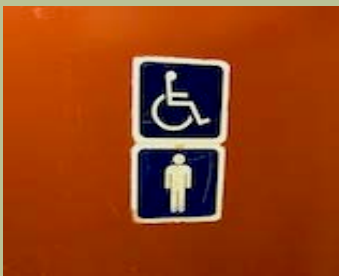
Accessible restrooms have non-compliant signage with no tactile characters in Federal Street Elementary School.

Federal Street Elementary School (See pg. 23 for summary of evaluation)					
Location	Barrier	Suggested Action	Cost Estimate	Priority*	Timeframe
Approach & Entrance	Exterior Accessible Route	Resurface Accessible Route	\$15,000.00	2	1 year
Access to Goods and Services	Interior Accessible Route	Remove obstructions at all elevators	\$50.00	2	<1 year
	Signage	Provide Accessible Signage	\$200.00	2	2 years
*1 = Safety Hazard 2 = Major Barrier 3 = Moderate Barrier 4 = Negligible Impact

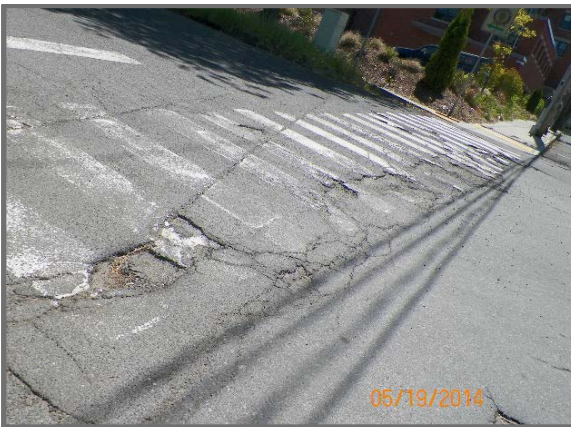
Crosswalk at Legion Ave and Wells Street

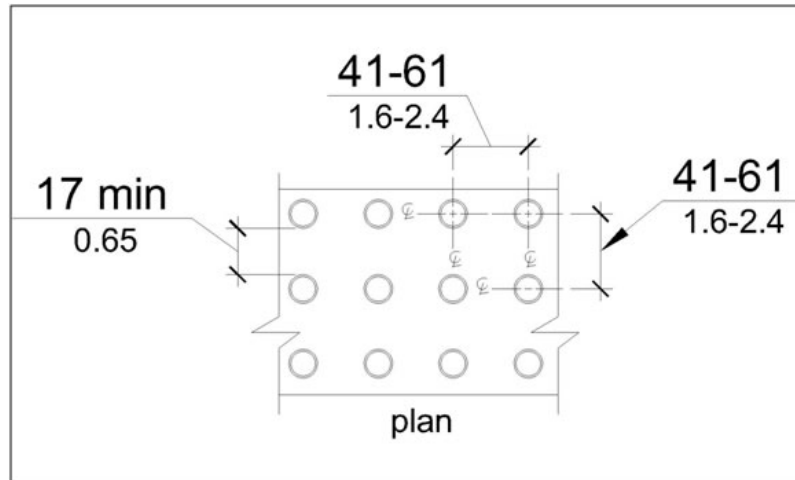
Contrast. Detectable warning surfaces shall contrast visually with adjacent gutter, street or highway, or pedestrian access route surface, either light-on-dark or dark-on-light.

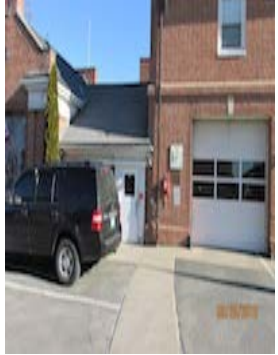
GREENFIELD FIRE STATION				
Project: Greenfield ADA		Building location: 418 Main Street		
Surveys completed by BRPC building specialist sub-consultant				
1. Approach & Entrance				
		Yes	No	PHOTOS
1.1	Route from site arrival points (parking, passenger loading zones, sidewalks) 2010 ADA Standards for Accessible Design - 206.2.1- Accessible from parking location to entrance needs to be redesigned.		X

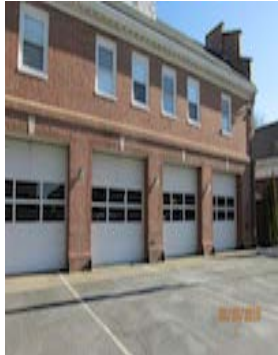
Exterior Accessible Route			
1.13	Route Stable, firm and slip-resistant? 302.1		X

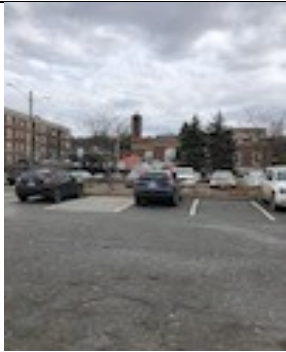
GREENFIELD PUBLIC LIBRARY				
Project: Greenfield ADA		Building location: 412 Main Street		
Surveys completed by BRPC building specialist sub-consultant				
1. Approach & Entrance				
		Yes	No	PHOTOS
1.1	Route from site arrival points (parking, passenger loading zones, sidewalks) 2010 ADA Standards for Accessible Design - 206.2.1- Accessible from parking location crosses in front of Fire Station where emergency vehicles enter and exit.		X

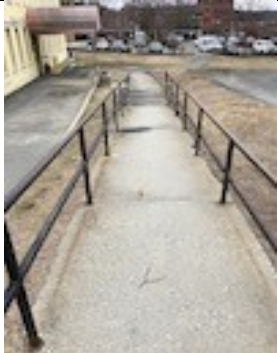
Exterior Accessible Route				
1.13	Route Stable, firm and slip-resistant? 302.1- Route has large crevices and is uneven.		X

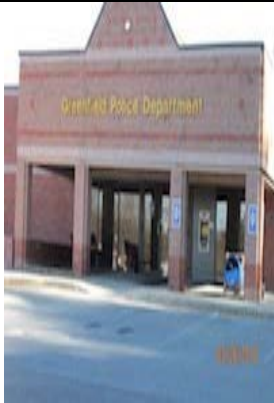
GREENFIELD POLICE STATION				
Project: Greenfield ADA		Building location: 321 High Street		
Surveys completed by BRPC building specialist sub-consultant				
1. Approach & Entrance				
		Yes	No	PHOTOS
	Approach & Entrance			
1.1	Route from site arrival points (parking, passenger loading zones, sidewalks) 2010 ADA Standards for Accessible Design - 206.2.1- Accessible from parking location to entrance is has mats on the route that need to be removed.		X

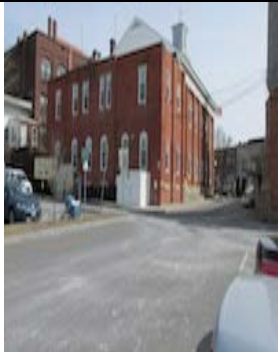
Exterior Accessible Route				
1.13	Route Stable, firm and slip-resistant? Accessible route is obstructed with trash containers.	X

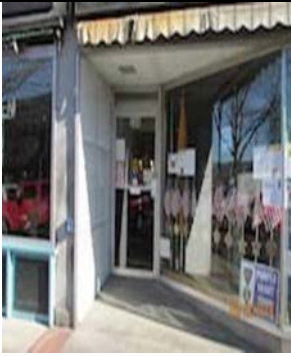
GREENFIELD VETERAN'S CENTER				
Project: Greenfield ADA Building location: 294 Main Street				
Surveys completed by BRPC building specialist sub-consultant				
1. Approach & Entrance				
		Yes	No	PHOTOS
1.1	Route from site arrival points (parking, passenger loading zones, sidewalks) 2010 ADA Standards for Accessible Design - 206.2.1- Accessible from parking location to entry is difficult to entry.		X

Exterior Accessible Route				
1.13	Route Stable, firm and slip-resistant? 302.1- Route has large crevices and is uneven.		X	
Ramps				
1:25	Ramp is at least 36"? 405.5		X	
1:26	Ramp surface stable, firm and slip resistant? 405.4		X	
1:29	Level landing where direction changes is at least 60 x 60? 405.7.4		X	
1:30	Ramp has a rise higher than 6" handrails on both sides? 405.8		X

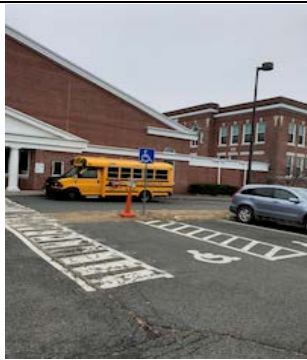
FEDERAL STREET ELEMENTARY SCHOOL				
Project: Greenfield ADA Building location: 125 Federal Street				
Surveys completed by BRPC building specialist sub-consultant				
1. Approach & Entrance				
		Yes	No	PHOTOS
1.1	Route from site arrival points (parking, passenger loading zones, sidewalks) 2010 ADA Standards for Accessible Design - 206.2.1- Accessible from parking location to entrance is needs to be repaired.		X

Exterior Accessible Route				
1.13	Route Stable, firm and slip-resistant? 302.1- surface is not properly marked and is route is not firm and accessible.		X

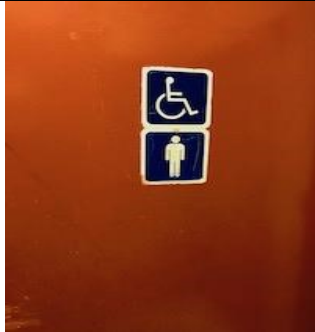
FEDERAL STREET ELEMENTARY SCHOOL				
Project: Greenfield ADA Building location: 125 Federal Street				
Surveys completed by BRPC building specialist sub-consultant				
		Yes	No	PHOTOS
2.5	If the route is greater than 200', less than 60" wide, is there a passing space? 403.5.3		X	
2.9	Are there elevators or platform lifts to all public stories?			
Signs				
2:38	Signs designation permanent rooms and spaces? 216.2, 703.5, 703.2, 703.3		X	
2:39	Signs that provide direction to information about interior spaces? 703.5.1- all signage needs to be updated to currently ADA requirements.		X

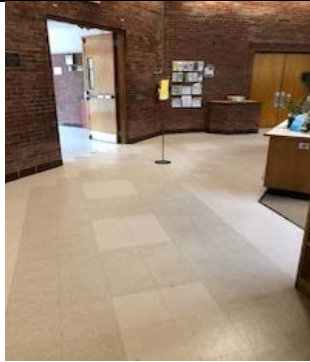
Interior Accessible Route				
2.2	Are all public spaces on at least one accessible route? 206.2.4		X	
2.3	Is the route stable, firm and slip-resistant?		X	
2.5	If the route is greater than 200', less than 60" wide, is there a passing space? 403.5.3		X	
2.9	Are there elevators or platform lifts to all public stories?			
Signs				
2:38	Signs designation permanent rooms and spaces? 216.2, 703.5, 703.2, 703.3		X	
FOUR CORNERS SCHOOL

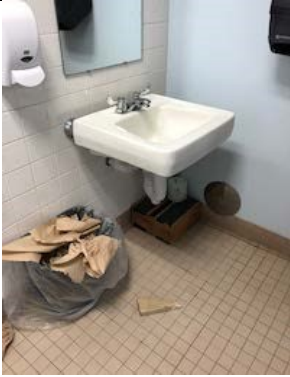
FOUR CORNERS SCHOOL Project: Greenfield ADA Building location: 21 Ferrante Avenue				
Surveys completed by BRPC building specialist sub-consultant				
		Yes	No	PHOTOS
3.22	Do no less than 17" and no greater than 25" of the clear floor space extend under the lavatory so that a person using a wheelchair can get close enough to reach the faucet? 306.2		X	
3.23	Is the front of the lavatory or counter surface, whichever is higher, no more than 34" above the floor? 606.3		X	
3.24	Is there at least 27 inches clearance from the floor to the bottom of the lavatory that extends at least 8" under the lavatory for knee clearance? 306.3.3		X

3.25	Is there toe clearance at least 9" high? 306.3.3		X

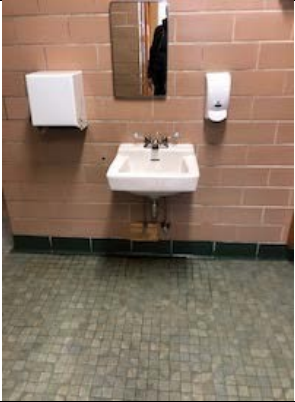
FOUR CORNERS SCHOOL				
Project: Greenfield ADA		Building location: 21 Ferrante Avenue		
Surveys completed by BRPC building specialist sub-consultant				
		Yes	No	PHOTOS
3.26	Are pipes below the lavatory insulated or otherwise configured to protect against contact? 606.5		X

3.27	Can the faucet be operated with tight grasping, pinching, or twisting of the wrist? 606.4		X	
Soap Dispensers and Hand Dryers				
3.28	Are the operable parts of the soap dispenser or counters no less than 20" no greater than 25" deep, no higher than 44" above the floor? 308.2.2		X	
3.29	Are the operable parts of the hand dryer or towel dispenser no less than 20" and no greater than 25" deep: no higher than 44" above the floor? 309.4, 308.2		X

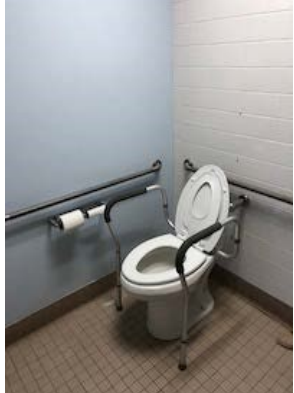
FOUR CORNERS SCHOOL				
Project: Greenfield ADA		Building location: 21 Ferrante Avenue		
Surveys completed by BRPC building specialist sub-consultant				
		Yes	No	PHOTOS
Toilet Compartments (Stalls)				
3.41	Is the door opening width at least 32" clear, between the face of the door and the stop, when the door is open 90 degrees? 604.8.1.2	X

3.42	If there is a front approach to the pull side of the door, is there at least 18" of maneuvering clearance beyond the latch side plus 60" clear depth? 604.8.1.2	X		
3.43	Is the door self-closing? 604.8.1.2	X		
3.44	Are there door pulls on both sides of the door that are operable with one hand and do not require tight grasping pinching or twisting of the wrist? 604.8.1.2	X

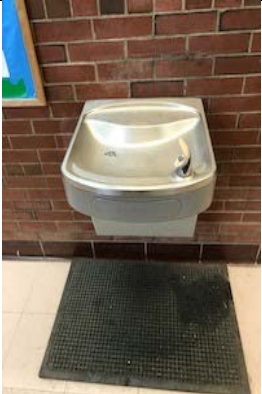
FOUR CORNERS SCHOOL				
Project: Greenfield ADA		Building location: 21 Ferrante Avenue		
Surveys completed by BRPC building specialist sub-consultant				
		Yes	No	PHOTOS
3.50	If the door swings in, is the minimum required compartment area provided beyond the swing of the door (60" x 56") if water closet is wall hung or 59" if water closet is floor mounted? 604.8.1.1	X		
4. Additional Access				
Drinking Fountains				
4.1	Does at least one drinking fountain have a clear floor space at least 30" wide x at least 48" long centered in front of it for a forward approach? 602.2	X

4.2	If there is a forward approach, do no less than 17" and no greater than 25" of the clear floor space extend under the drinking fountain? 306.2.2. 306.2.3	X

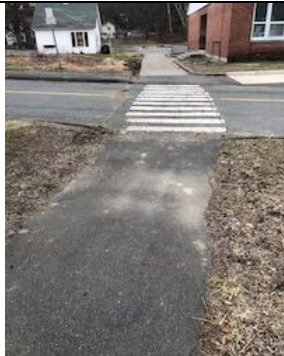
GREEN RIVER SCHOOL				
Project: Greenfield ADA		Building location: 82 Meridian Street		
Surveys completed by BRPC building specialist sub-consultant				
1. Approach & Entrance				
		Yes	No	PHOTOS
1.1	Route from site arrival points (parking, passenger loading zones, sidewalks) 2010 ADA Standards for Accessible Design - 206.2.1- Accessible from parking location to entrance needs to be resurfaced.		X

Exterior Accessible Route				
1.13	Route Stable, firm and slip-resistant? 302.1		X

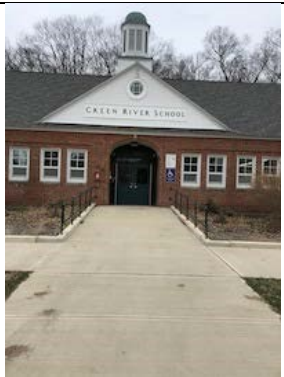
1:37	Is the Main entrance accessible?		X	
1:38	If not accessible is there an alternative entrance ?		X	
1:39	Do inaccessible entrances have signs indicating nearest accessible? 216.6	X

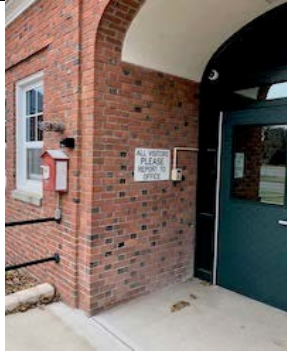
GREEN RIVER SCHOOL				
Project: Greenfield ADA		Building location: 82 Meridian Street		
Surveys completed by BRPC building specialist sub-consultant				
		Yes	No	PHOTOS
1:40	Accessible entrance with the International Symbol of Accessibility? 216.6	X		
1:41	Clear opening width of accessible entrance at least 32"? 404.2.3		X	
1:42	Pull side of door at least 18" of maneuvering clearance ? 404.2.4		X	
1:43	Threshold is vertical is it no more than 1/4" high ? 404.2.5		X

1:44	Door equipped with hardware that is operable with one hand ? 404.2.7		X	
1:45	Operable parts of door no less than 34" no greater than 48"? 404.2.7		X	
1:46	Door closer, does it take 5 seconds to close? 404.2.8		X

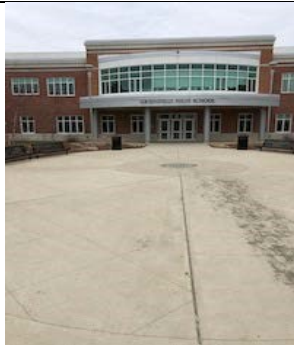
Exterior Accessible Route			
1.13	Route Stable, firm and slip-resistant? 302.1	x		
	Ramps			
1:25	Ramp is at least 36"? 405.5	x		
1:26	Ramp surface stable, firm and slip resistant? 405.4	x		
1:29	Level landing where direction changes is at least 60 x 60? 405.7.4	x		
1:30	Ramp has a rise higher than 6" handrails on both sides? 405.8	x		
1:35	Handrail 12" beyond top and bottom of ramp? 505.10.1	x		
1:37	Is the Main entrance accessible?	x

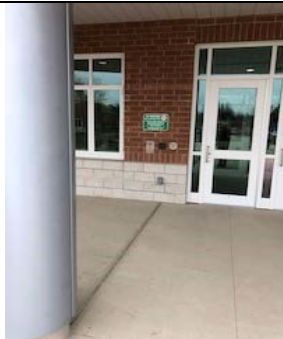
GREENFIELD HIGH SCHOOL				
Project: Greenfield ADA		Building location: 21 Barr Avenue		
Surveys completed by BRPC building specialist sub-consultant				
		Yes	No	PHOTOS
1:38	If not accessible is there an alternative entrance ?	x		
1:39	Do inaccessible entrances have signs indicating nearest accessible? 216.6	x		
1:40	Accessible entrance with the International Symbol of Accessibility? 216.6	x

1:41	Clear opening width of accessible entrance at least 32"? 404.2.3	x		
1:42	Pull side of door at least 18" of maneuvering clearance ? 404.2.4	x		
1:43	Threshold is vertical is it no more than 1/4" high ? 404.2.5	x		
1:44	Door equipped with hardware that is operable with one hand ? 404.2.7	x		
1:45	Operable parts of door no less than 34" no greater than 48"? 404.2.7	x

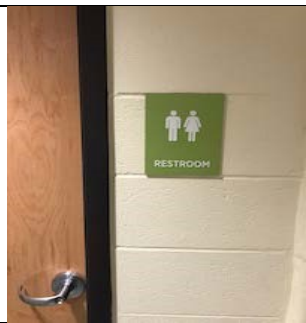
GREENFIELD HIGH SCHOOL				
Project: Greenfield ADA		Building location: 21 Barr Avenue		
Surveys completed by BRPC building specialist sub-consultant				
		Yes	No	PHOTOS
2:39	Signs that provide direction to information about interior spaces? 703.5.1	x

Controls-light switches, security				
2:50	Clear floor space at least 30" wide by 48" long ? 305.3	x		
2:51	Can the control be operated with one hand and without tight grasping, pinching, or twisting of the wrist? 309.4	x		
Seating: Assembly Areas				
2.52	Adequate number of wheelchair spaces provided? 221.2.1	x		
2.53	Wheelchair spaces dispersed to allow location choices and viewing? 221.2.3	x		
2.54	Wheelchair spaces have a clear line of sight? 802.2.1.1, 802.1.1.2	x

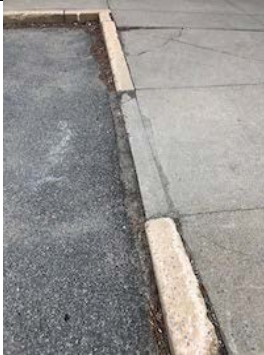
NORTH PARISH SCHOOL				
Project: Greenfield ADA		Building location: 1 Terrace Place		
Surveys completed by BRPC building specialist sub-consultant				
1. Approach & Entrance				
		Yes	No	PHOTOS
1.1	Route from site arrival points (parking, passenger loading zones, sidewalks) 2010 ADA Standards for Accessible Design - 206.2.1- Accessible from parking location to entrance is damage and uneven.		X

Exterior Accessible Route				
1.13	Route Stable, firm and slip-resistant? 302.1		X

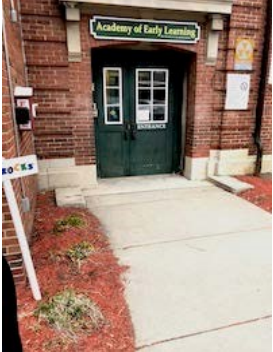
NORTH PARISH SCHOOL Project: Greenfield ADA Building location: 1 Terrace Place				
Surveys completed by BRPC building specialist sub-consultant				
		Yes	No	PHOTOS
1:29	Level landing where direction changes is at least 60 x 60? 405.7.4	X		
1:30	Ramp has a rise higher than 6" handrails on both sides? 405.8	X		
1:35	Handrail 12" beyond top and bottom of ramp? 505.10.1	X		
1:37	Is the Main entrance accessible?	X		
1:38	If not accessible is there an alternative entrance ?	X		
1:39	Do inaccessible entrances have signs indicating nearest accessible? 216.6		X

1:40	Accessible entrance with the International Symbol of Accessibility? 216.6		X
