CONSTRUCTION OBSERVATION REPORT

Date:
 November 30, 2021
 Time On Site:
 8:30 AM
 Time Off Site:
 11:00 AM

Project:
 Middlebury River Flood Resiliency Project (15032.00002)

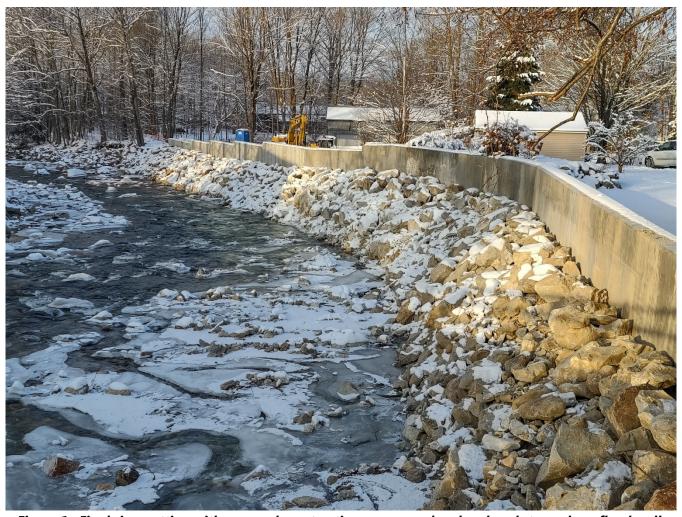
- Flood Wall Area
 - Completed removal of construction access road to river. Dimensions of stone fill match plans.
 All river work complete.
 - Steeper and shorter earth slope requested behind new flood wall by landowner to be planted with native wildflower and annual rye seed, and covered with mulch. This area will not be mowed. Birch saplings to be installed near toe of slope in spring 2022.

Figure 1: Final river setting with removed construction access road and replaced stone along flood wall.

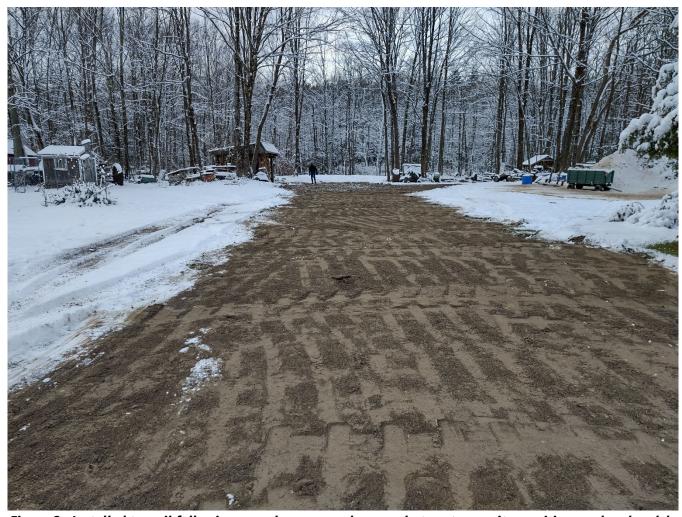
- o Gravel access drive properly removed. Landowner pleased with work.
- Additional tasks to be completed.
 - Seed and mulch.
 - Plant bare root trees on flatter area along flood chute.

Figure 2: Installed topsoil following gravel access road removal at upstream site awaiting seed and mulch.

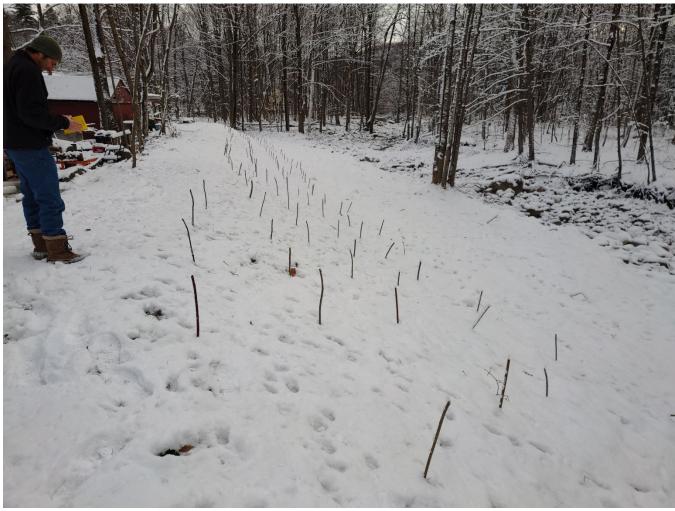
Figure 3: Installed dormant stake plantings at the upstream site along the armored slope. Note that these need to be driven in further.

- Live stakes installed on riprap slope. These need to be driven in further (>1/2 length minimum) to promote future growth. OK to move stake a bit to find planting crevice. OK to hammer in stakes with mallet. Pry bar likely needed to poke around. This update is needed for all live stake plantings.

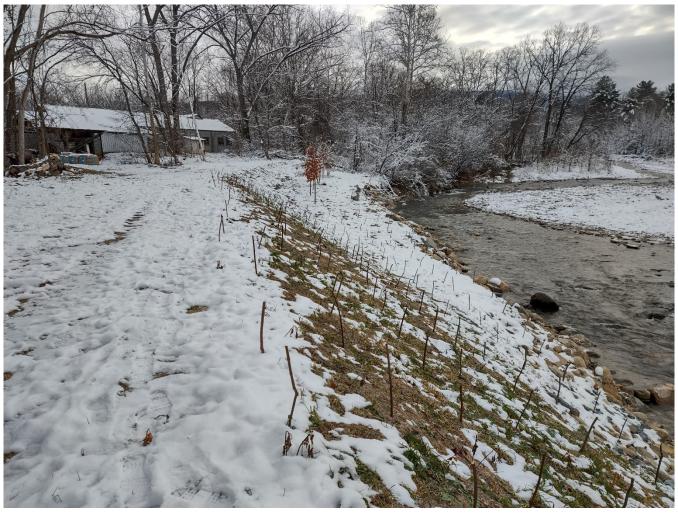
- Goodro's Site
 - Larger trees properly planted.
 - Additional tasks to be completed.
 - Update live stakes per above note.
 - Plant bare root trees on flatter floodplain area and in pockets at base of berm.

Figure 4: Planted larger trees (background) and dormant stakes (foreground) at the Goodro Lumber site.

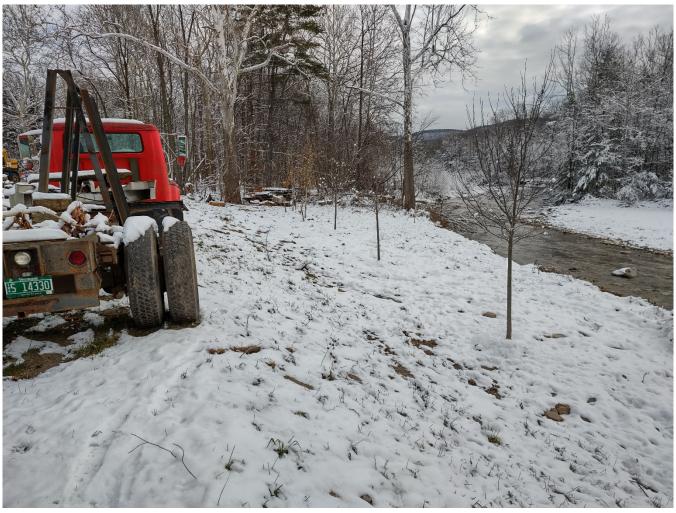
- Eric Murray's Site
 - Larger trees properly planted.
 - Additional tasks to be completed.
 - Update live stakes per above note.
 - Plant bare root trees on flatter floodplain area and in pockets at base of berm.

Figure 5: Installed large trees at the Murray site.

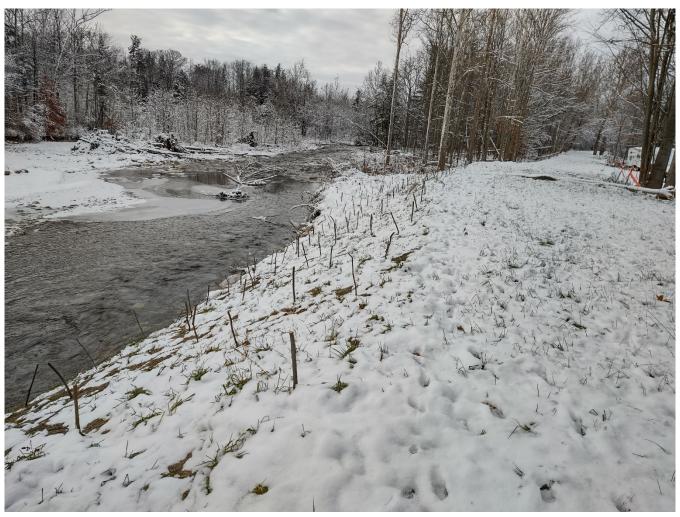
Figure 6: Installed dormant stakes at the Murray site.

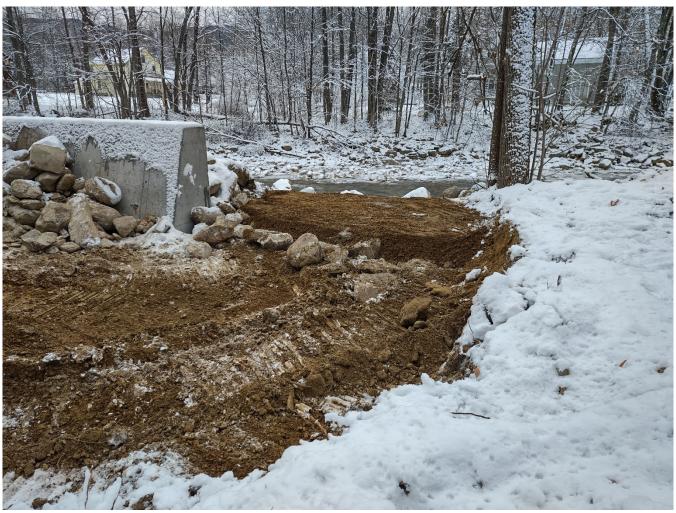
- Place cobble on stone at downstream section of wall to replicate previous cobble. Blend into earthen fill behind wall.
 - Created flatter opening with stone and gravel for river access and viewing. Area will be covered with topsoil and seeded.

Figure 7: Placing stone fill and gravel at the flood wall opening to create elevated access and river viewing area. This approach allows future river access by the Town, while also meeting desires of landowners.
