CITY OF SHREWSBURY

SPORT COURT ASSESSMENT MATRIX

Courts and Conditions

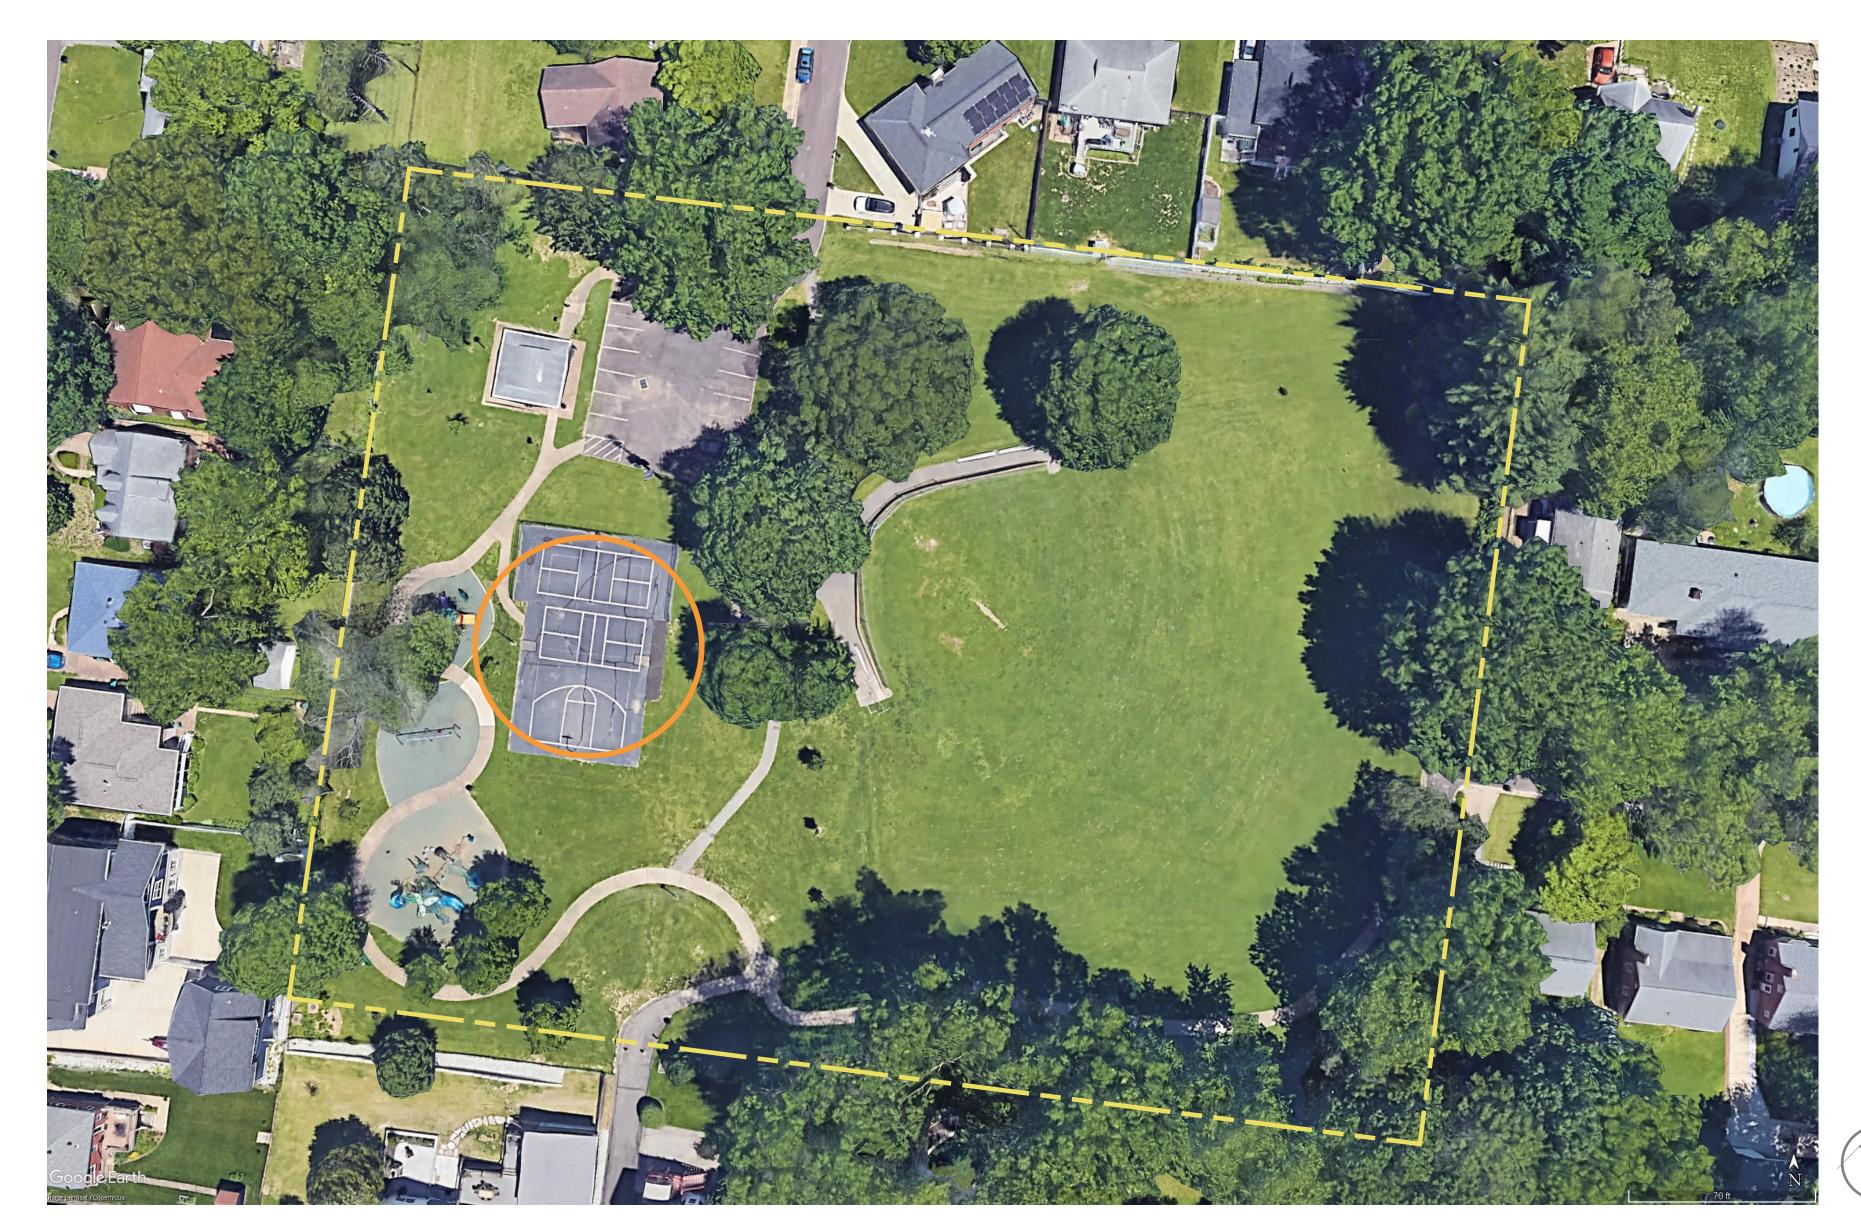
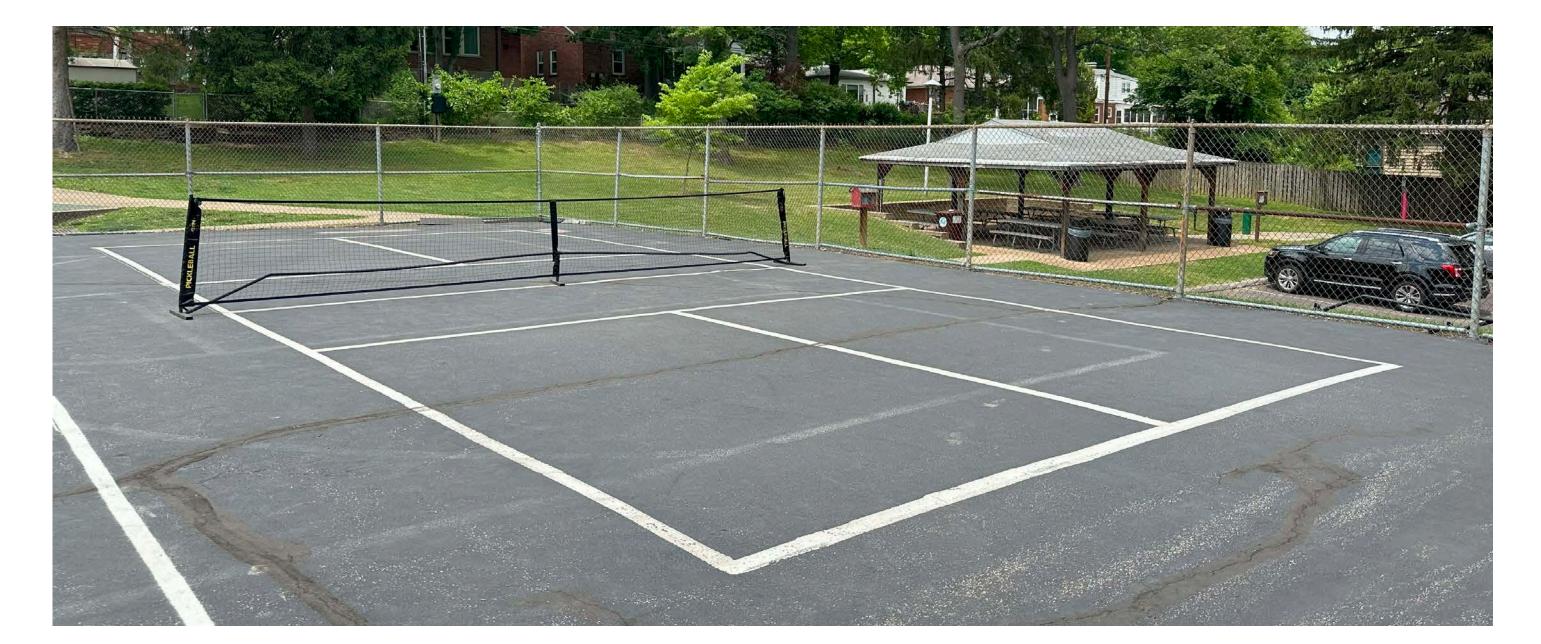
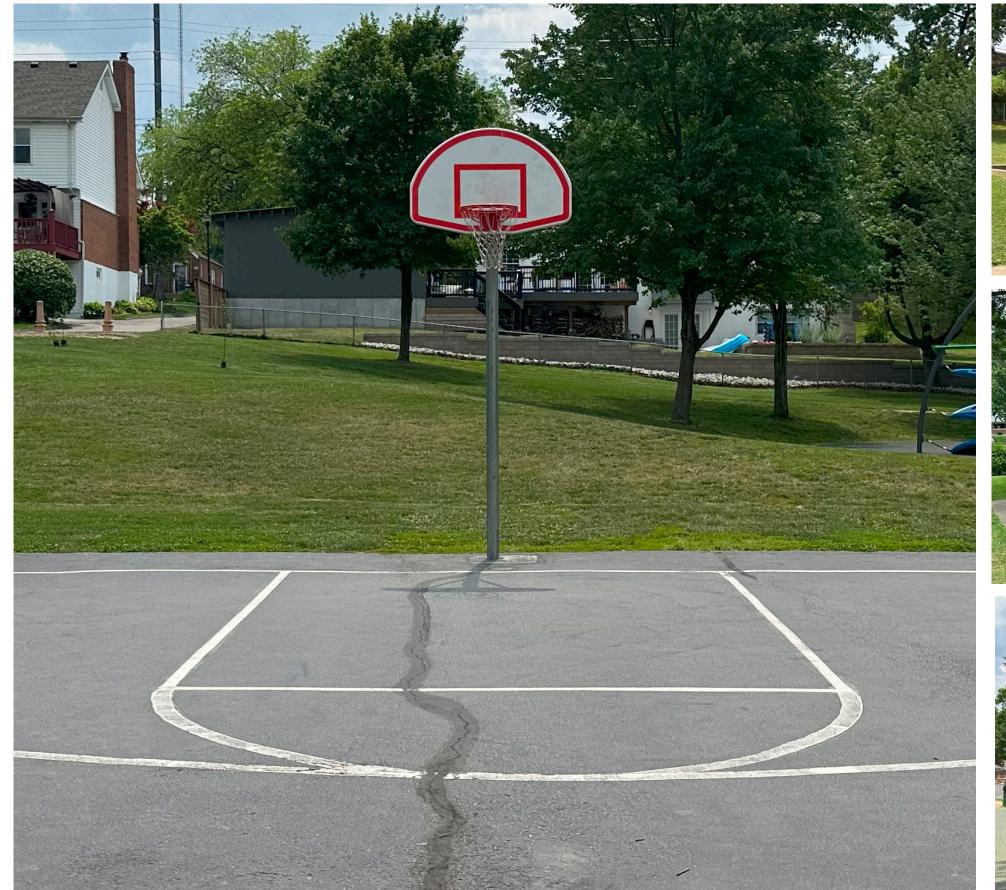
Basketball

| | CRITERIA | SCORE | NOTES |
|---|---|---|--|
| nt & | General Condition | 0 | surface cracking /slope, court undersized |
| quip | Surfacing | 0 | Sloped surface, cracks |

| | CRITERIA | SCORE | NOTES |
|---|---|---|--|
| nt 8 | General Condition | 0 | Hoop in good condition, surface cracking, sloping |
| Equipment Accessibilit | Surfacing | 0 | Sloped surface, cracks |

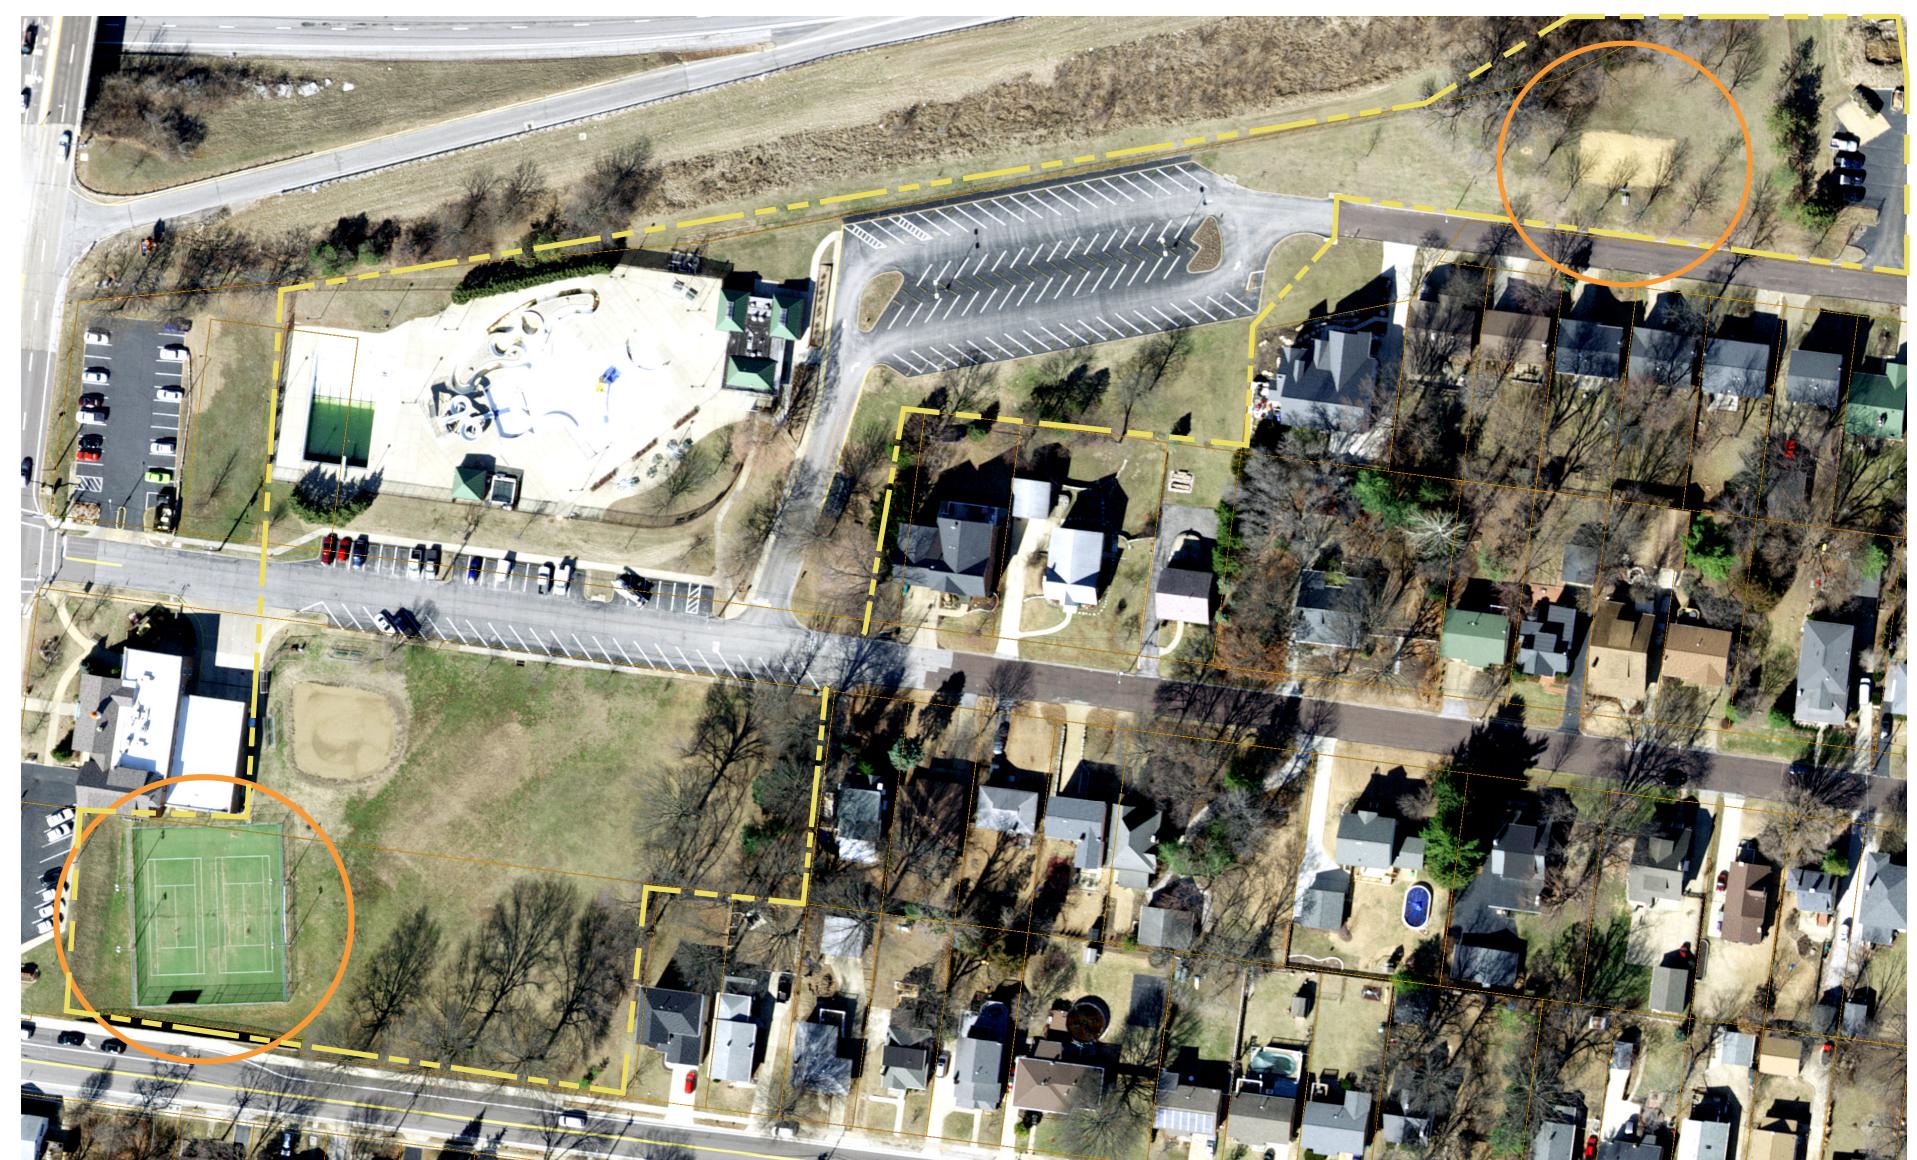
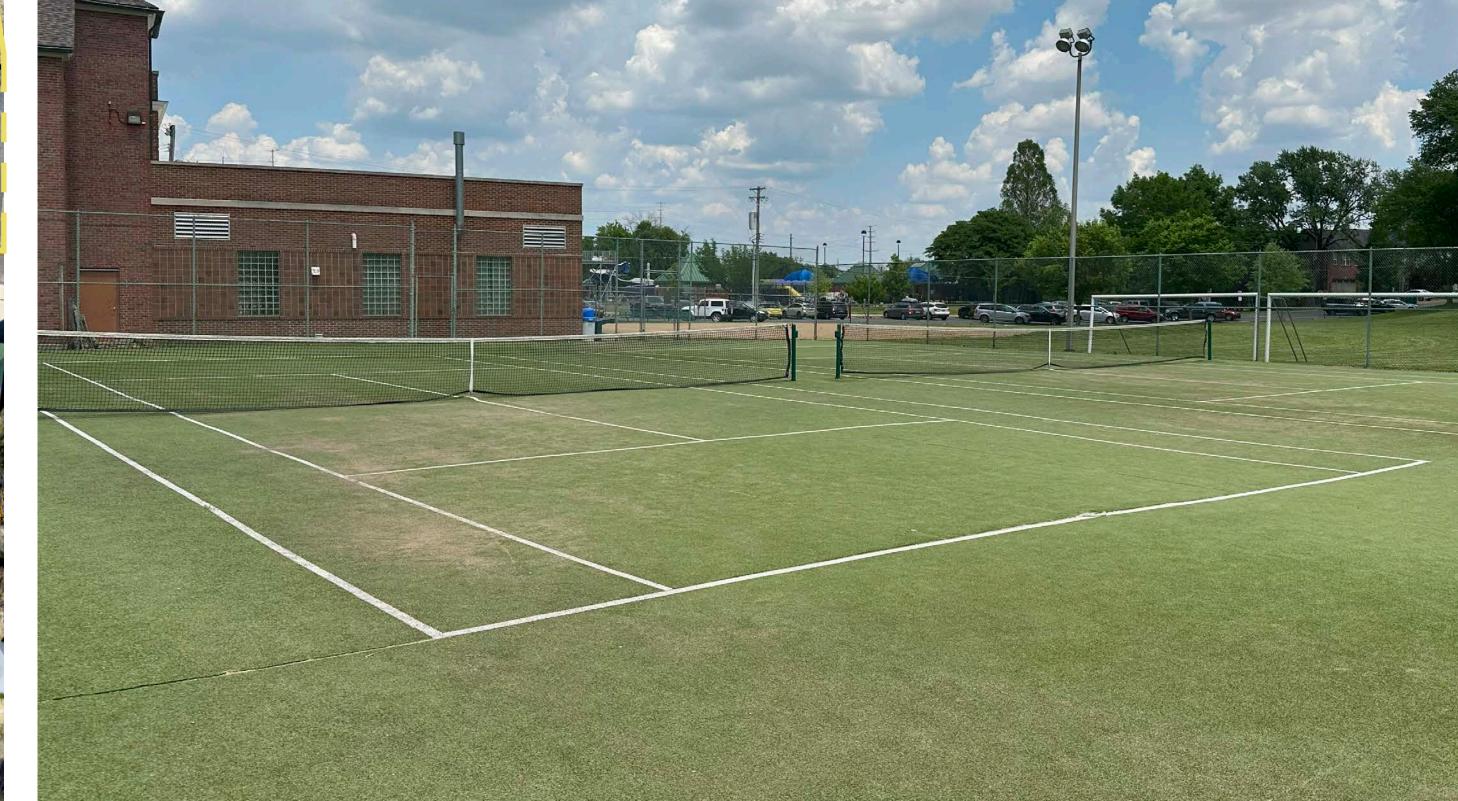
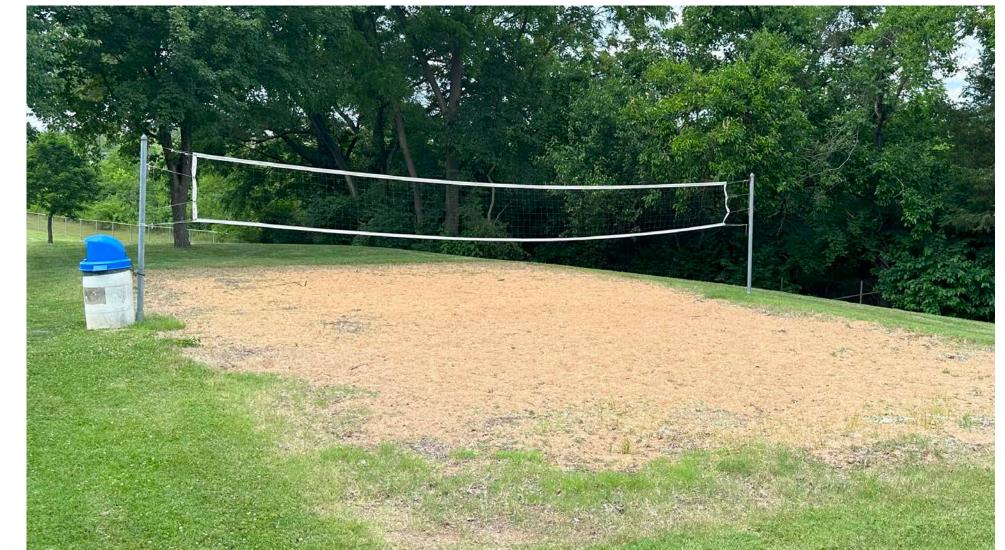
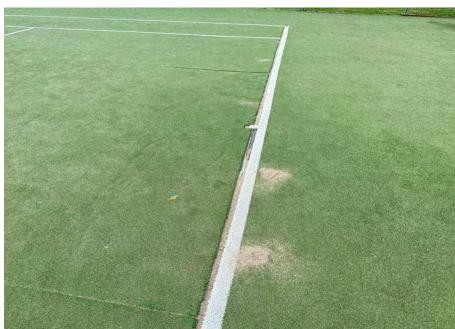
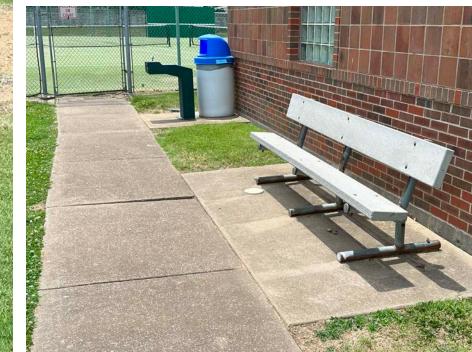
Sand Volleyball

| | CRITERIA | SCORE | NOTES |
|---|---|---|---|
| Court & Location | Surface | NA | Synthetic turf on asphalt base |
| nt & | General Condition | 0 | turf seams separating, fence bowing |
| quip | Surfacing | 0 | Turf is nearing end of lifespan |

| | CRITERIA | SCORE | NOTES |
|---|---|---|---|
| nt 8 | General Condition | 2 | Court overgrown in locations |

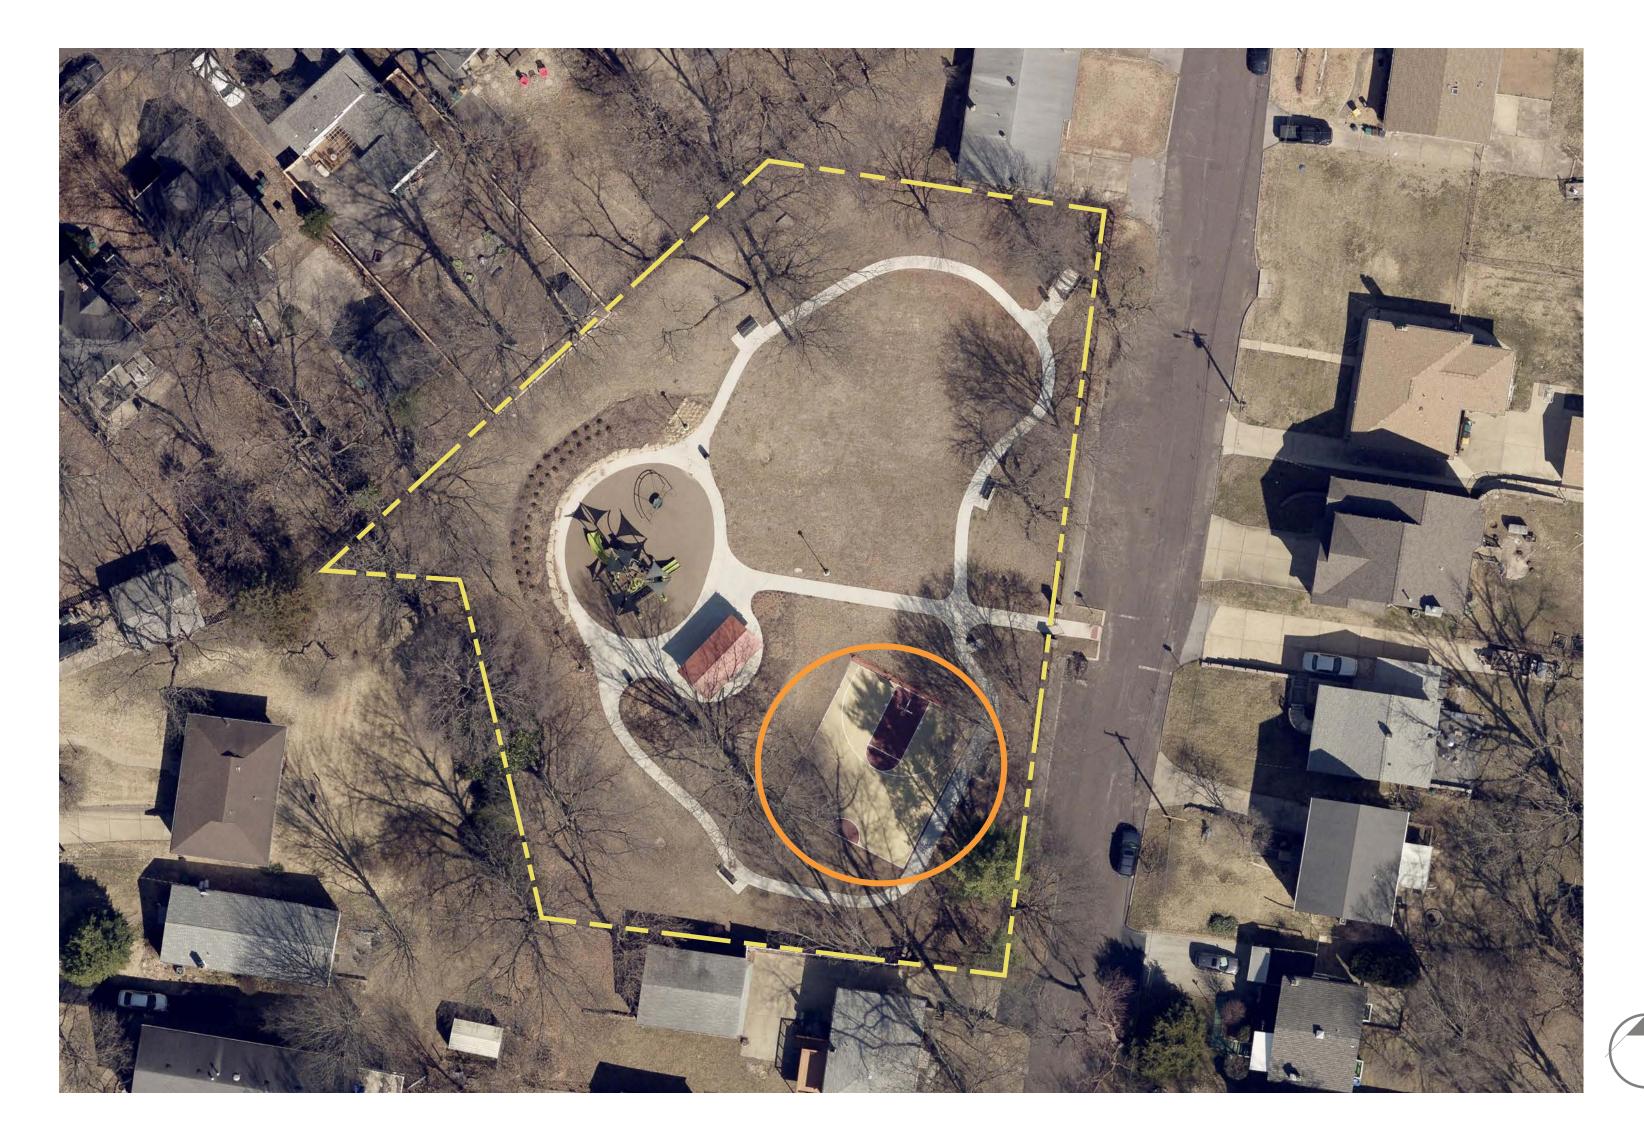
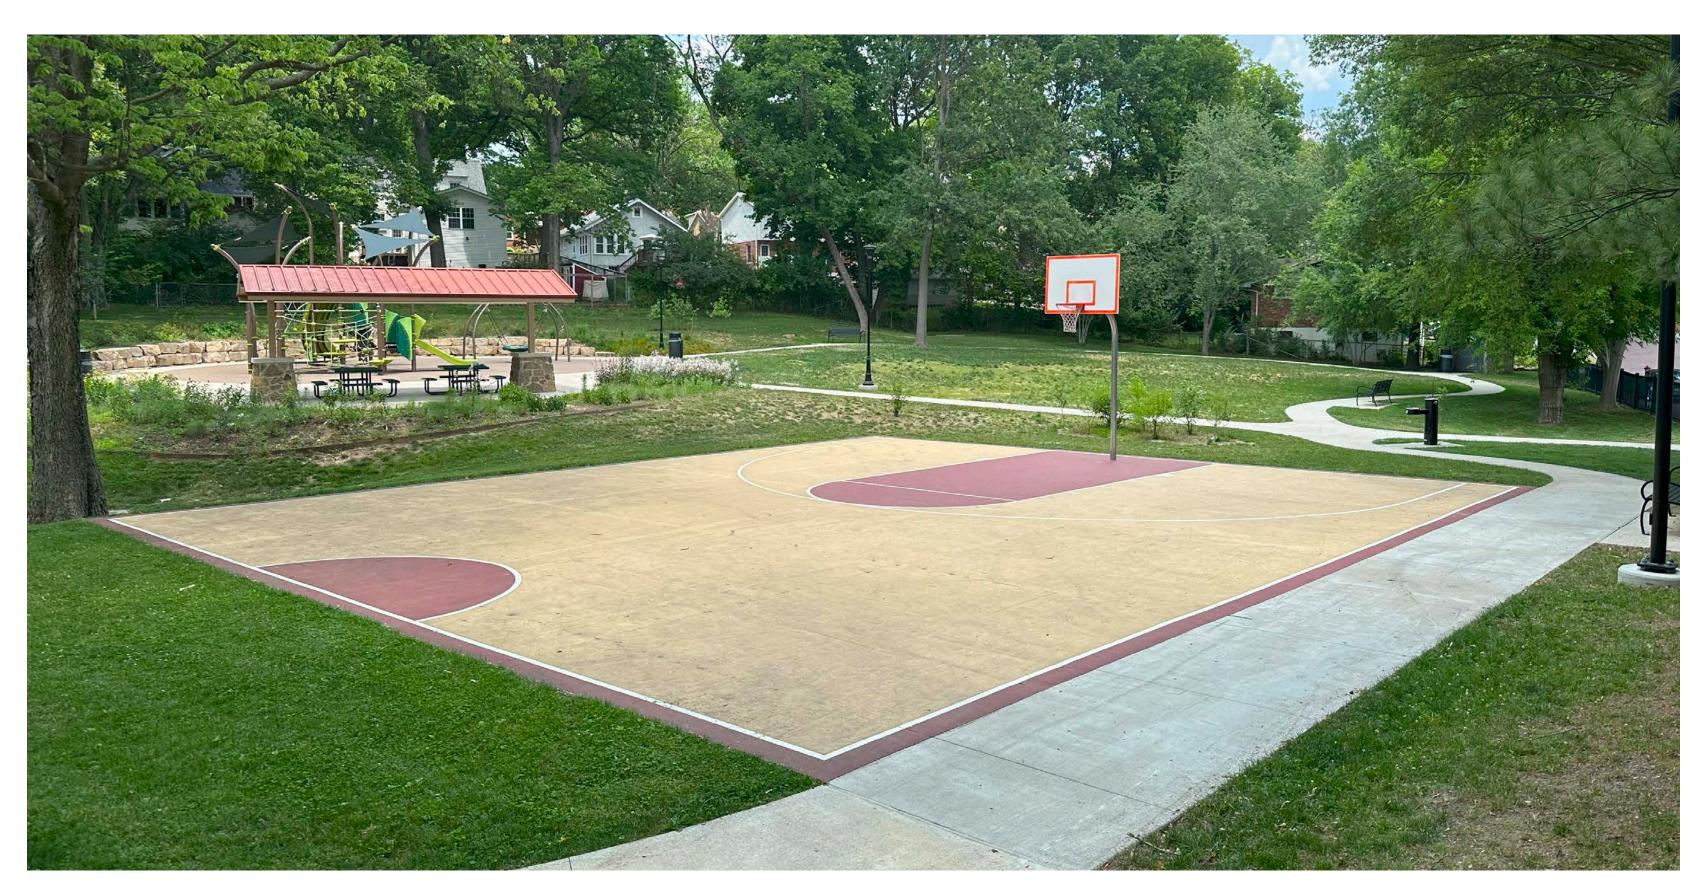
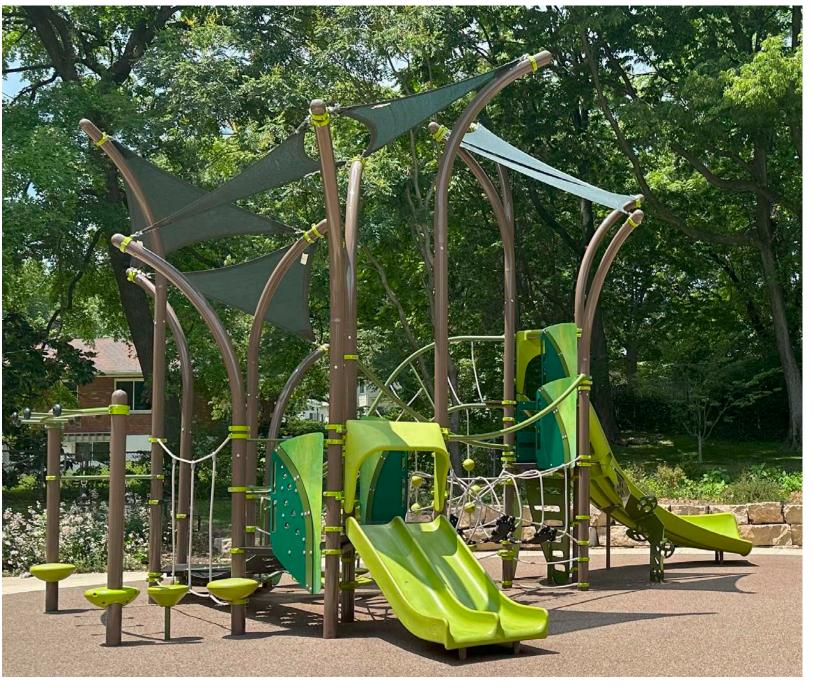
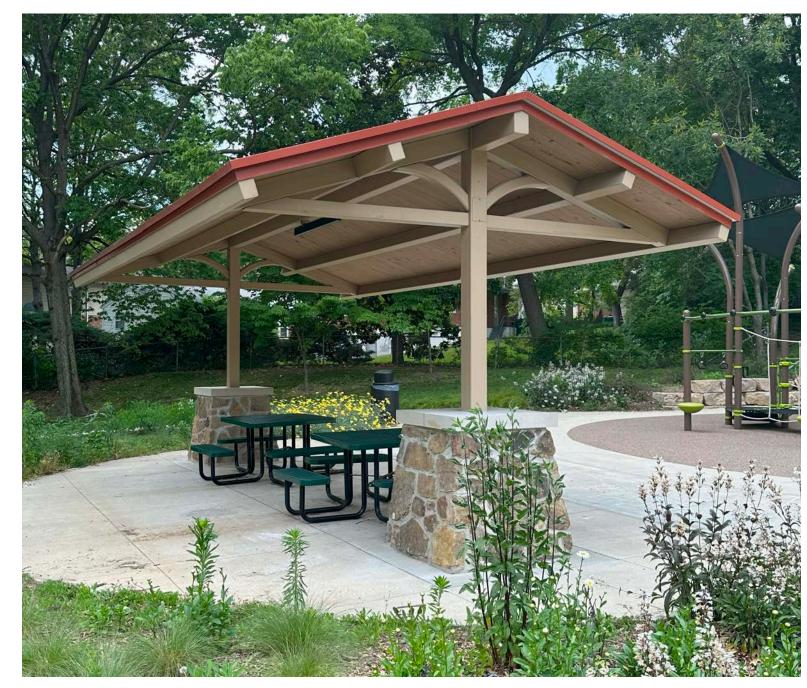
| | CRITERIA | SCORE | NOTES | |
|---|---|---|--|--|
| | Surface | NA | Concrete | |
| | General Condition | 3 | Hoop in good condition, surface flat and in good shape | |
| | Surfacing | 3 | Ideal surface for use | |
