**ATLANTIC INTRACOASTAL
WATERWAY
MAINTENANCE DREDGING
NASSAU COUNTY REACH I, FLORIDA**

DMMA NA-1 Site Reconnaissance Report
DMMA DU-2 Site Reconnaissance Report

Re: Professional Engineering Services, Task 1.2 DMMA Reconnaissance (NA-1)
Maintenance Dredging of Nassau Reach I and Applicable Portions of Fernandina Harbor Project,
Nassau County, FL
FIND Work Order 15-08; TE Contract C2015-048

Re: Professional Engineering Services, Task 1.2 DMMA Reconnaissance (DU-2)
Maintenance Dredging of Nassau Reach I and Applicable Portions of Fernandina Harbor Project,
Nassau County, FL
FIND Work Order 15-08; TE Contract C2015-048

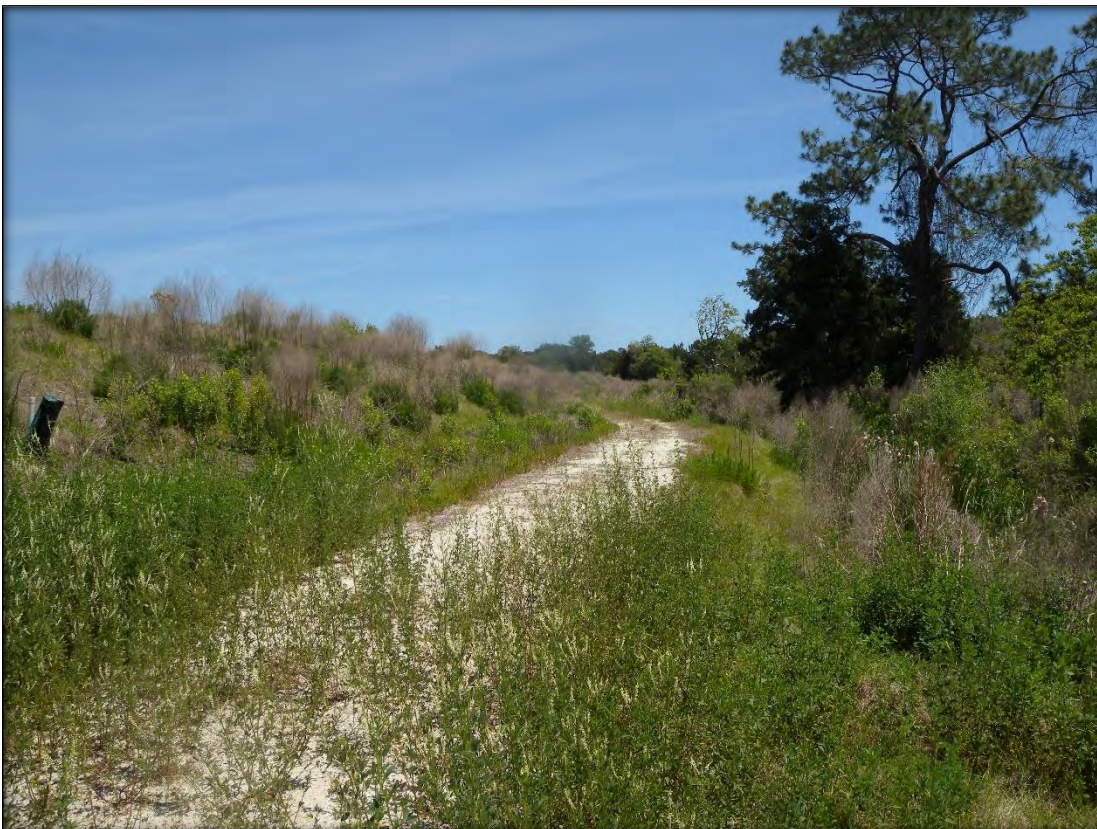
Image 2. View towards east of southern perimeter road

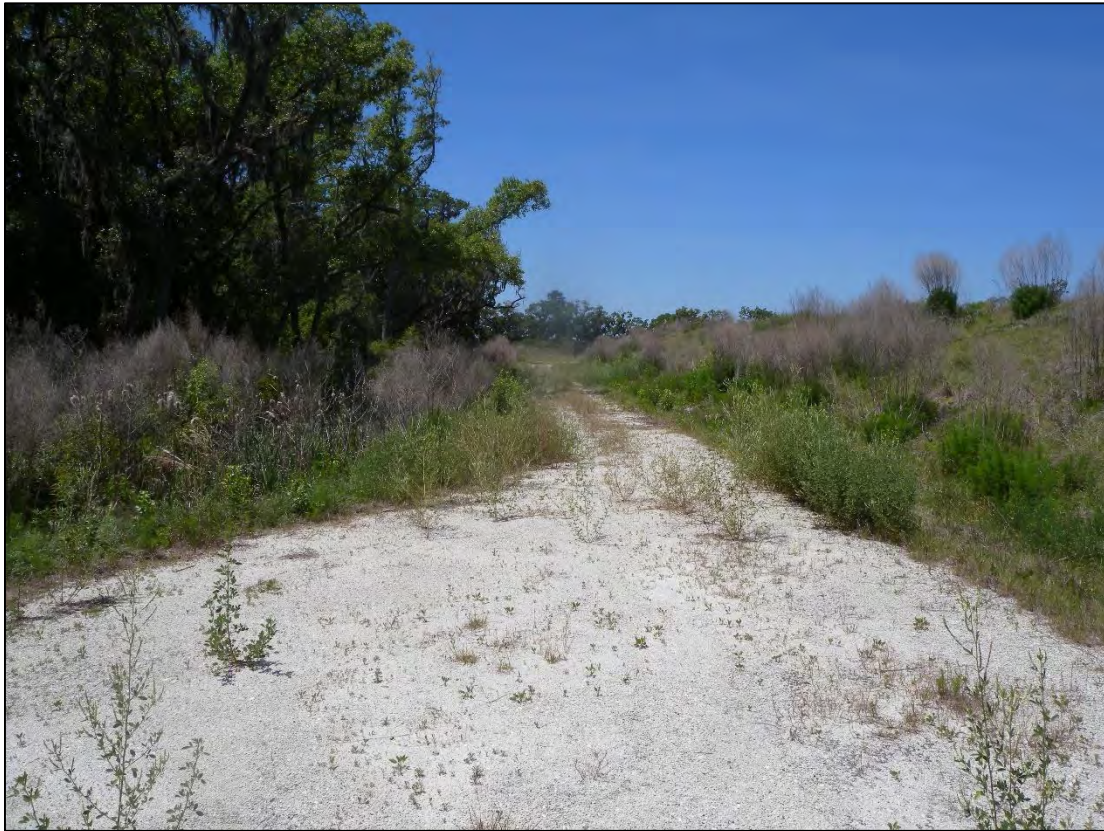
Image 3. View towards west of southern perimeter road

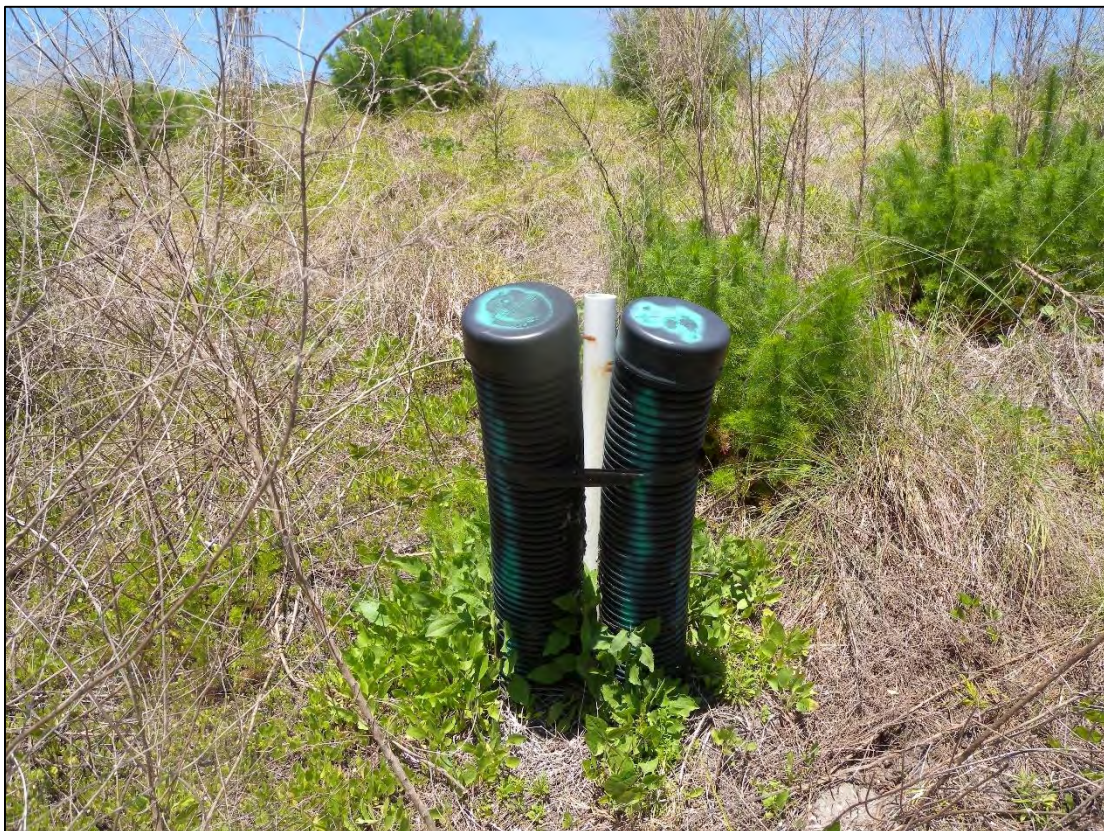
Image 4. View toward north of a wick drain outlet in southern stability berm

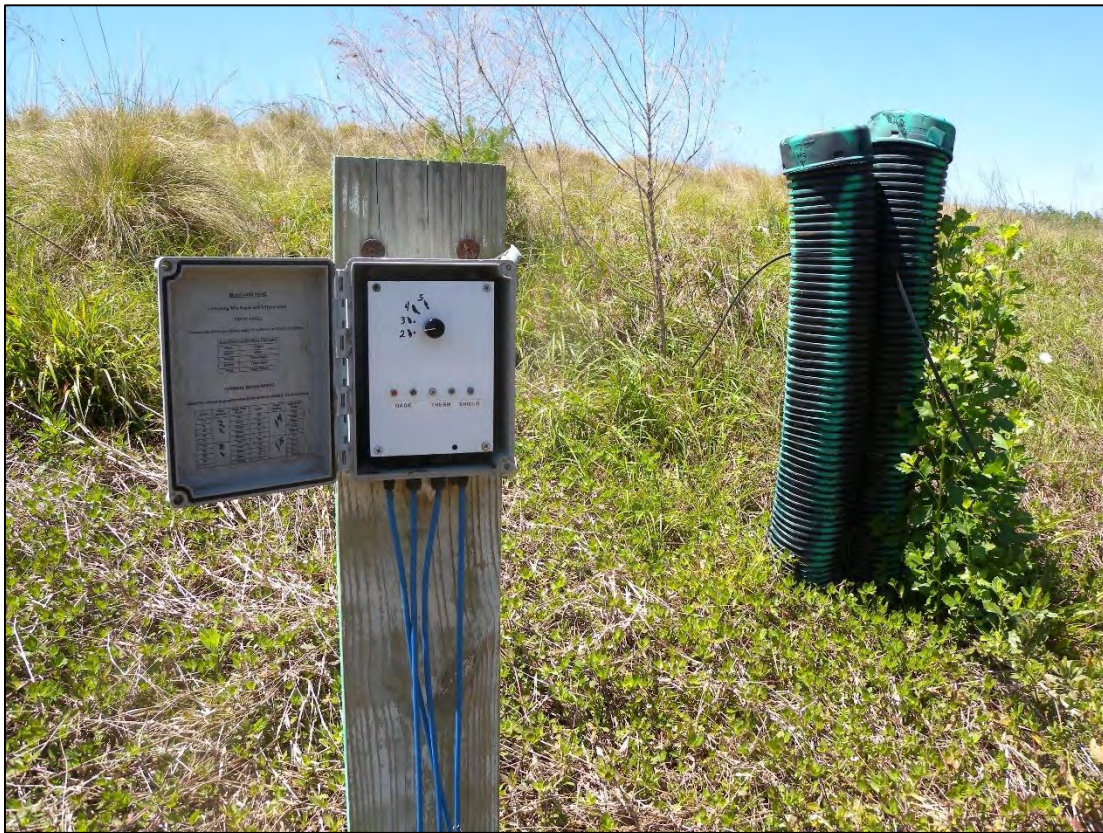
Image 5. View towards northwest of piezometer data logger at eastern stability berm

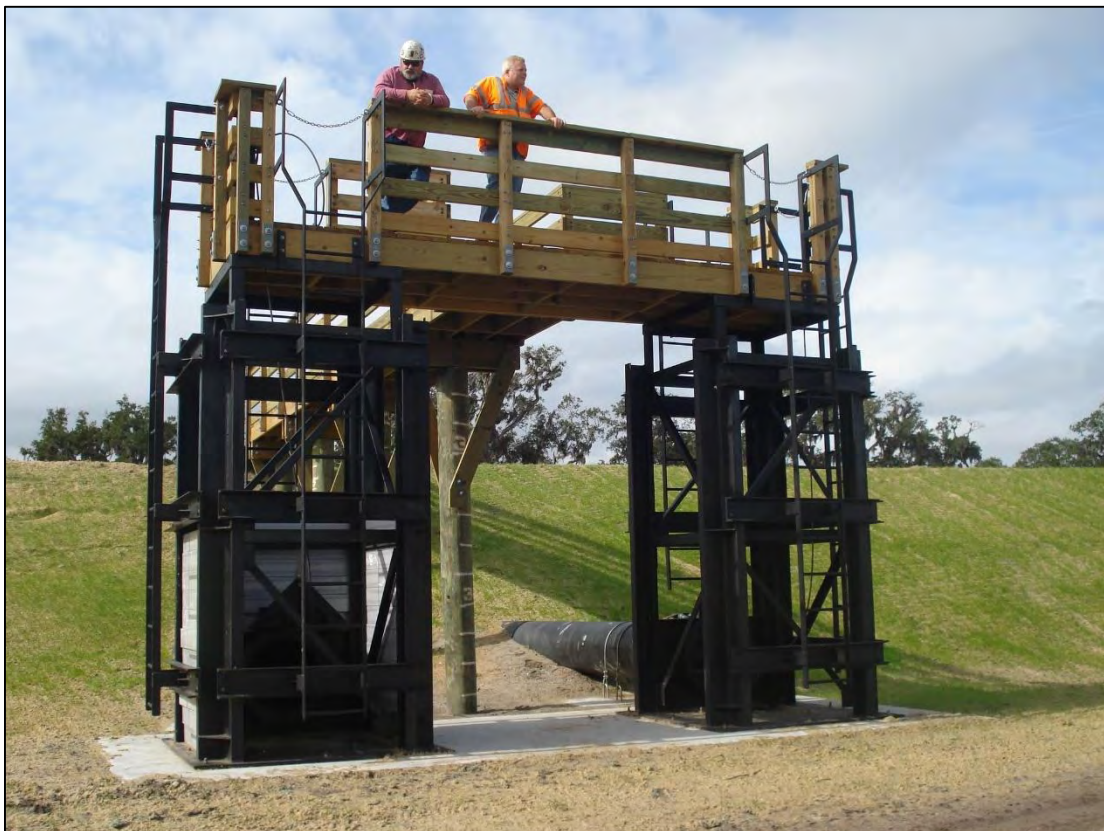
Image 10. View looking west of weirs and timber deck (picture is from a previous site visit and shown for context)

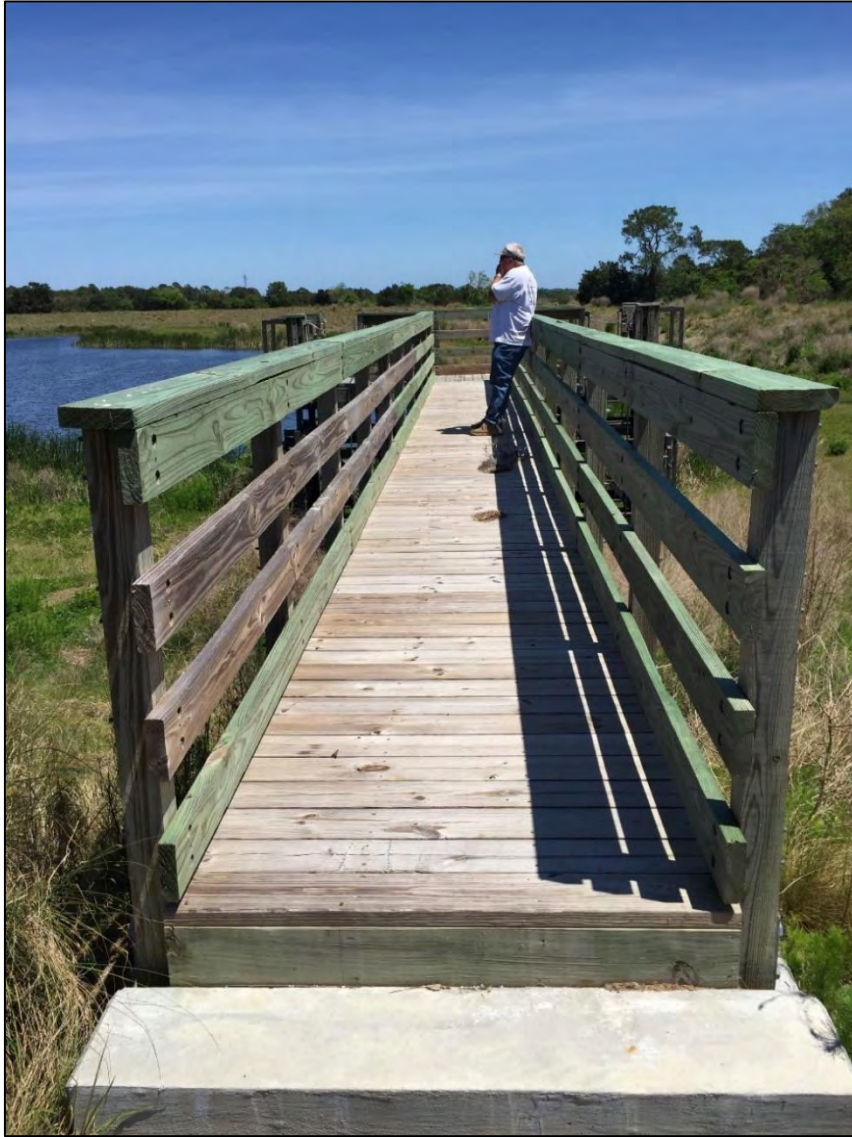
Image 11. View looking east from entrance to weir timber walk

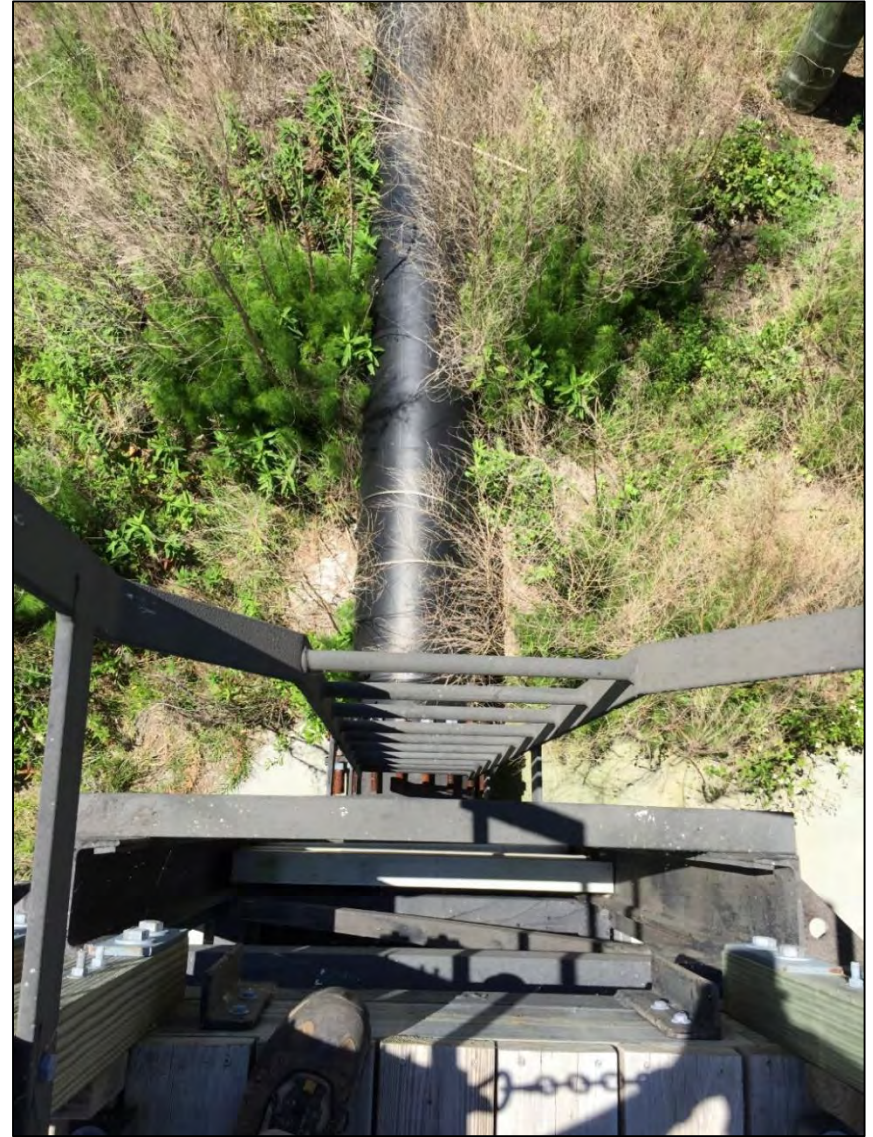
Image 12. Looking down at HDPE weir outlet pipe prior to its crossing through the western dike

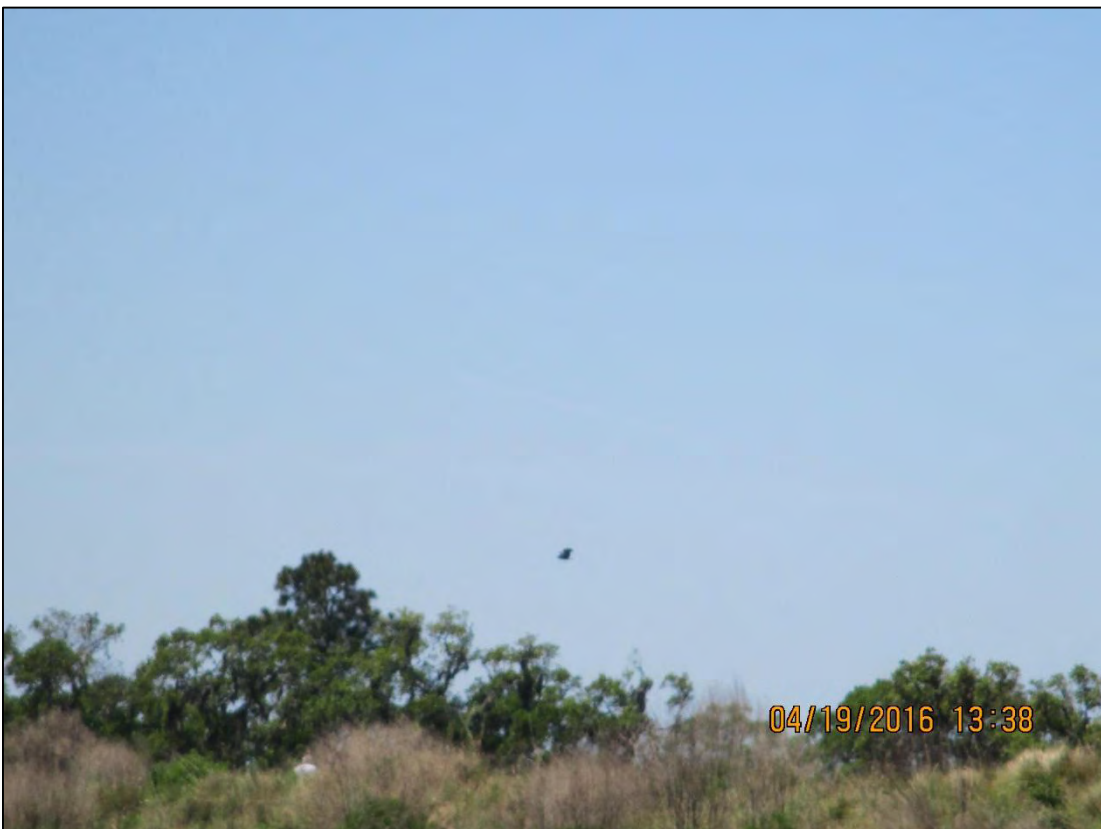
During the site visit Taylor Engineering staff identified eagle nest NA911 in its described location (Appendix B, Image 31). Staff members also observed the presence of one juvenile and one adult bald eagle in close proximity to the nest (Appendix B, Image 32). No nesting activities were observed during the site visit. Through ongoing permitting activities for the upcoming construction project, Taylor Engineering is coordinating with USFWS and Environmental Services, Inc., FIND's environmental consultant for the eagle nest, to ensure that proper measures are taken to limit disturbance to the eagles.

Image 32. Juvenile eagle flying around the site

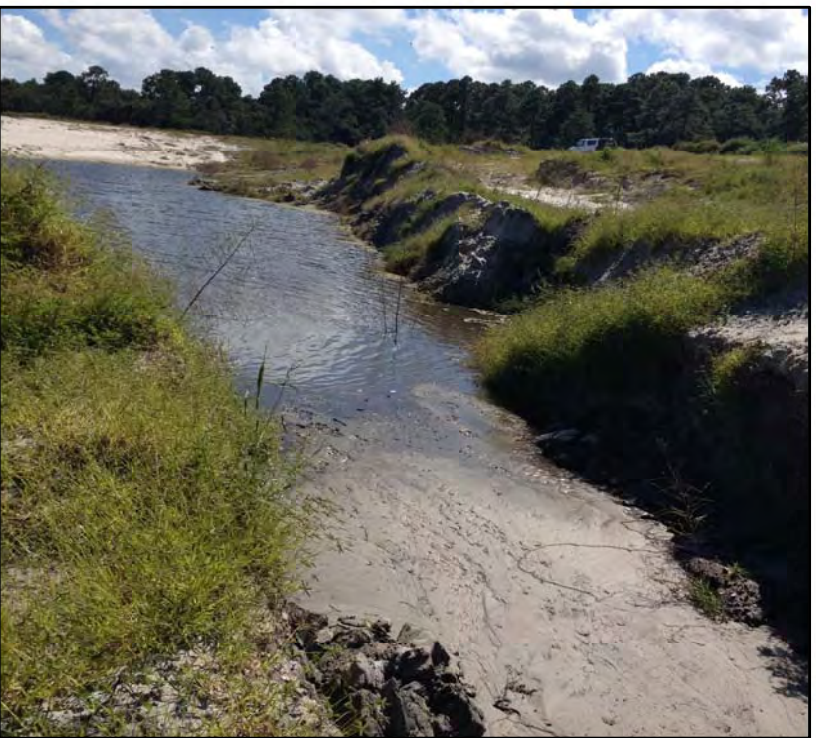
TYPICAL SITE CONDITION AT
TIME OF SURVEY

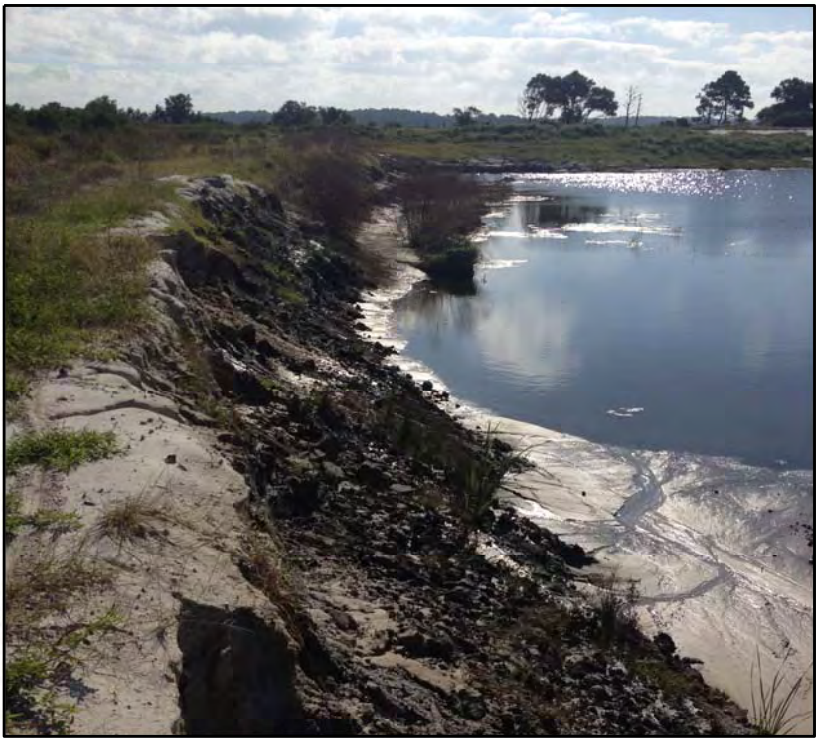
TYPICAL SITE CONDITION AT
TIME OF SURVEY

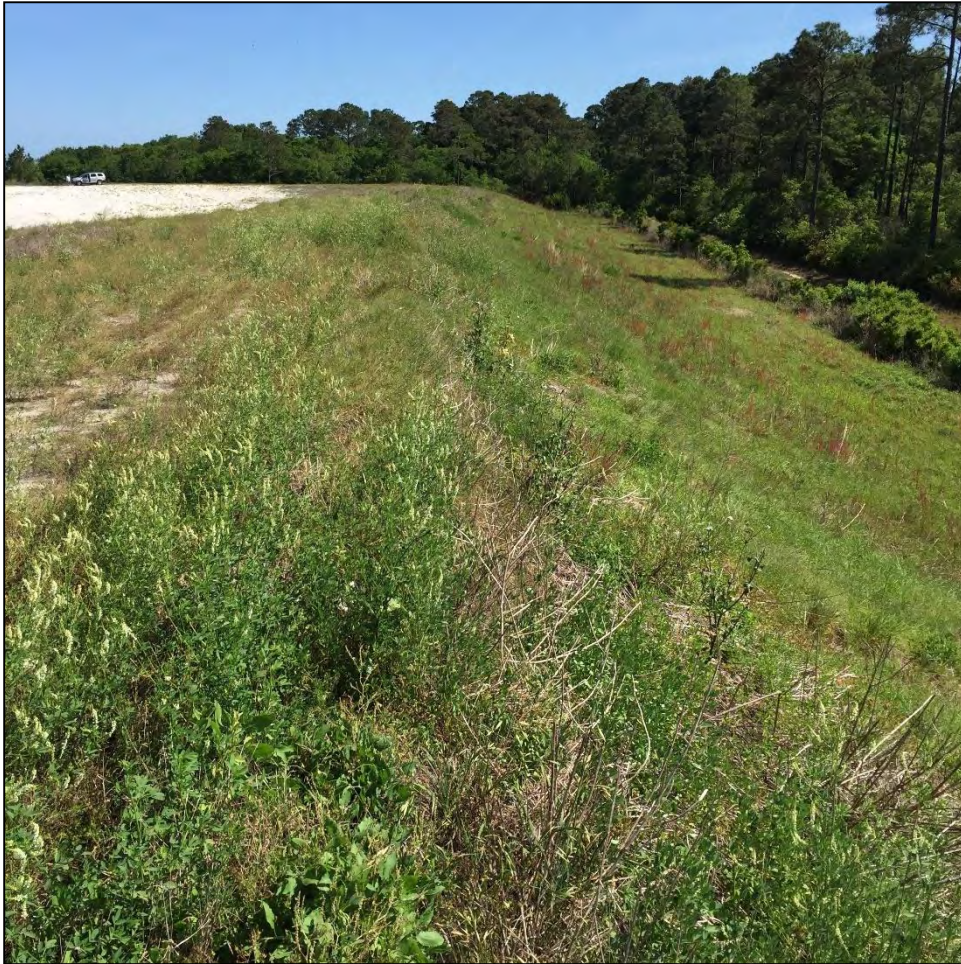
Image 1. Looking south along the western dike

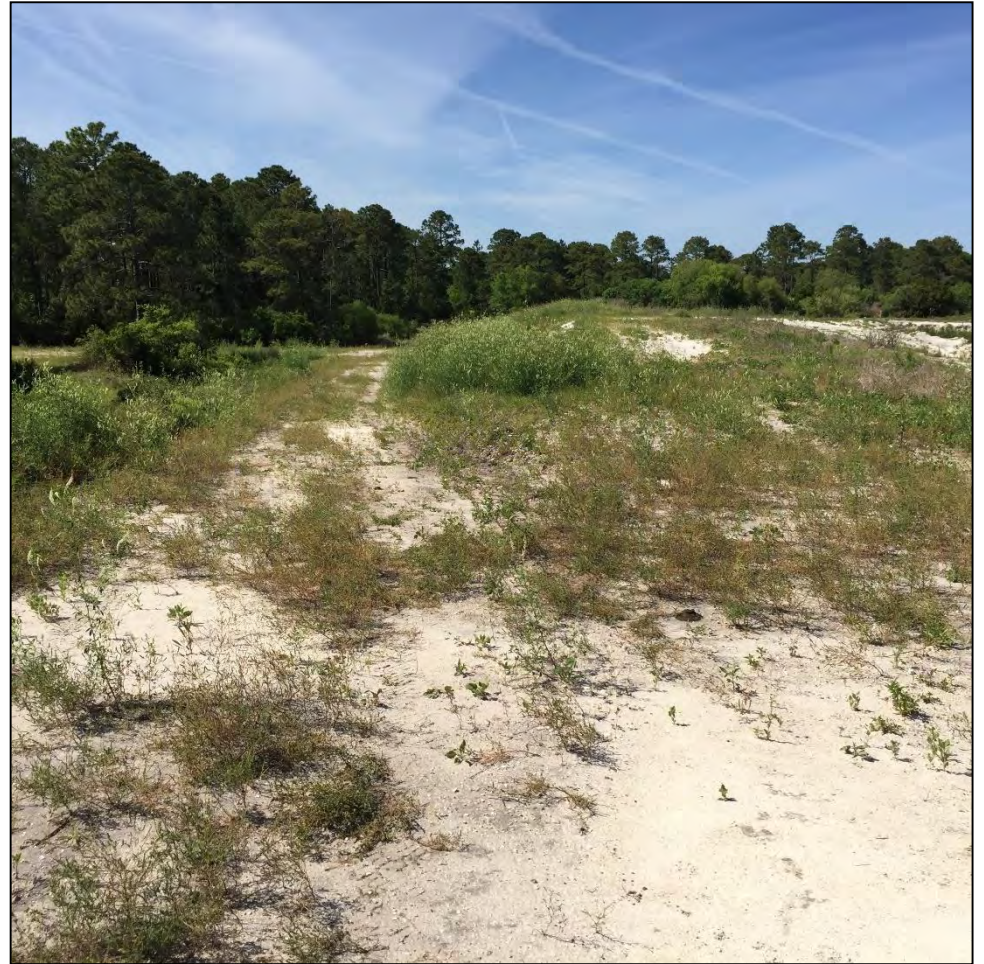
Image 2. Looking north from the top of the dike ramp

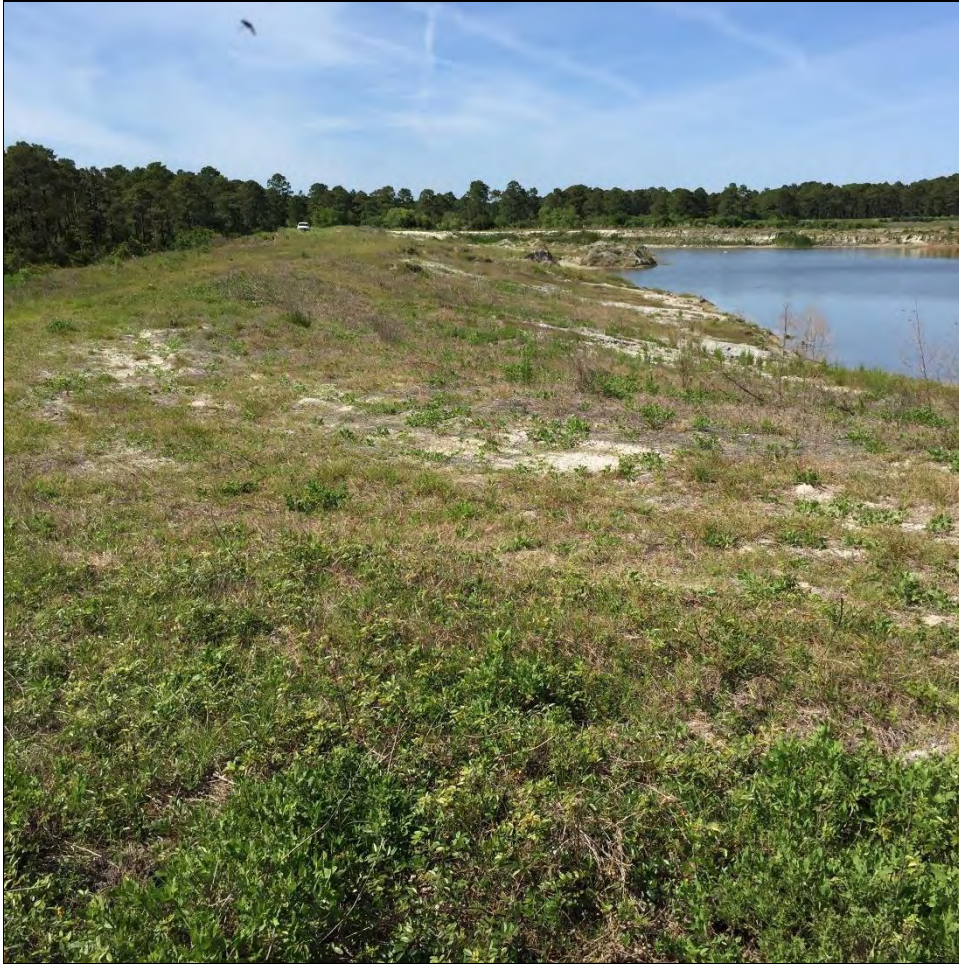
Image 3. Looking north from the southwestern corner of the DMMA

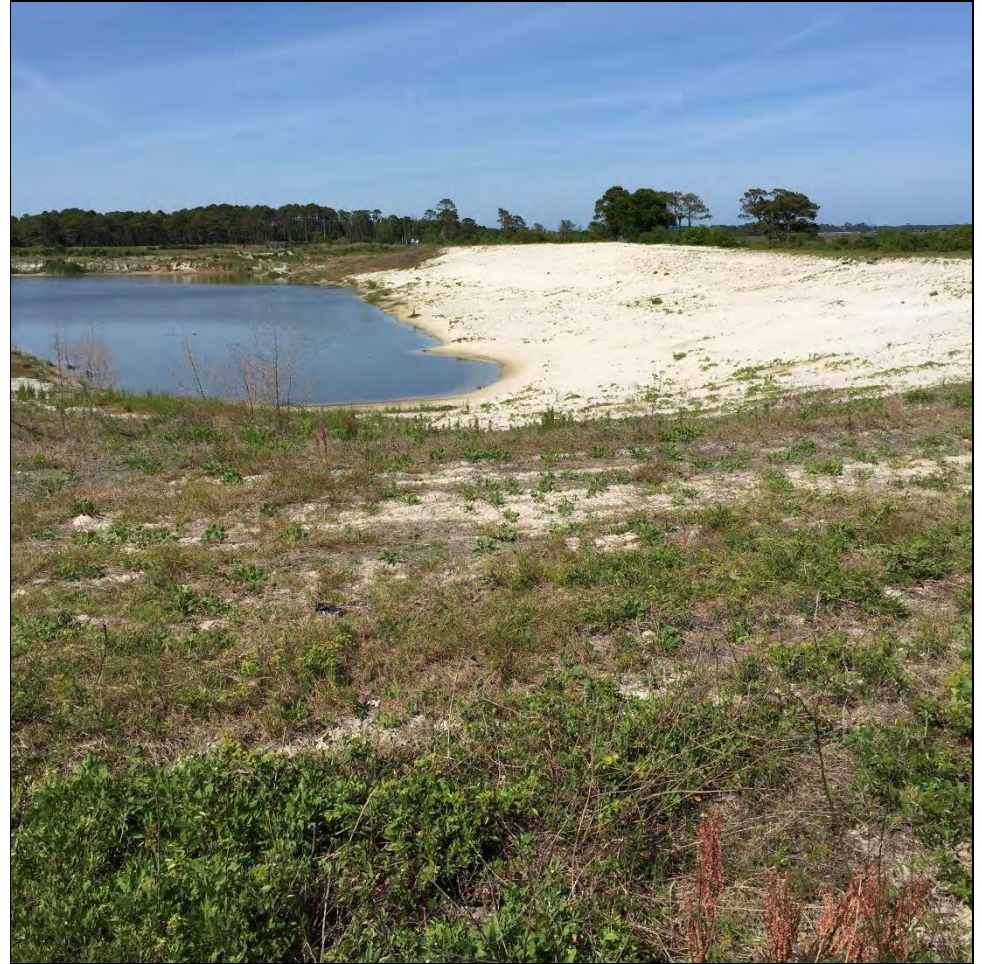
Image 4. Looking northwest from the southeastern corner of the DMMA

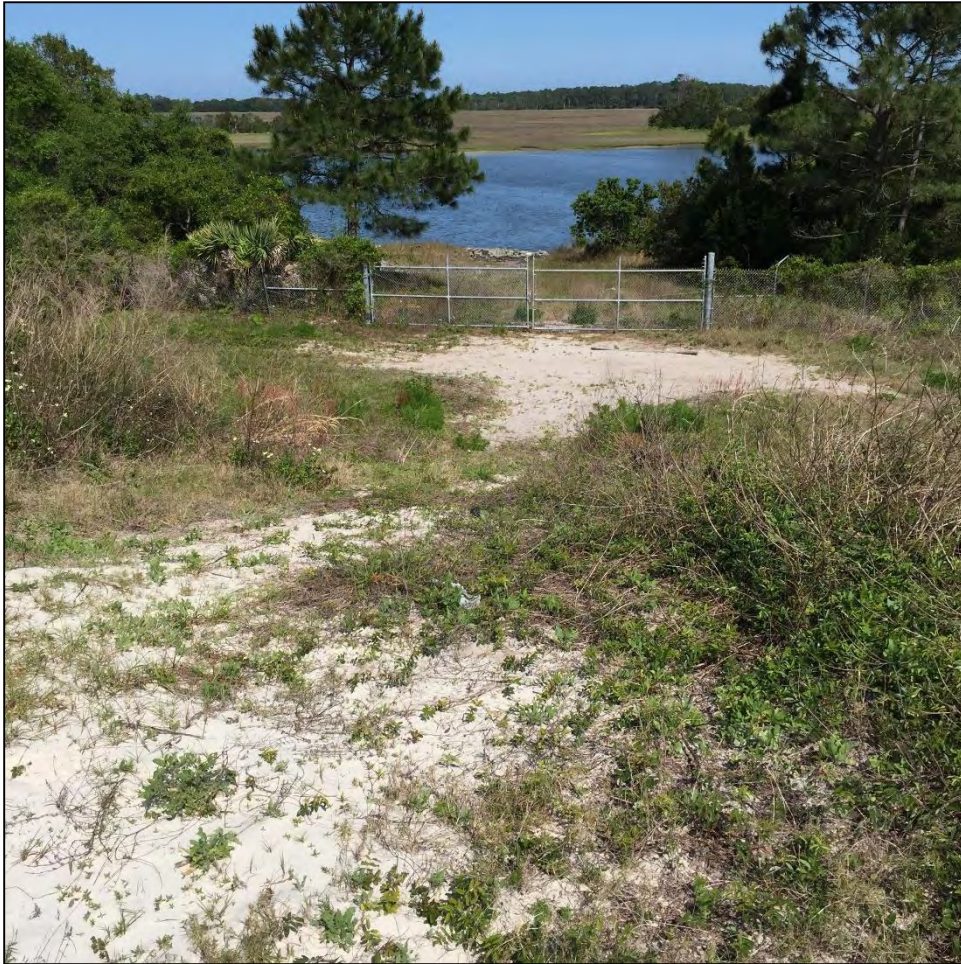
Image 5. Looking northeast toward the southern pipeline access gate

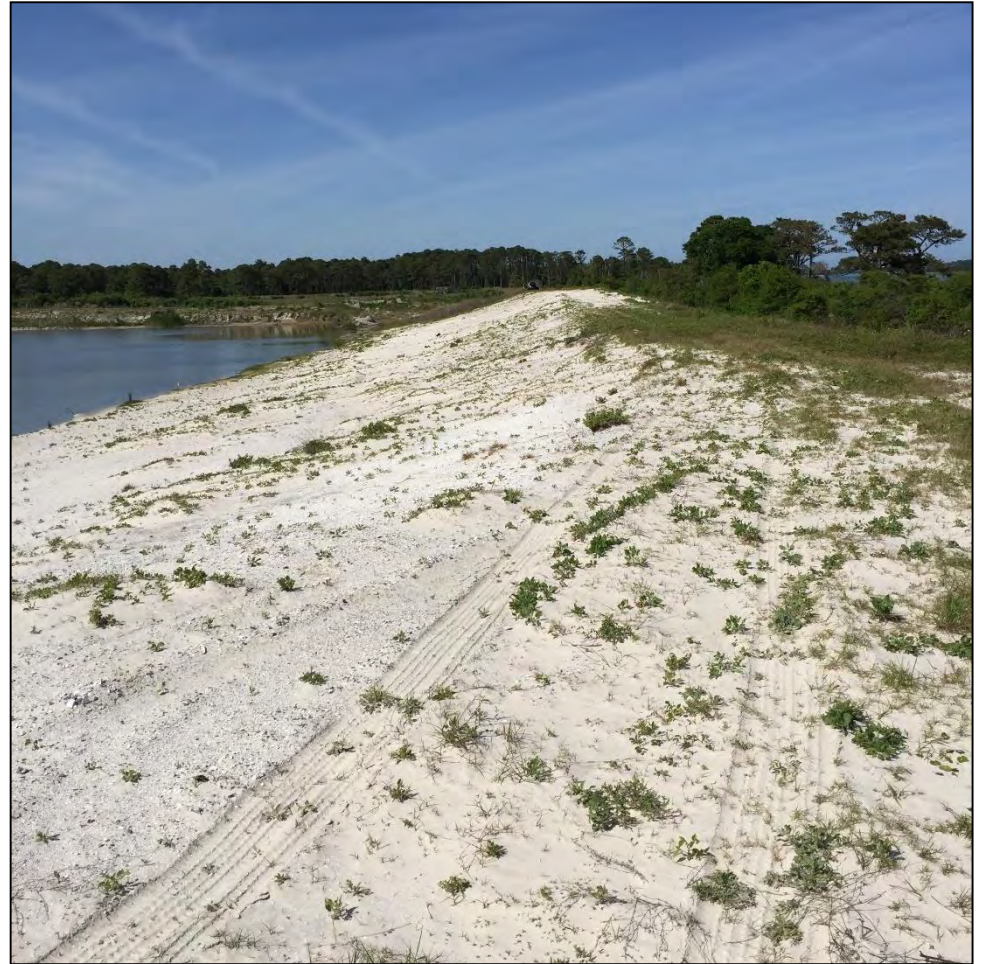
Image 6. Looking northeast from the southern dike crest

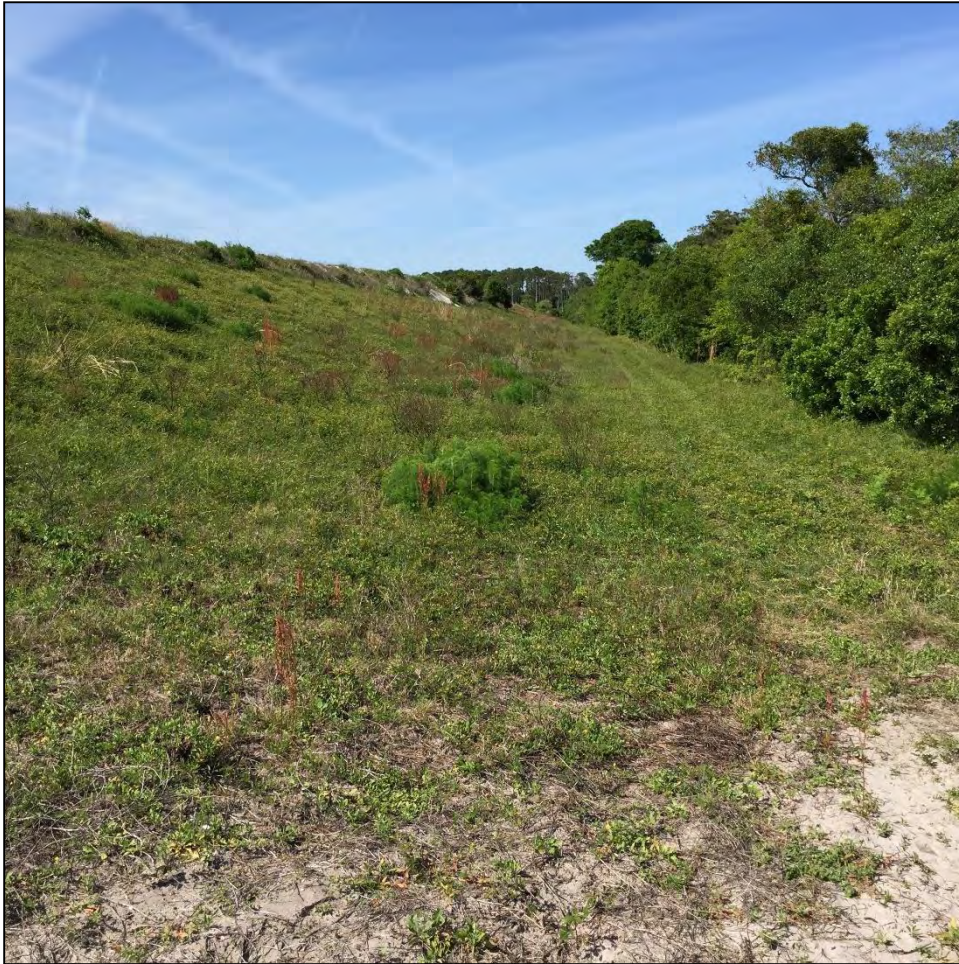
Image 7. Looking north along the toe of the eastern dike

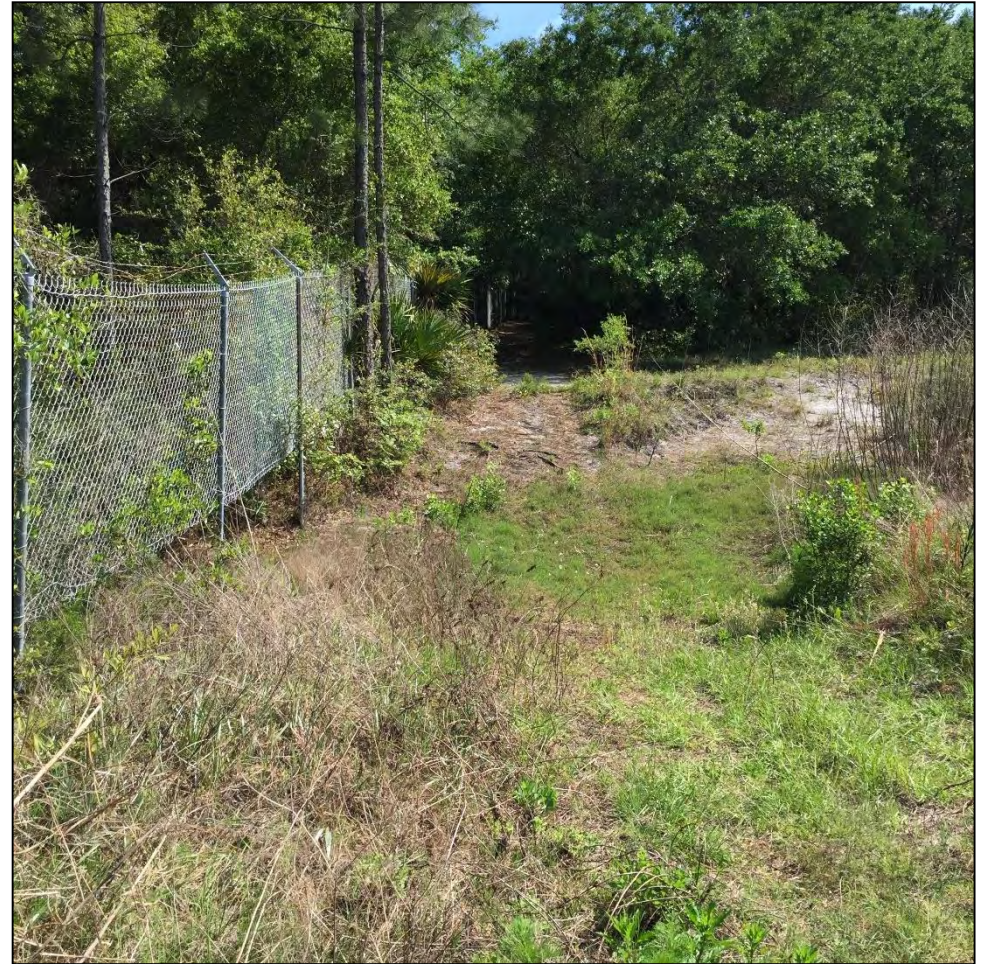
Image 8. Looking south along the property line from the southern pipeline access

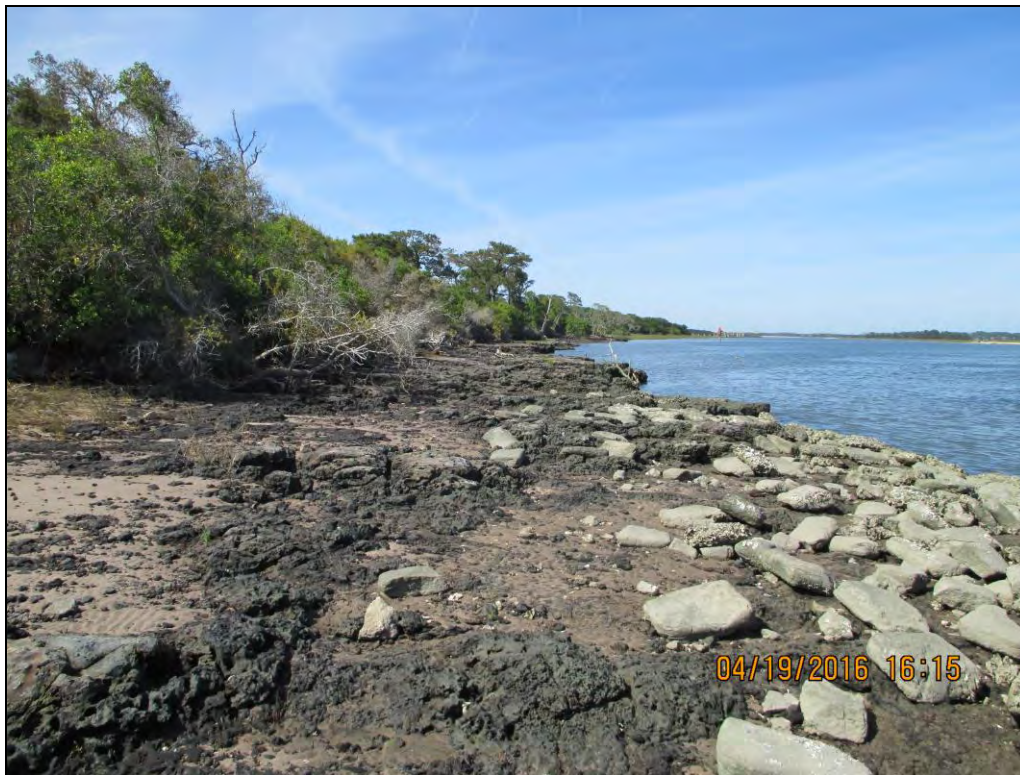
Image 9. Looking northeast along the shoreline of the southern pipeline access

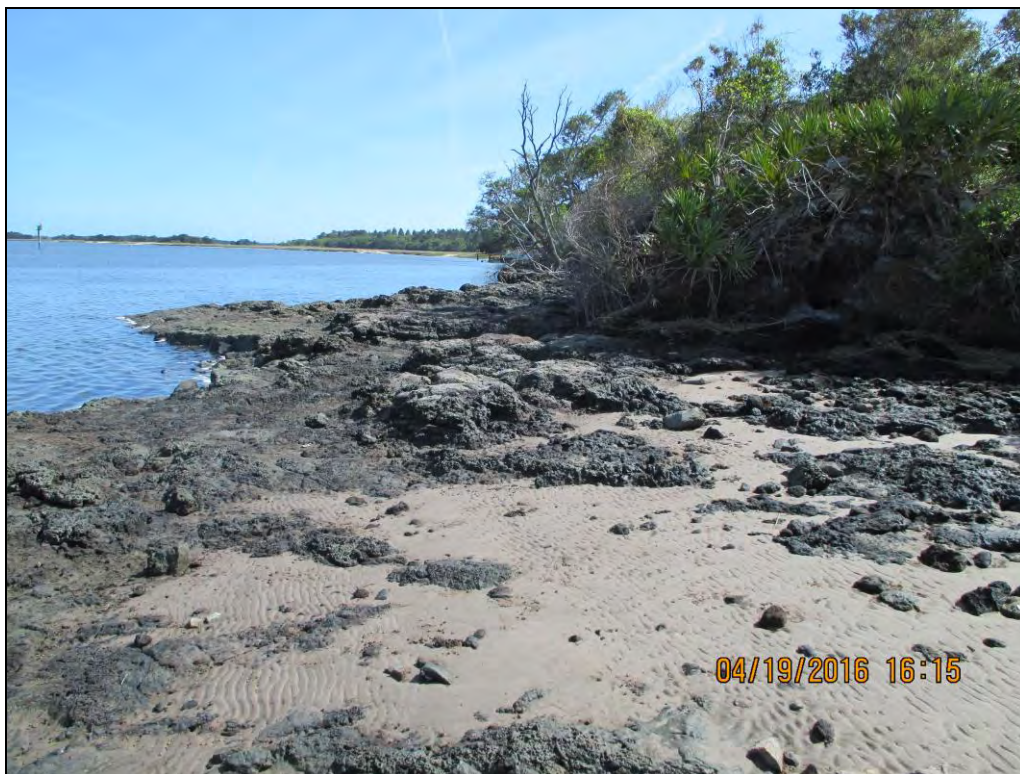
Image 10. Looking southwest along the shoreline of the southern pipeline access

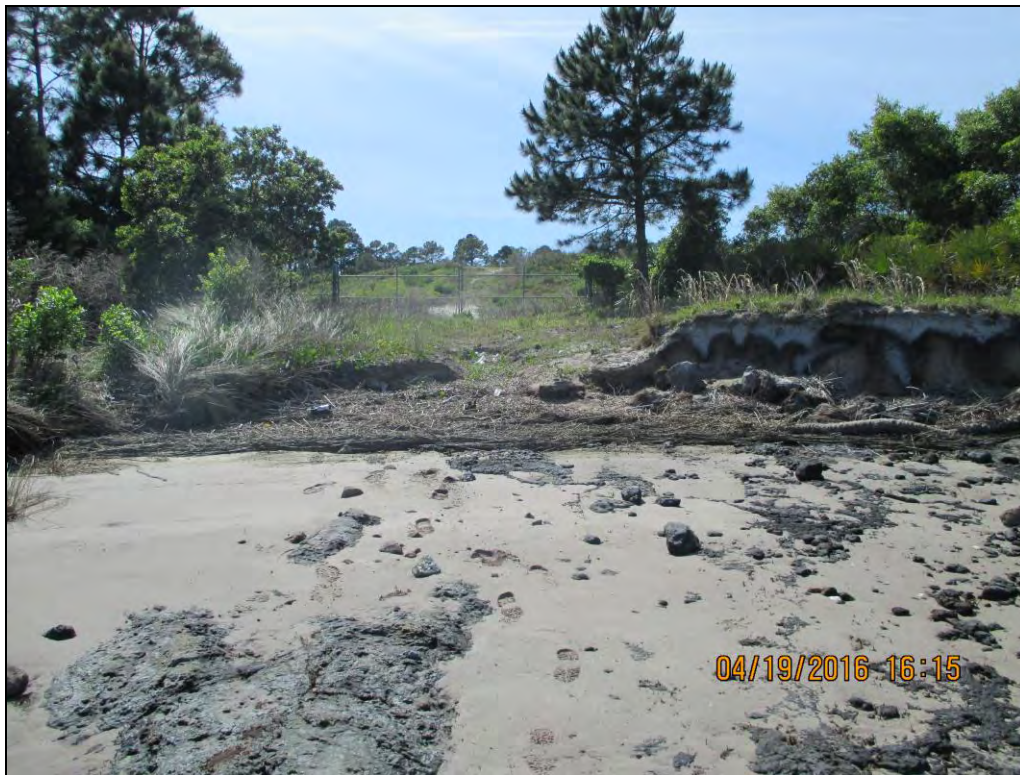
Image 11. Looking west toward southern pipeline access gate from AICW

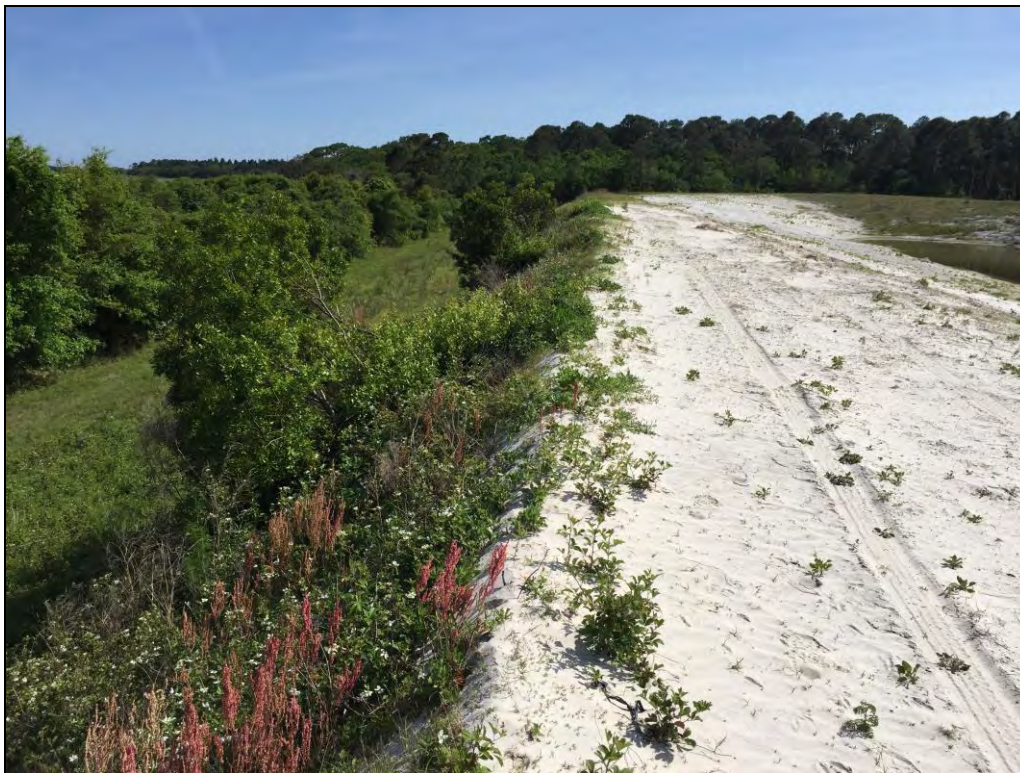
- (1) Around the center of the eastern embankment, there are two stands of medium sized bay trees growing near the top of the exterior of the embankment (Attachment B, Image 12).

Image 12. Looking along eastern dike crest toward two stands of bay trees on the dike exterior

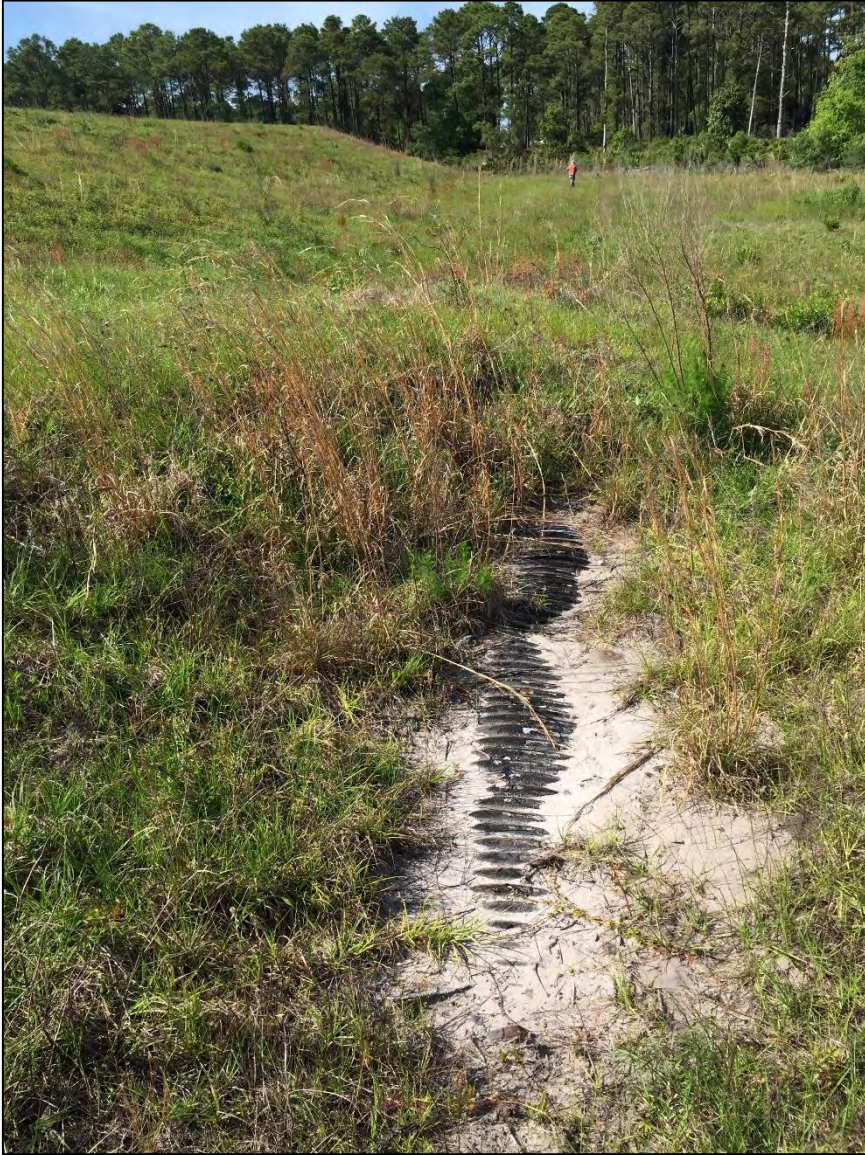
Image 23. Looking north at weir outfall manifold pipe

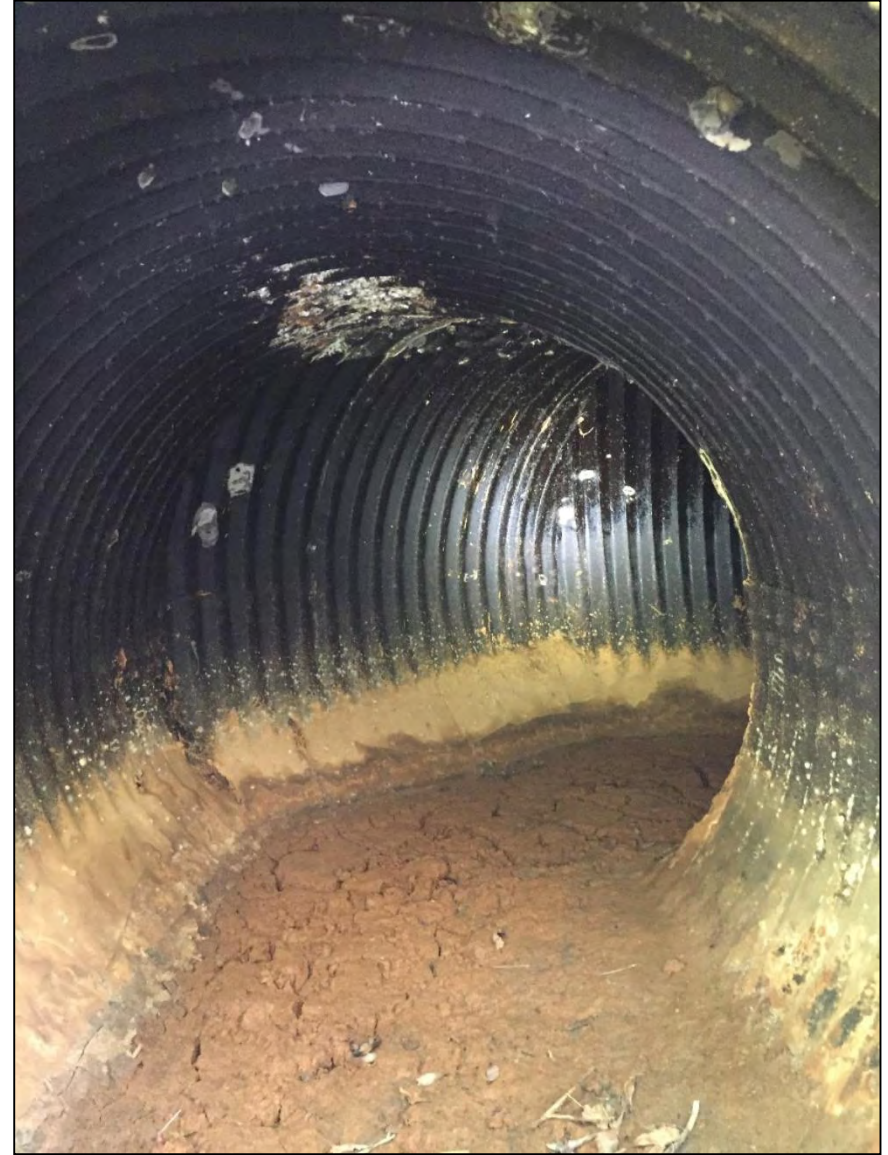
Image 24. Looking west into weir outfall pipe

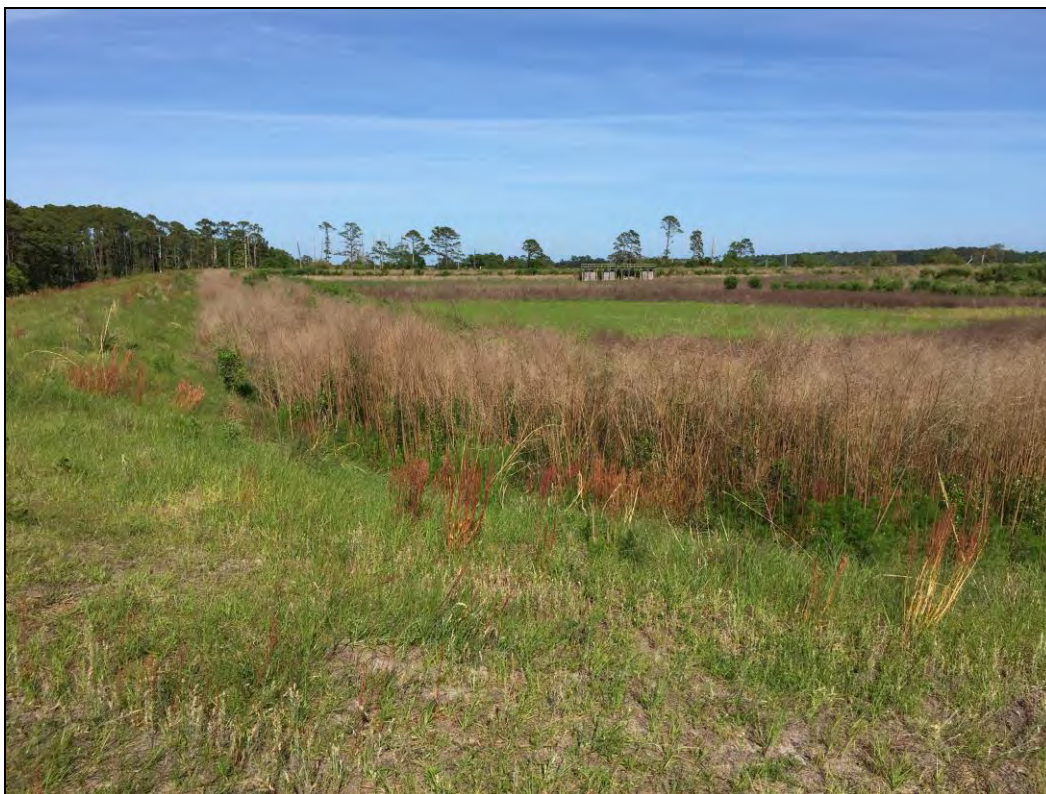
Image 28. Looking east from corner of northwestern dike crest
