**ATLANTIC INTRACOASTAL
WATERWAY
MAINTENANCE DREDGING
NASSAU COUNTY REACH I, FLORIDA**

DMMA NA-1 Site Reconnaissance Report
DMMA DU-2 Site Reconnaissance Report

Re: Professional Engineering Services, Task 1.2 DMMA Reconnaissance (NA-1)
Maintenance Dredging of Nassau Reach I and Applicable Portions of Fernandina Harbor Project,
Nassau County, FL
FIND Work Order 15-08; TE Contract C2015-048

Re: Professional Engineering Services, Task 1.2 DMMA Reconnaissance (DU-2)
Maintenance Dredging of Nassau Reach I and Applicable Portions of Fernandina Harbor Project,
Nassau County, FL
FIND Work Order 15-08; TE Contract C2015-048

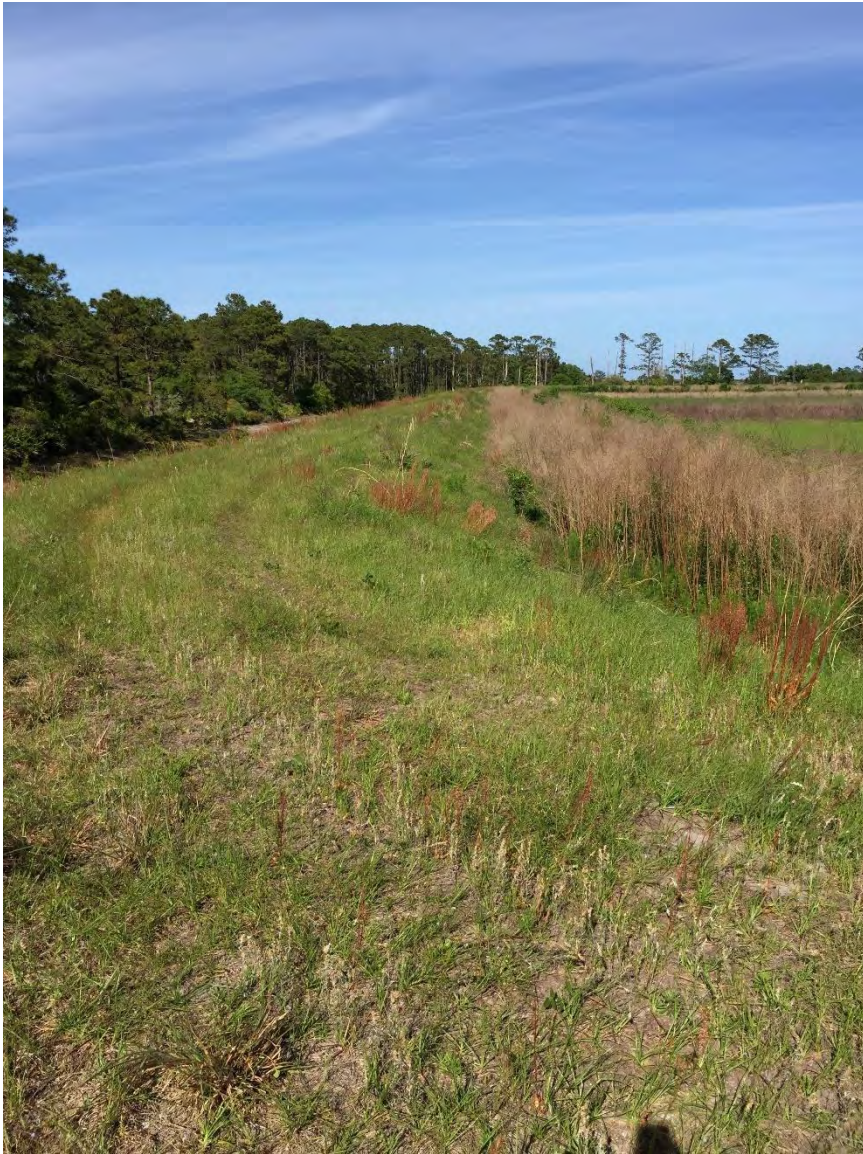
Image 29. Looking east from corner of northwestern dike crest

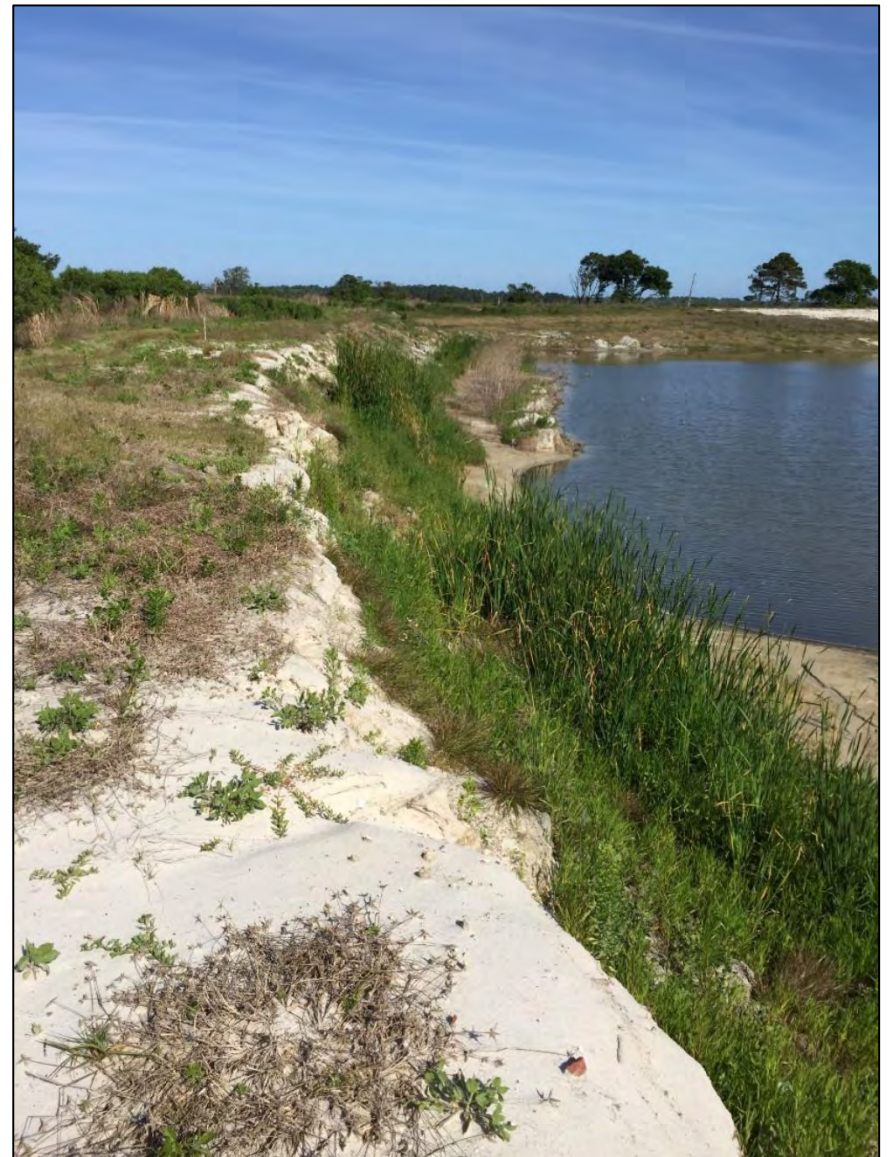
Image 30. Looking northeast, into the DMMA, at a scarp between eastern offloaded portion of DMMA and western portion of DMMA
