## **APPENDIX A:**

### Mill Creek Restriction Sections

**APPENDIX C:**  
FIELD ASSESSMENT PHOTOS –  
OUTFALLS

### Stormwater Retrofit Assessment Reports

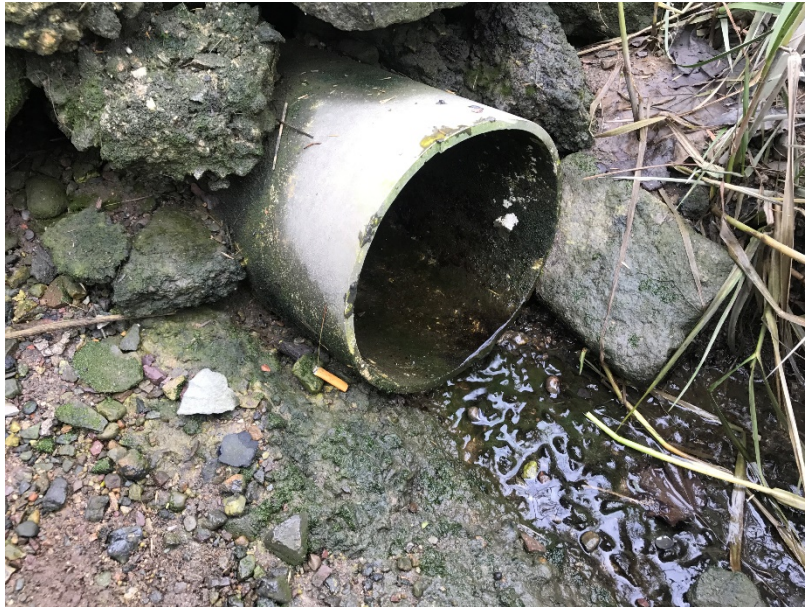
**Photo 5:** Photo of Outfall 3 looking towards Mill Creek

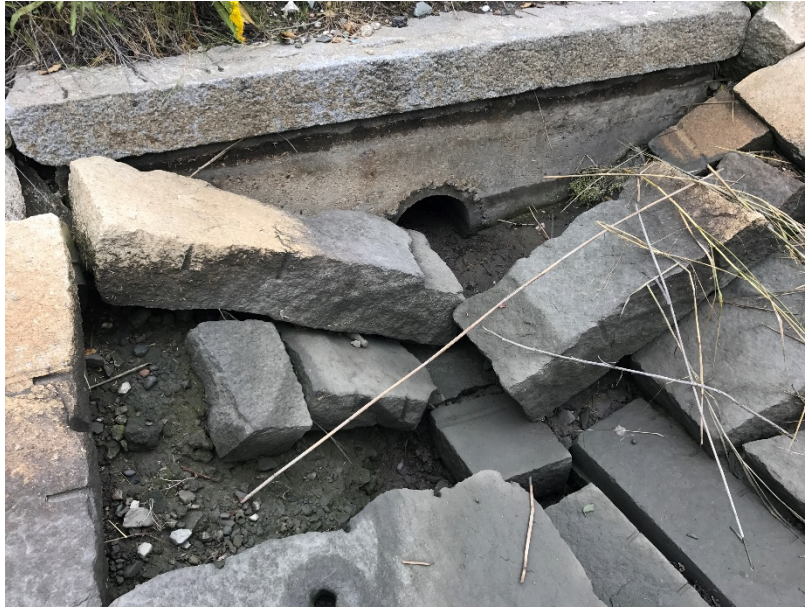
**Photo 7:** Photo of concrete channel at Outfall 4

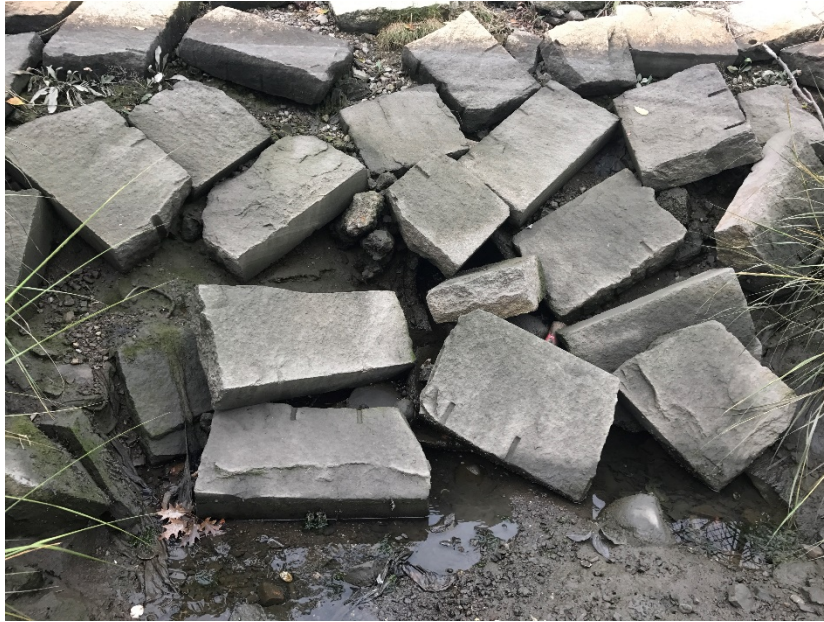
**Photo 11:** Photo at Outfall 6 looking downstream

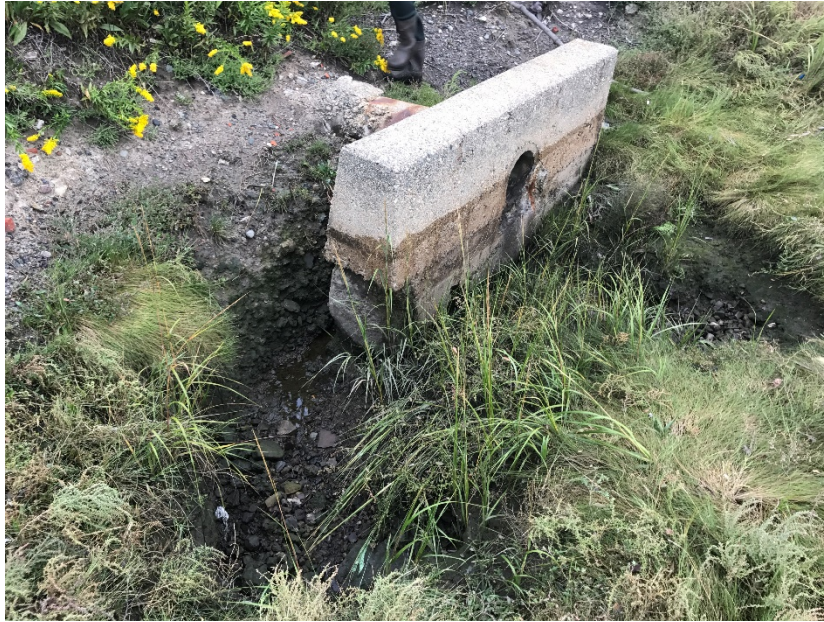
**Photo 13:** Photo of Outfall 7 looking downstream

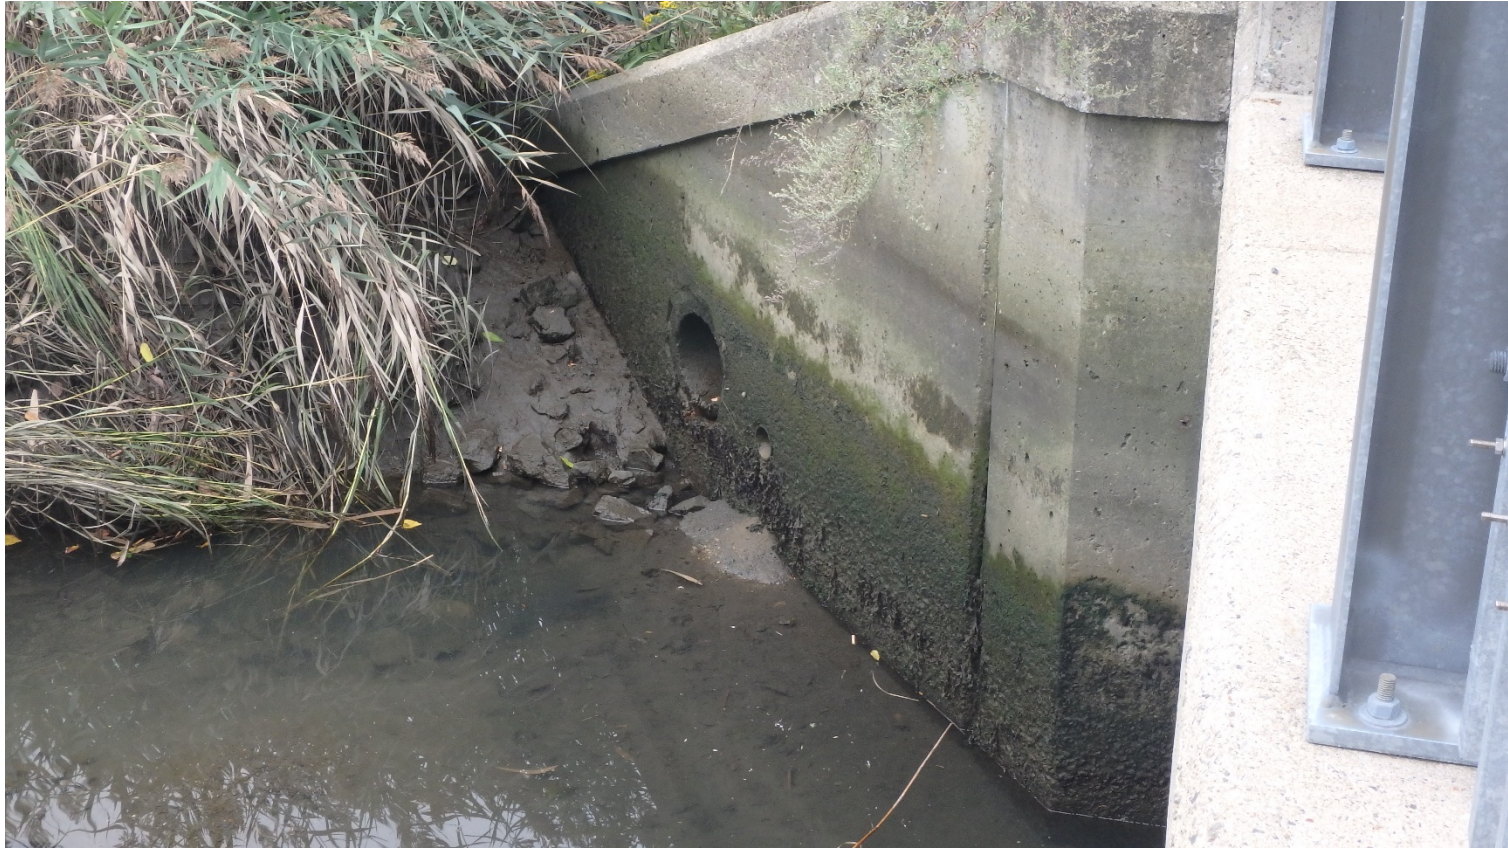
**Photo 17:** Photo looking upstream towards Outfall 9

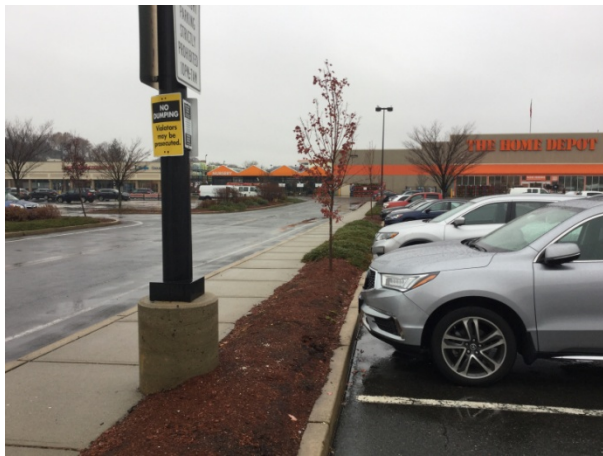
**Additional Photo Caption:**  
Sidewalk next to parking lot

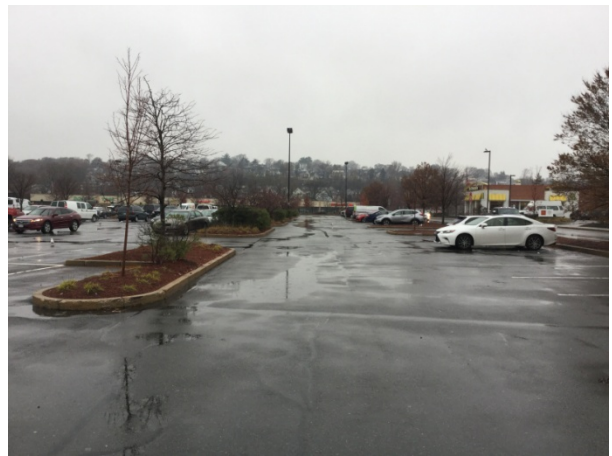
**Additional Photo Caption:**  
Large driving lanes in parking lot

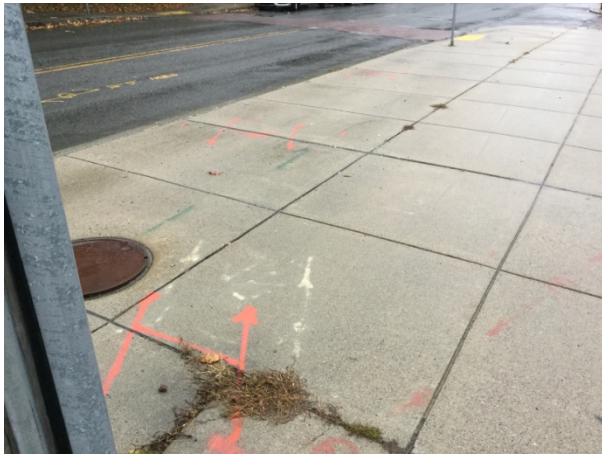
**Additional Photo Caption:**  
Overhead and underground utilities

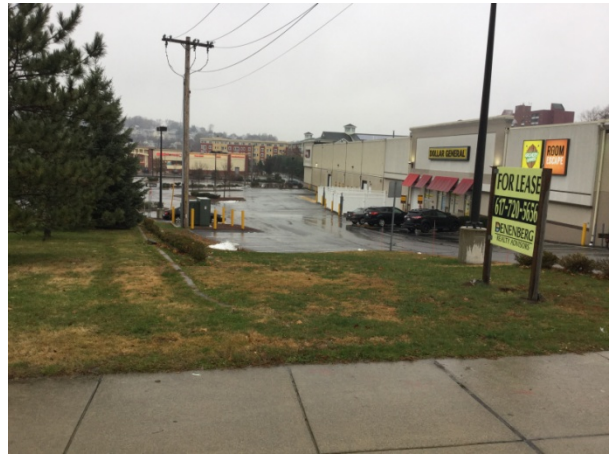
**Additional Photo Caption:**  
Bordering open space and parking lot

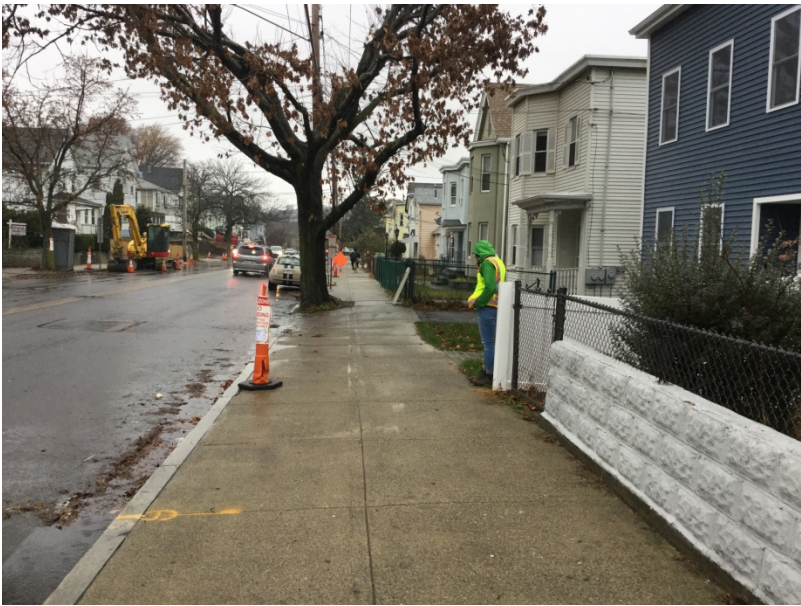
<b>Site Description:</b> Large sidewalk in residential area; area avoids utilities (gas) and entry way conflict; overhead utilities present; no CB close. Isolated opportunities along other sections of Webster Avenue.
		<b>Ownership:</b> Public (City-owned)
		<b>Primary Land Use:</b> Road/ROW
		<b>Primary Pollutants:</b> Leaves , Debris
<b>Sidewalk Width:</b> 9'	<b>Road Width:</b> N/A	<b>Parking Lot Dimensions:</b> N/A
<b>Site Overview Picture:</b>

<b>Site Overview Caption:</b> Space for ROW swale between entrance and gas line		
<b>PROPOSED BEST MANAGEMENT PRACTICE</b>		
<b>Type:</b> ROW Swale (without tree)		
<b>Primary BMP Benefit:</b> Water Quality		
<b>Primary Observed Site Conflict:</b> Overhead Utilities		
<b>Primary Non-Structural Control:</b> Street/Parking Lot Sweeping

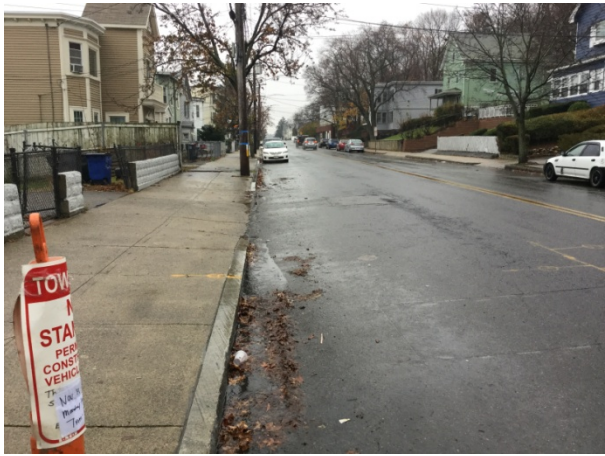
**Additional Photo Caption:**  
Leaves and ponding on street; no CB nearby

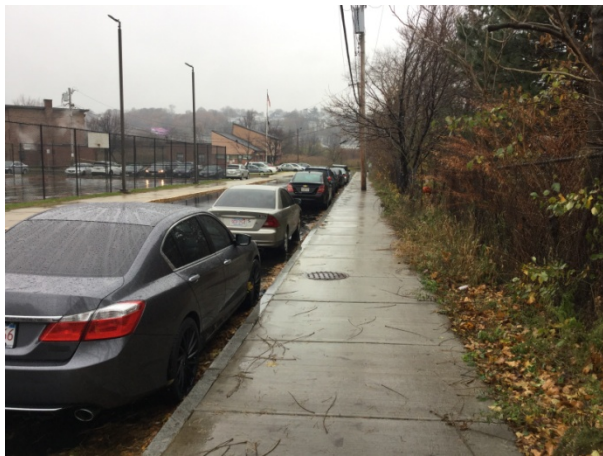
**Additional Photo Caption:**  
Or install bumpout at end of road

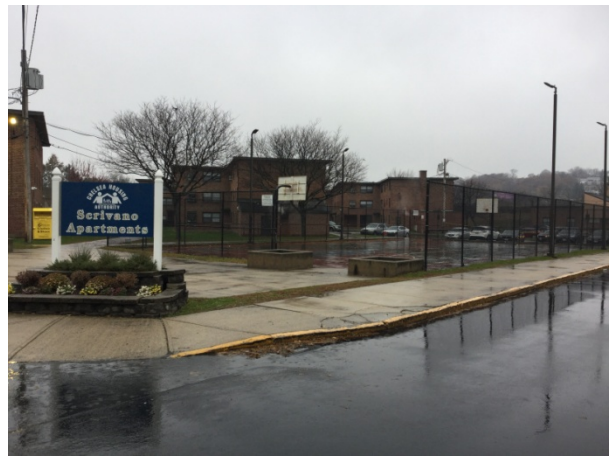
**Additional Photo Caption:**  
Low point at entrance to housing development

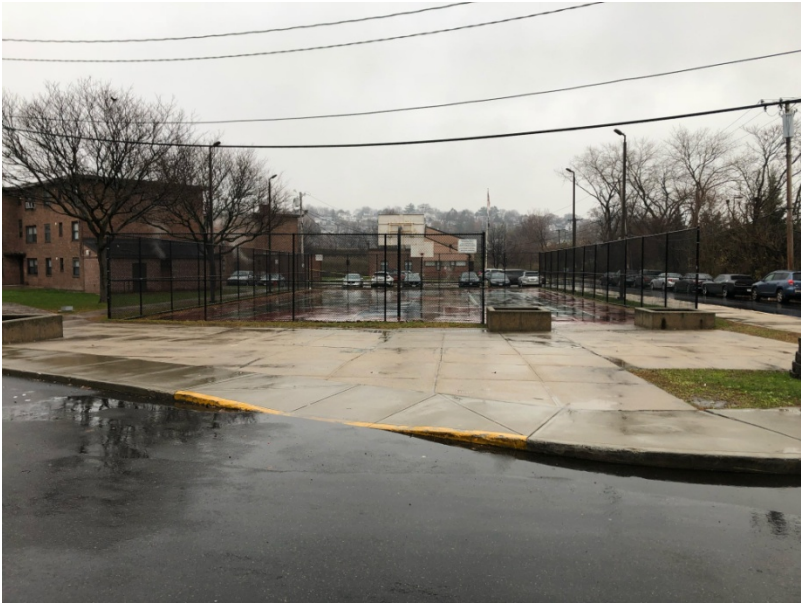
<b>Site Description:</b> Open space and tennis court; area draining to catch basin in sidewalk area. Replace impervious with bio retention area to add green space.
		<b>Ownership:</b> Public (City-owned)
		<b>Primary Land Use:</b> Park/Playground
		<b>Primary Pollutants:</b> Leaves
<b>Sidewalk Width:</b> >10'	<b>Road Width:</b> N/A	<b>Parking Lot Dimensions:</b> N/A
<b>Site Overview Picture:</b>

<b>Site Overview Caption:</b> Tennis court and open space		
<b>PROPOSED BEST MANAGEMENT PRACTICE</b>		
<b>Type:</b> Bioretention		
<b>Primary BMP Benefit:</b> Water Quality		
<b>Primary Observed Site Conflict:</b> Overhead Utilities		
<b>Primary Non-Structural Control:</b> Street/Parking Lot Sweeping

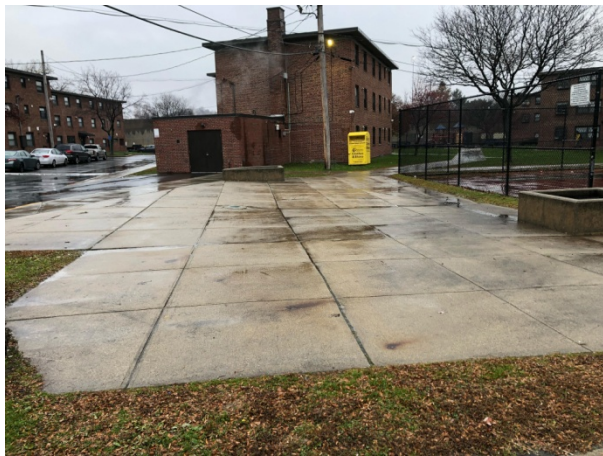
**Additional Photo Caption:**  
Open space/ sidewalk area

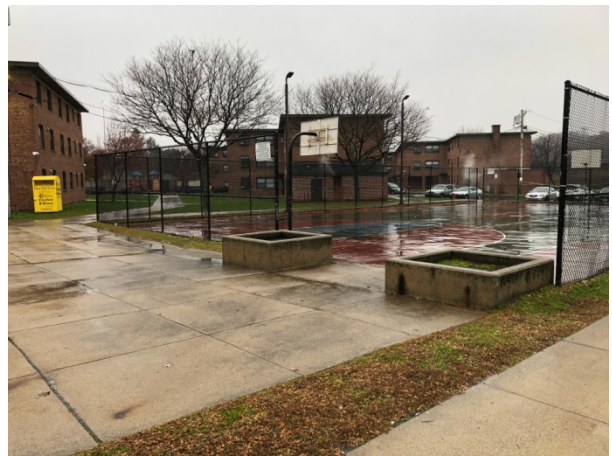
**Additional Photo Caption:**  
Raised planters could be replaced

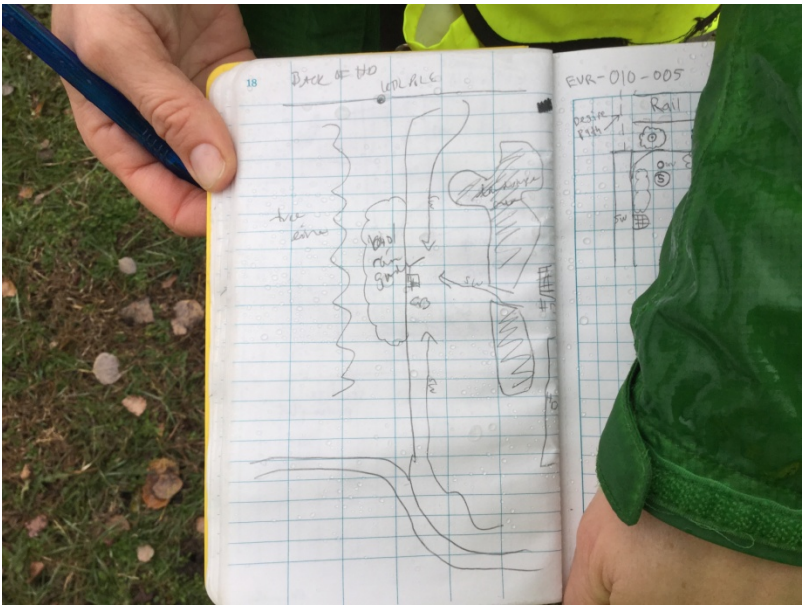
**Sketch Caption:** Install bioretention in open space

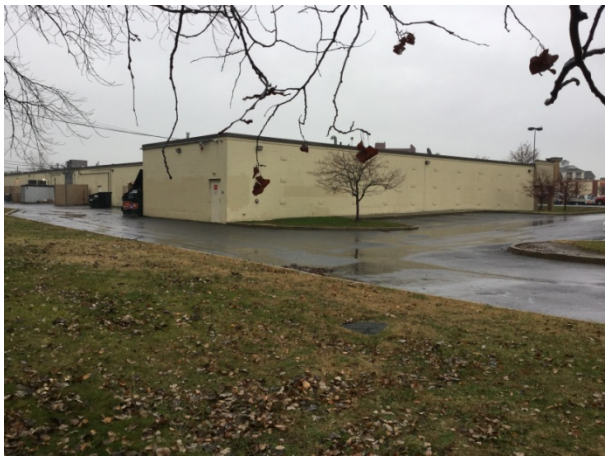
**Additional Photo Caption:**  
CB takes surface runoff from three sides

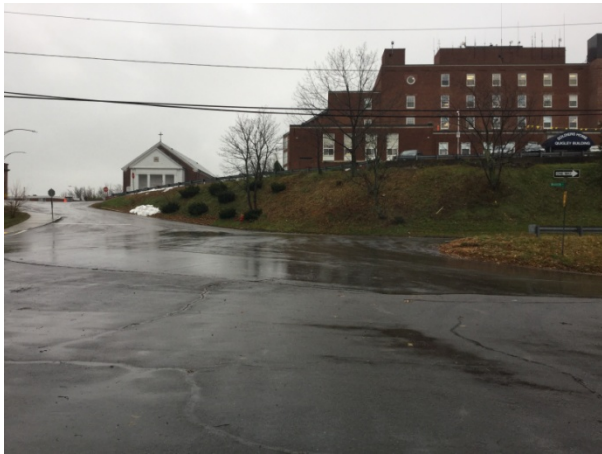
**Additional Photo Caption:**  
Large access road to hospital

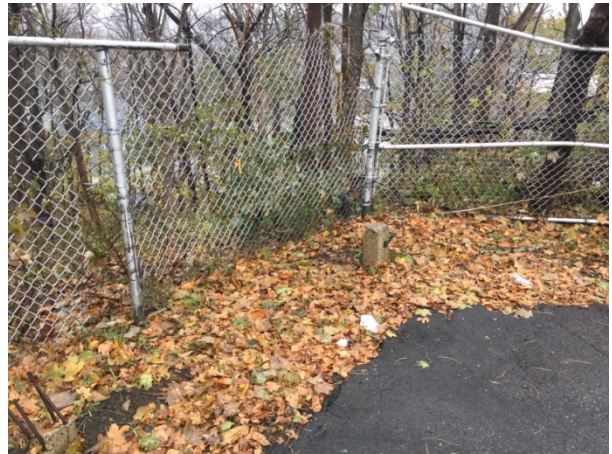
<b>Site Description:</b> Overflow parking for hospital mostly empty at site visit; large impervious area on top of the hill next to steep slopes; no CBs observed. Water appears to be running overland onto slope; Potentially replace some of the impervious area with pavers or pervious area.
		<b>Ownership:</b> State owned
		<b>Primary Land Use:</b> Parking Lot
		<b>Primary Pollutants:</b> Leaves
<b>Sidewalk Width:</b> N/A	<b>Road Width:</b> N/A	<b>Parking Lot Dimensions:</b> 9'x17', 35 spaces
<b>Site Overview Picture:</b>

**Additional Photo Caption:**  
Runoff discharges to steep slope

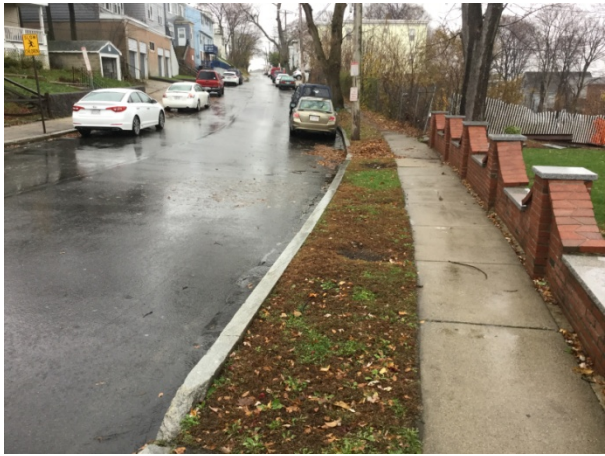
Additional Photo Caption:  
Steep slopes on Warren Avenue

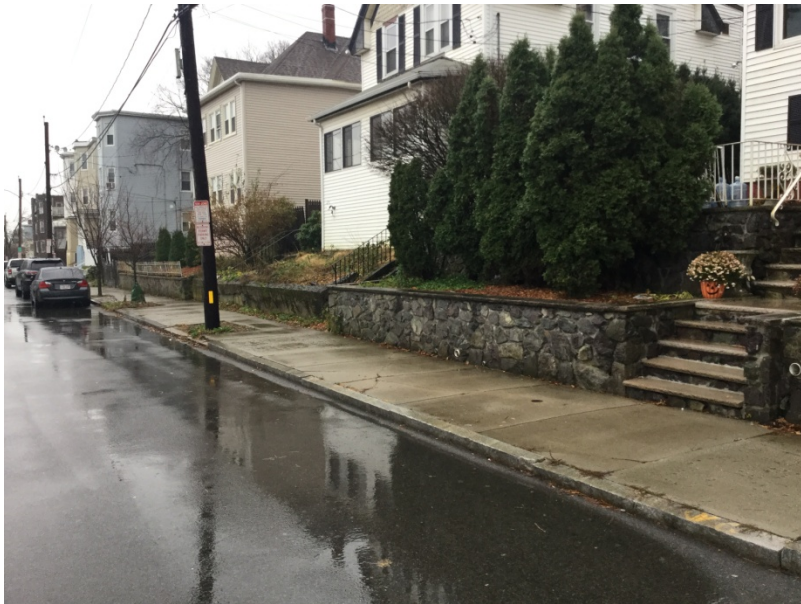
<b>Site Description:</b> Flat area on residential road; 30' space between entrances and gas lines; under overhead utilities. Opportunity for a ROW swale or bumpout if parking is removed. Other opportunities on Jefferson Avenue.
		<b>Ownership:</b> Public (City-owned)
		<b>Primary Land Use:</b> Road/ROW
		<b>Primary Pollutants:</b> Trash , Leaves
<b>Sidewalk Width:</b> 8'	<b>Road Width:</b> 30'	<b>Parking Lot Dimensions:</b> N/A
<b>Site Overview Picture:</b>

<b>Site Overview Caption:</b> 30' between entrances and utilities		
<b>PROPOSED BEST MANAGEMENT PRACTICE</b>		
<b>Type:</b> ROW Swale (without tree)		
<b>Primary BMP Benefit:</b> Water Quality		
<b>Primary Observed Site Conflict:</b> Overhead Utilities		
<b>Primary Non-Structural Control:</b> Street/Parking Lot Sweeping

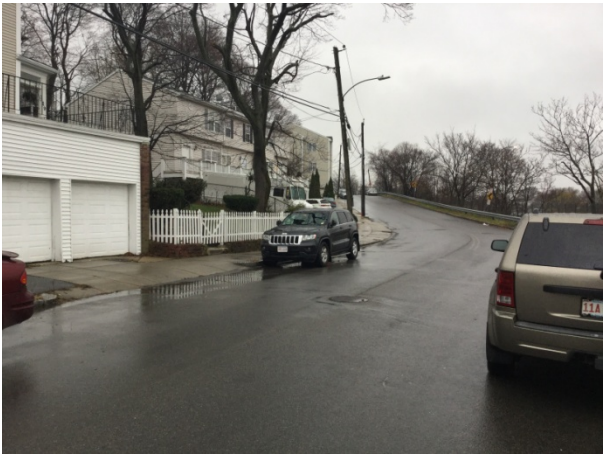
Additional Photo Caption:  
Steep slopes on Jefferson Avenue

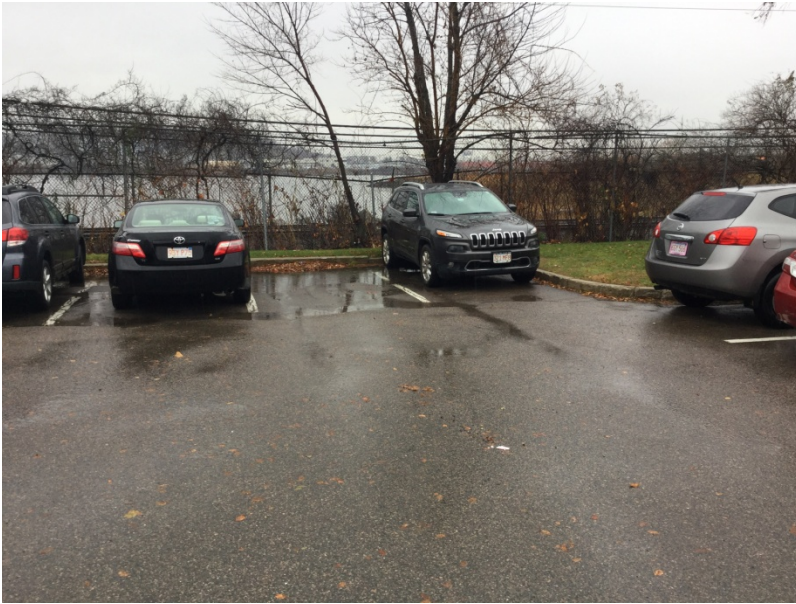
<b>Site Description:</b> Highly used parking lot used by elementary school parking; abuts MBTA railroad. Replace impervious area with pavers and regrade parking lot to avoid run on; potentially create bioretention area in back to catch more runoff (need to berm it in the back to avoid flow to MBTA).  <b>Ownership:</b> Public (City-owned)  <b>Primary Land Use:</b> Parking Lot  <b>Primary Pollutants:</b> Oil/Gas (sheen)
<b>Sidewalk Width:</b> N/A	<b>Road Width:</b> N/A	<b>Parking Lot Dimensions:</b> 100 spaces, 8'x12'
<b>Site Overview Picture:</b>

<b>Site Overview Caption:</b> Resurface parking spaces/ build bioretention area		
<b>PROPOSED BEST MANAGEMENT PRACTICE</b>		
<b>Type:</b> Remove Impervious Surface/Bioretention		
<b>Primary BMP Benefit:</b> Water Quality		
<b>Primary Observed Site Conflict:</b> Entrances/Driveway

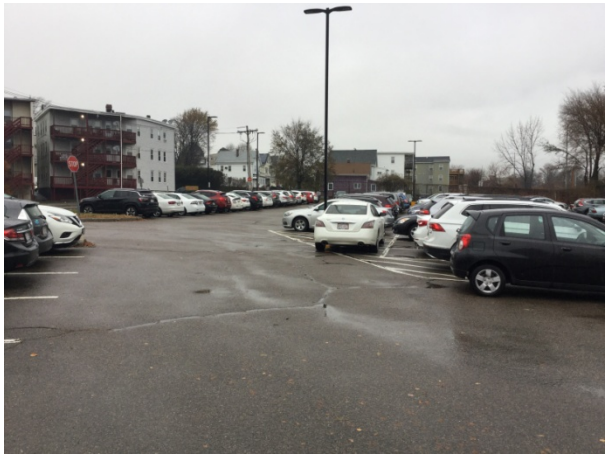
Additional Photo Caption:  
Heavily used parking lot

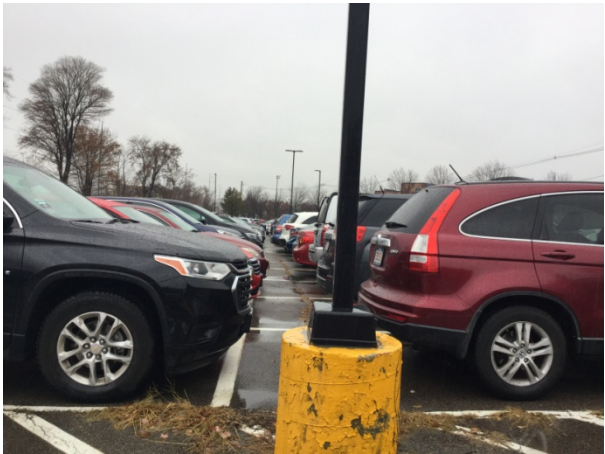
Additional Photo Caption:  
Parking space outlay

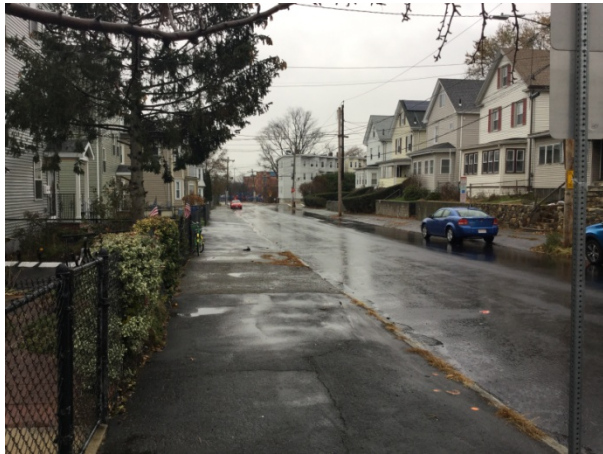
**Additional Photo Caption:**  
Minimal utilities observed

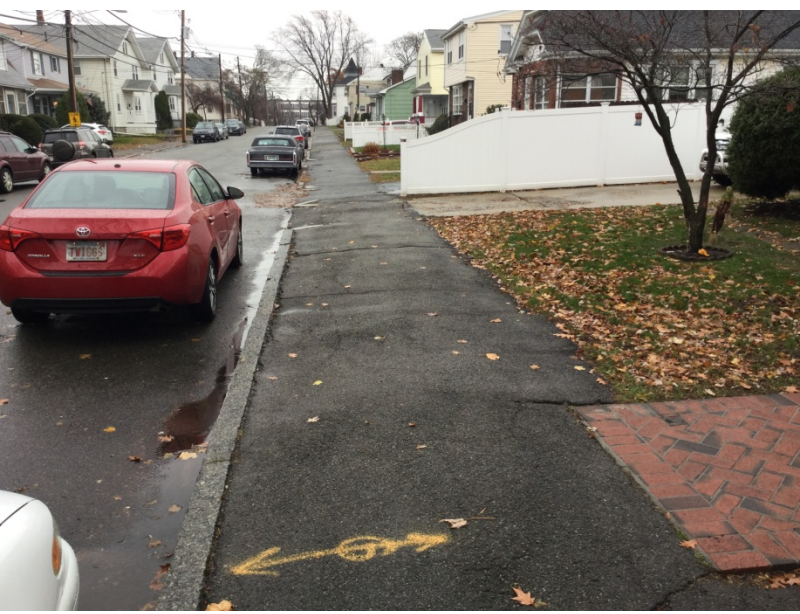
<b>Site Description:</b> 30' long area in residential sidewalk between driveway, gas line and overhead utilities. Good location for tree trench at the bottom of Vinal Street (very broad one-way).
		<b>Ownership:</b> Public (City-owned)
		<b>Primary Land Use:</b> Road/ROW
		<b>Primary Pollutants:</b> Leaves
<b>Sidewalk Width:</b> 8'	<b>Road Width:</b> N/A	<b>Parking Lot Dimensions:</b> N/A
<b>Site Overview Picture:</b>

<b>Site Overview Caption:</b> 30' stretch between gas line and drive way		
<b>PROPOSED BEST MANAGEMENT PRACTICE</b>		
<b>Type:</b> Tree Trench		
<b>Primary BMP Benefit:</b> Water Quality		
<b>Primary Observed Site Conflict:</b> Entrances/Driveway		
<b>Primary Non-Structural Control:</b> Street/Parking Lot Sweeping

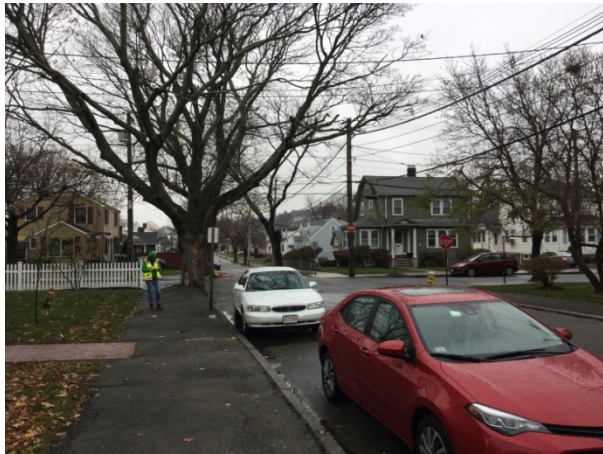
**Additional Photo Caption:**  
Overhead utilities over gas line

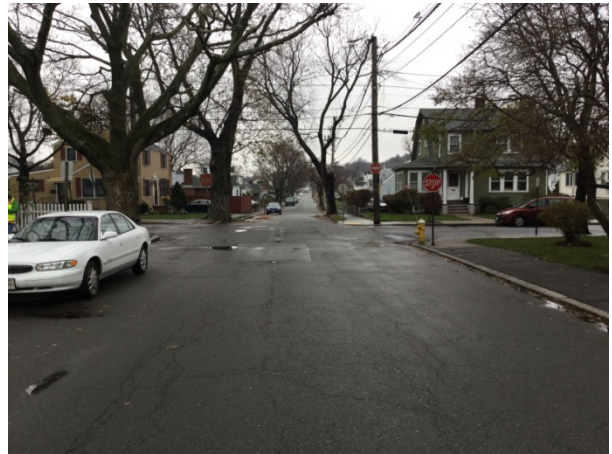
**Additional Photo Caption:**  
Other side of Vinal Street is much narrower

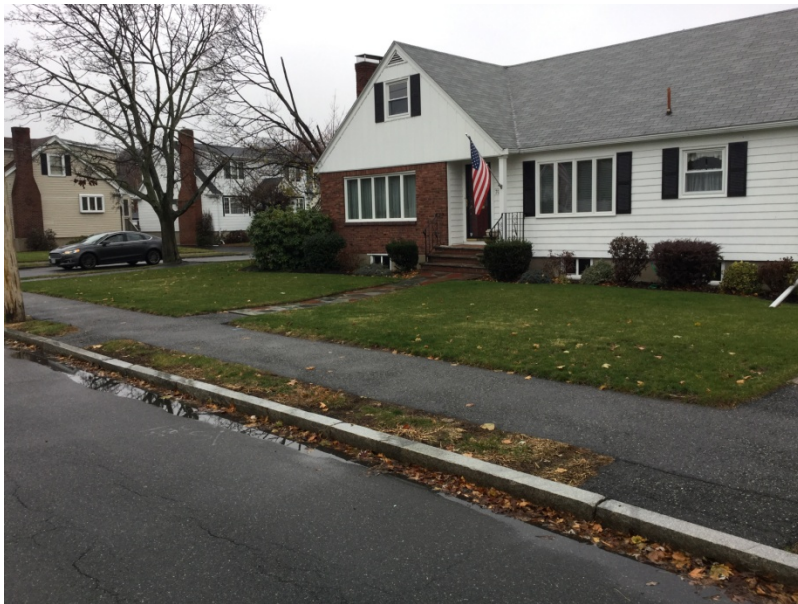
Name: 70 Vinal Street		Priority Subshed # 3
<b>Site Location:</b>

<b>Site Description:</b> Residential one-way with parking on one side. Narrow sidewalk (5' wide) plus 2' green strip. Potentially 2-3' of green space can be used for bumpout and for traffic calming for a tree trench.
		<b>Ownership:</b> Public (City-owned)
		<b>Primary Land Use:</b> Road/ROW
		<b>Primary Pollutants:</b> Leaves
<b>Sidewalk Width:</b> 5'	<b>Road Width:</b> 24'	<b>Parking Lot Dimensions:</b> N/A
<b>Site Overview Picture:</b>

<b>Site Overview Caption:</b> 30' area for tree trenches 80 Vinal Street		
<b>PROPOSED BEST MANAGEMENT PRACTICE</b>		
<b>Type:</b> Tree Trench		
<b>Primary BMP Benefit:</b> Water Quality		
<b>Primary Observed Site Conflict:</b> Overhead Utilities , Underground Utilities		
<b>Primary Non-Structural Control:</b> Street/Parking Lot Sweeping

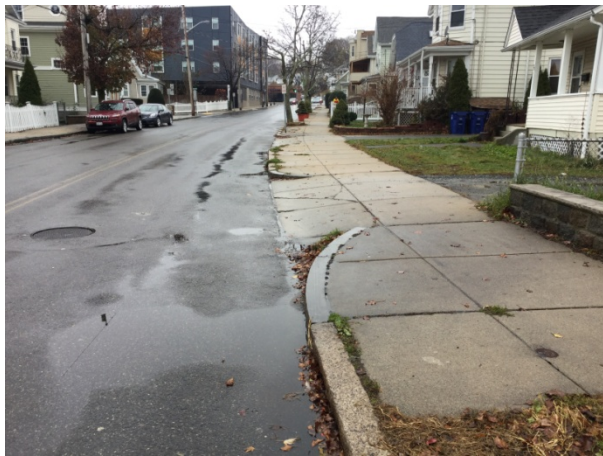
<b>Site Description:</b> Empty tree pit could be transformed into 5'x12' tree trench between gas line and drive way; water access line would need to be dealt with; overhead utilities demand low growth tree; no CB.
		<b>Ownership:</b> Public (City-owned)
		<b>Primary Land Use:</b> Road/ROW
		<b>Primary Pollutants:</b> Leaves
<b>Sidewalk Width:</b> 9'	<b>Road Width:</b> N/A	<b>Parking Lot Dimensions:</b> N/A
<b>Site Overview Picture:</b>

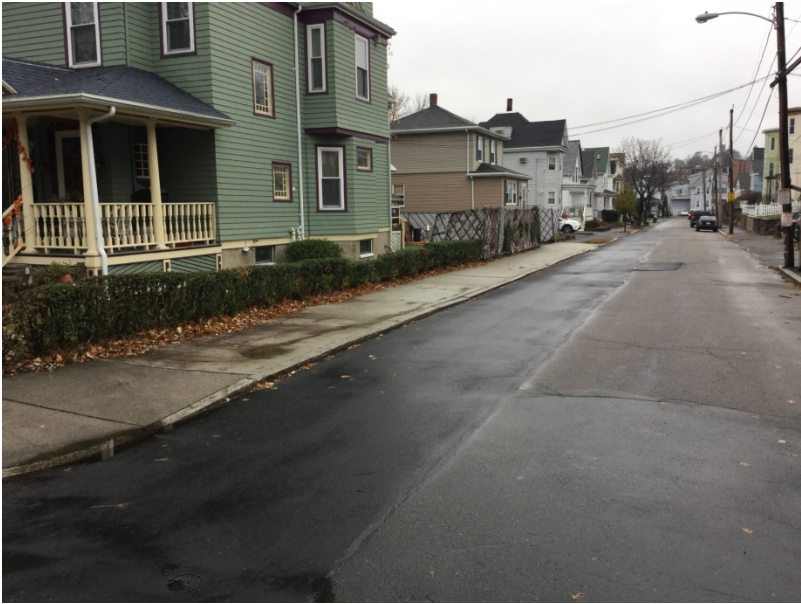
Name: Hall Street		Priority Subshed # 3
<b>Site Location:</b>

<b>Site Description:</b> Large stretch of impervious area (8' sidewalk next to a 24' one-way). No observable utilities. Opportunity for tree trenches on both sides of street, better on southern side.
		<b>Ownership:</b> Public (City-owned)
		<b>Primary Land Use:</b> Road/ROW
		<b>Primary Pollutants:</b> Leaves
<b>Sidewalk Width:</b> 8'	<b>Road Width:</b> 24'	<b>Parking Lot Dimensions:</b> N/A
<b>Site Overview Picture:</b>

<b>Site Overview Caption:</b> Long stretch without utilities		
<b>PROPOSED BEST MANAGEMENT PRACTICE</b>		
<b>Type:</b> Tree Trench		
<b>Primary BMP Benefit:</b> Water Quality		
<b>Primary Observed Site Conflict:</b> Overhead Utilities		
<b>Primary Non-Structural Control:</b> Street/Parking Lot Sweeping

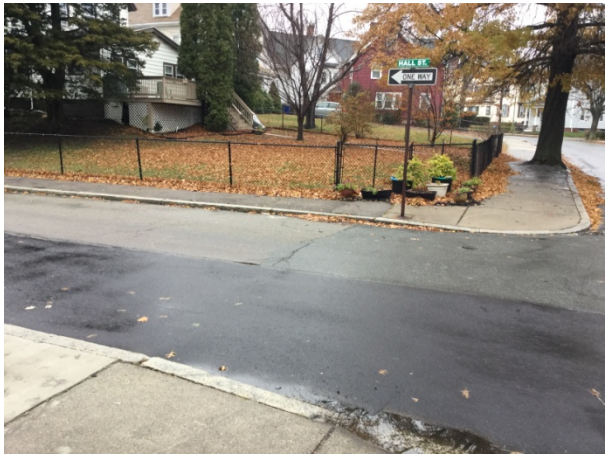
Additional Photo Caption:  
24' wide one-way

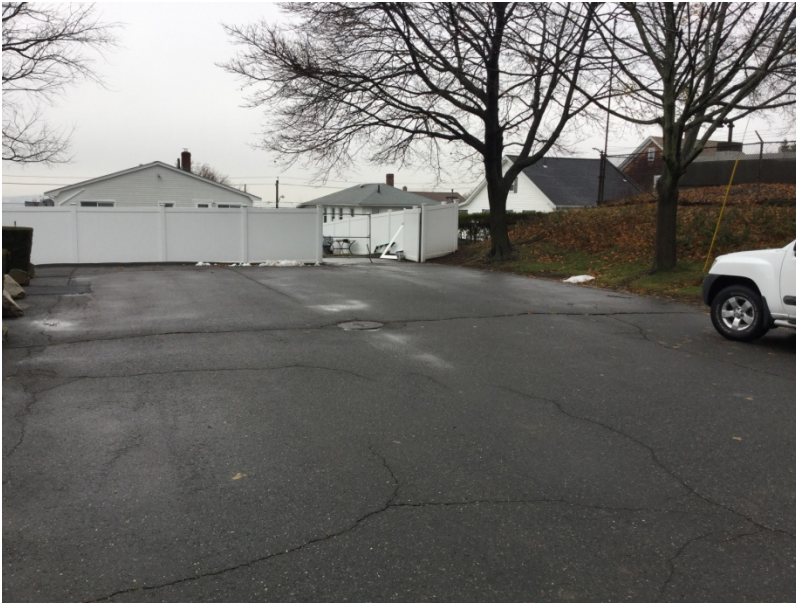
Name: 68 Tudor Street		Priority Subshed # 1
<b>Site Location:</b>

<b>Site Description:</b> Dead end of Tudor Street is extremely wide, at top of the hill. Parking on one side. Adjacent to a reservoir. Need to maintain entrance ways on other side, but can remove impervious area or use pavers.
		<b>Ownership:</b> Public (City-owned)
		<b>Primary Land Use:</b> Road/ROW
		<b>Primary Pollutants:</b> Leaves
<b>Sidewalk Width:</b> N/A	<b>Road Width:</b> 35'	<b>Parking Lot Dimensions:</b> N/A
<b>Site Overview Picture:</b>

<b>Site Overview Caption:</b> Large unused impervious area		
<b>PROPOSED BEST MANAGEMENT PRACTICE</b>		
<b>Type:</b> Remove Impervious Surface		
<b>Primary BMP Benefit:</b> Water Quality		
<b>Primary Observed Site Conflict:</b> Overhead Utilities , Entrances/Driveway		
<b>Primary Non-Structural Control:</b> Street/Parking Lot Sweeping

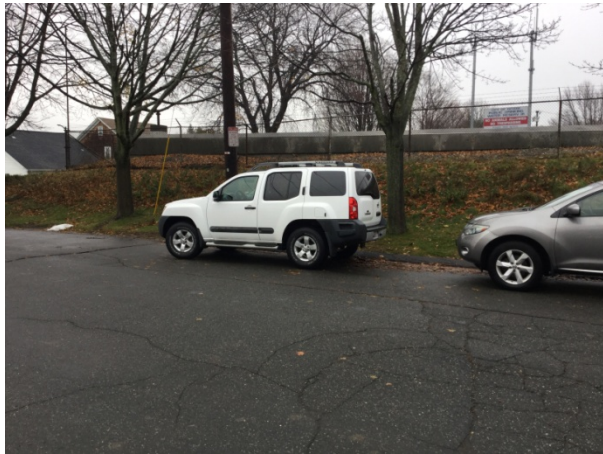
**Additional Photo Caption:**  
Street parking on one side

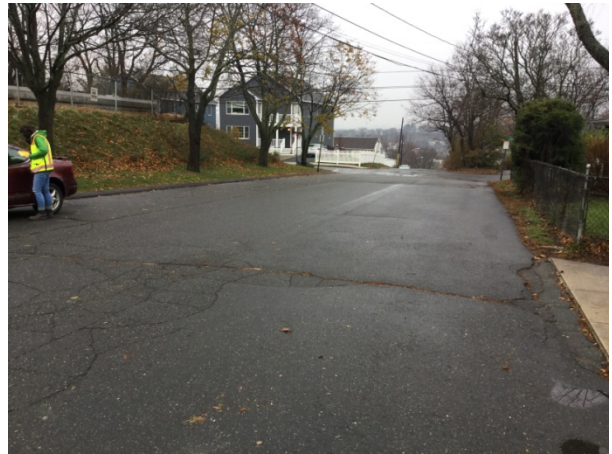
**Additional Photo Caption:**  
Dead end of Tudor Street

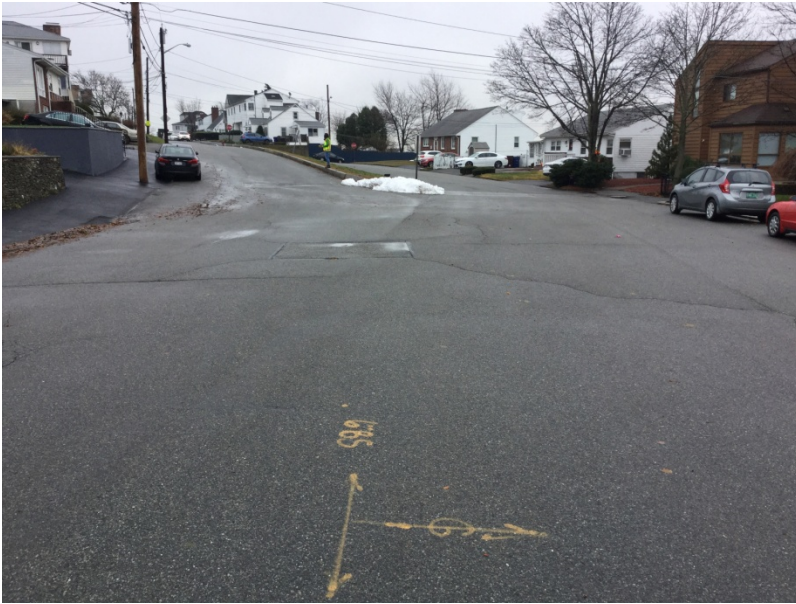
Name: 243 Suffolk Avenue		Priority Subshed # 1
<b>Site Location:</b>

<b>Site Description:</b> Two parts of Suffolk Avenue come together (50' street width). Grass area between streets on steep slope. Both streets are two-ways with one sided parking. Could turn streets into two one-ways with rotary design with pervious center. Rotary could capture water from nearby catch basin.
		<b>Ownership:</b> Public (City-owned)
		<b>Primary Land Use:</b> Road/ROW
		<b>Primary Pollutants:</b> Leaves
<b>Sidewalk Width:</b> N/A	<b>Road Width:</b> 25'	<b>Parking Lot Dimensions:</b> N/A
<b>Site Overview Picture:</b>

<b>Site Overview Caption:</b> Large street splits into two		
<b>PROPOSED BEST MANAGEMENT PRACTICE</b>		
<b>Type:</b> Remove impervious area		
<b>Primary BMP Benefit:</b> Water Quality		
<b>Primary Observed Site Conflict:</b> Overhead Utilities		
<b>Primary Non-Structural Control:</b> Street/Parking Lot Sweeping

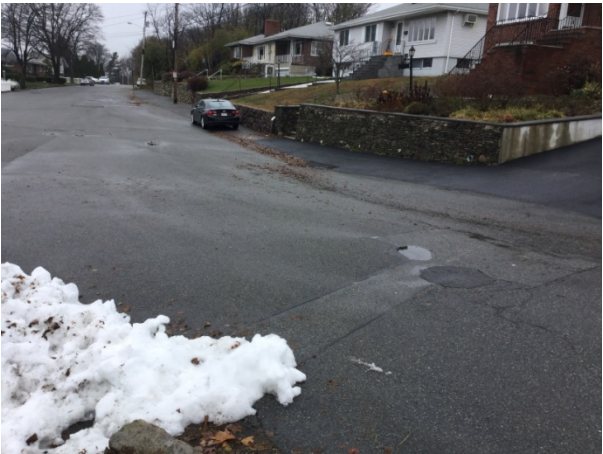
Additional Photo Caption:  
Rotary could take water from nearby CB

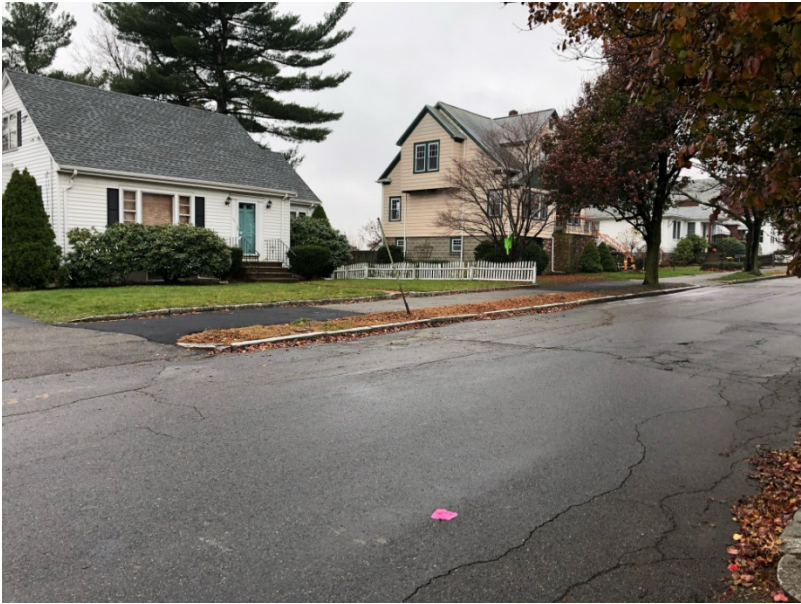
Name: 186 Prospect Avenue		Priority Subshed # 2
<b>Site Location:</b>

<b>Site Description:</b> Wide sidewalk. Opening in tree canopy. Limited conflicts from utilities. Opportunity for tree trench or ROW swale. Limited opportunities along other parts of Prospect Avenue due to canopy cover and utilities.
		<b>Ownership:</b> Public (City-owned)
		<b>Primary Land Use:</b> Road/ROW
		<b>Primary Pollutants:</b> Leaves
<b>Sidewalk Width:</b> >10'	<b>Road Width:</b> 25'	<b>Parking Lot Dimensions:</b> N/A
<b>Site Overview Picture:</b>

<b>Site Overview Caption:</b> Tree trench opportunity		
<b>PROPOSED BEST MANAGEMENT PRACTICE</b>		
<b>Type:</b> Tree Trench		
<b>Primary BMP Benefit:</b> Water Quality		
<b>Primary Observed Site Conflict:</b> Entrances/Driveway , Street Trees/Canopy		
<b>Primary Non-Structural Control:</b> Street/Parking Lot Sweeping

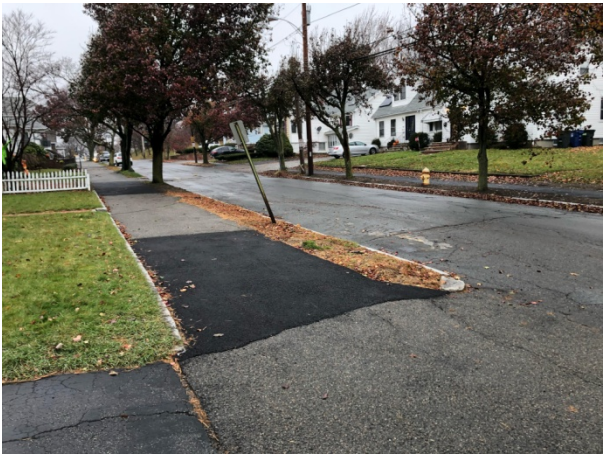
Additional Photo Caption:  
12 ft wide sidewalk area

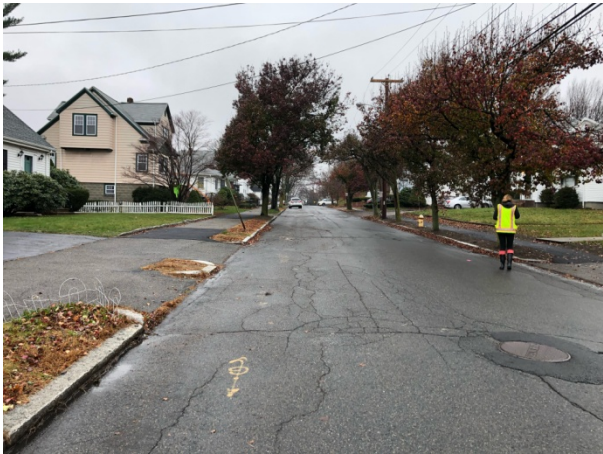
Additional Photo Caption:  
Drainage area
