# VILLAGE OF DECATUR

BUILDING ASSESSMENTS OF VILLAGE HALL & POLICE DEPARTMENT

DATE: April 15th, 2022

## BUILDING ASSESSMENTS OF PUBLIC WORKS DEPARTMENT

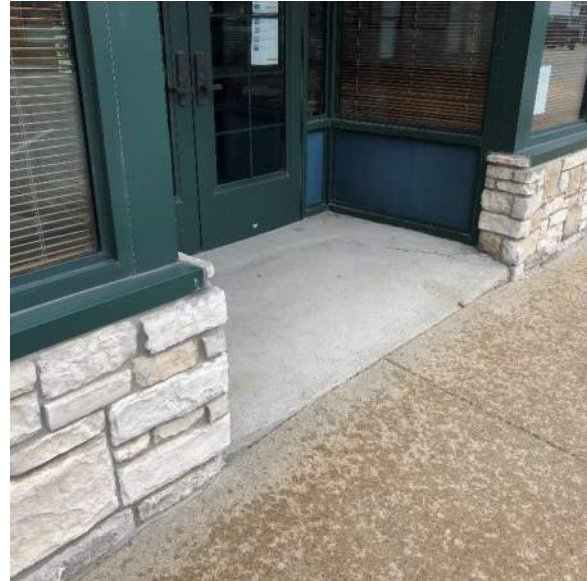
A-i: Concrete Pad

- i. Concrete Pad at entry door is showing signs of cracking & has a 1"-2" lip on the east & west side of pad at sidewalk, presents trip hazard. (Photo A-i)  
**Recommendation:** Remove & Replace new.  
**Cost Parameters:** \$500-\$1,500
- ii. Concrete Pad at entry door is not ADA compliant. (Photo A-ii)  
**Recommendation:** Redesign sidewalk in front of entrance (Design required).  
**Cost Parameters:** \$3,500-\$5,000

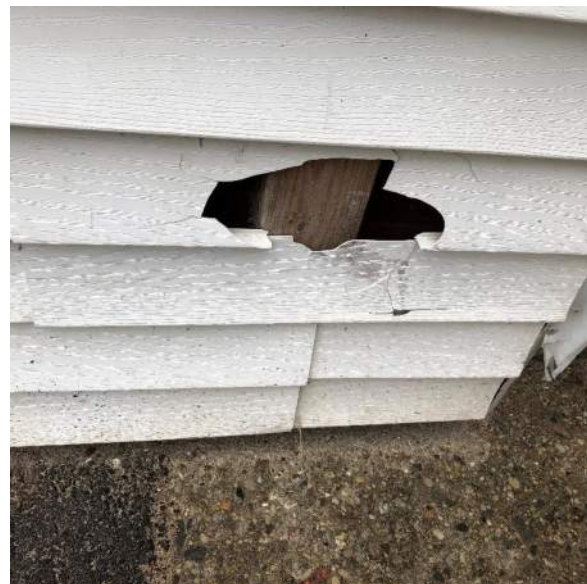
B-i: Metal Siding

- i. Metal siding is paint fading. (Photo B-i)  
**Recommendation:** Prep & Paint.  
**Cost Parameters:** \$3,000-\$5,000
- ii. Vinyl siding is broken. (Photo B-ii)  
**Recommendation:** Remove & Replace  
**Cost Parameters:** \$500-\$800
- iii. Dented Metal siding on North side corner of building. (Photo B-ii)  
**Recommendation:** Replace damaged metal siding.  
**Cost Parameters:** \$1,000-\$2,000

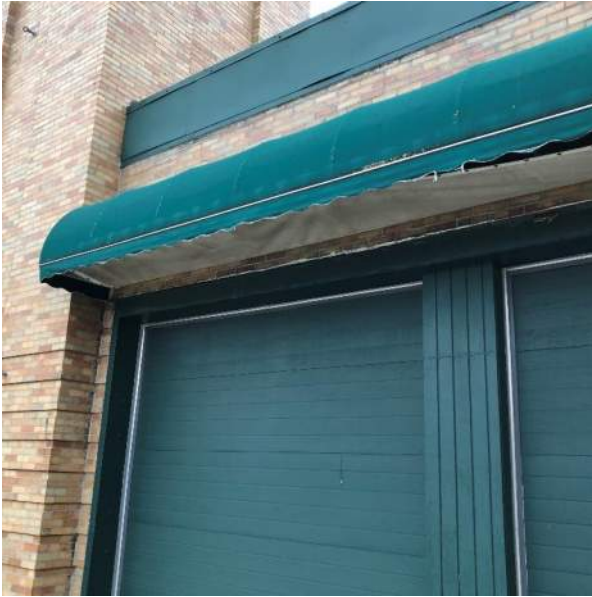
B-vi: Metal at Top of Wall

- vi. Replace sheet metal at top of wall above overhead doors. (Photo B-iv)  
**Recommendation:** Replace sheet metal at top of wall.  
**Cost Parameters:** \$3,000-\$5,000

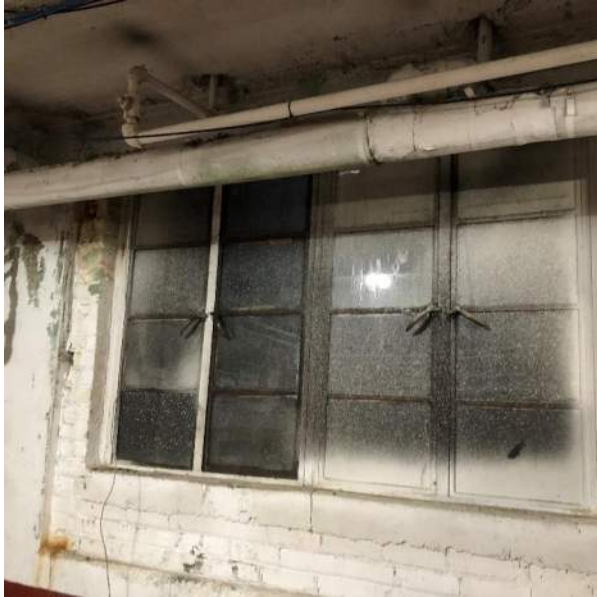
C-iii: Steel Window

- ii. Outdated steel window 5'x12'. (Photo C-ii)  
**Recommendation:** Replace Window  
**Cost Parameters:** \$7,000-\$10,000
- iii. Outdated steel window lower level 5'x8'. (Photo C-iii)  
**Recommendation:** Remove windows and Fill-In with brick  
**Cost Parameters:** \$2,000-\$3,000
- iv. Outdated stairwell #2 wood window 2'x3'. (Photo C-i)  
**Recommendation:** Replace Window  
**Cost Parameters:** \$1,000-\$2,000

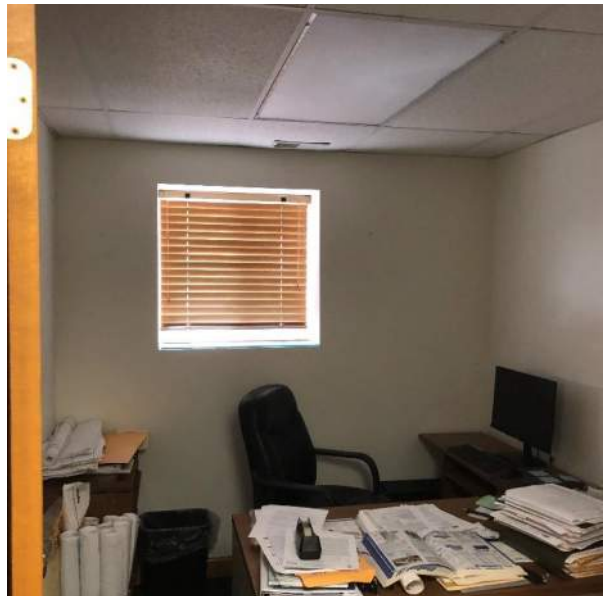
F-xxxi: Wallpaper

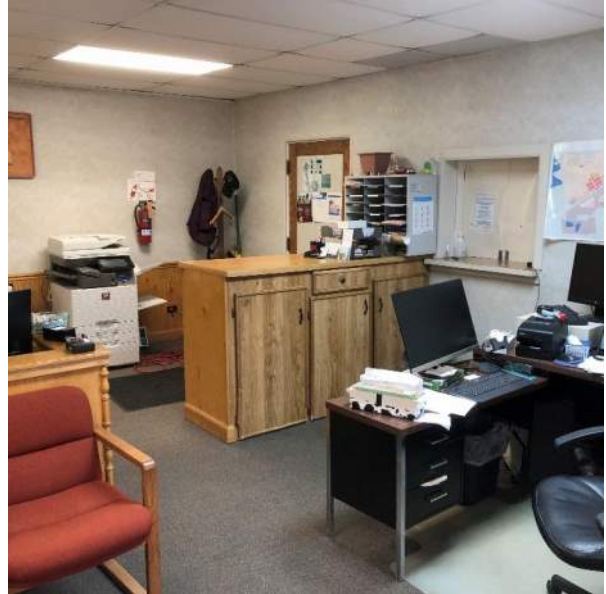
F-xxxiii: Carpet

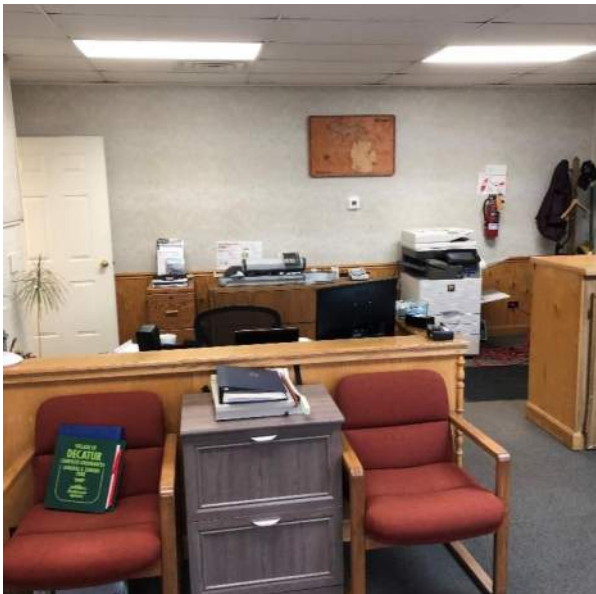
F-xxxiv: Wallpaper

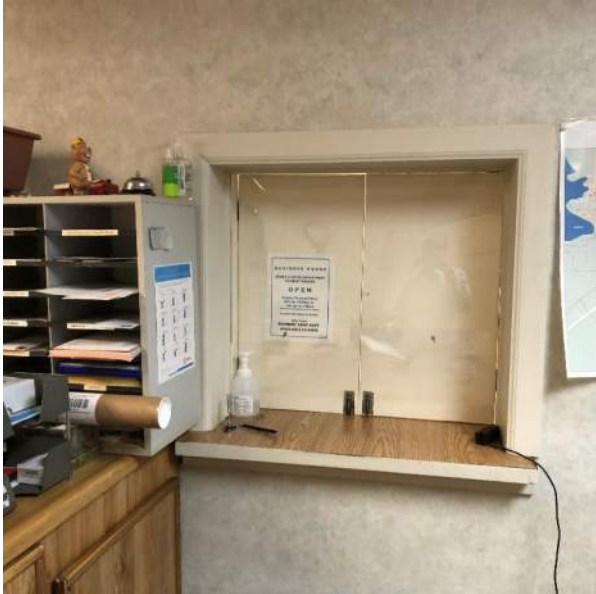
F-xxxvi: Pass Thru Window

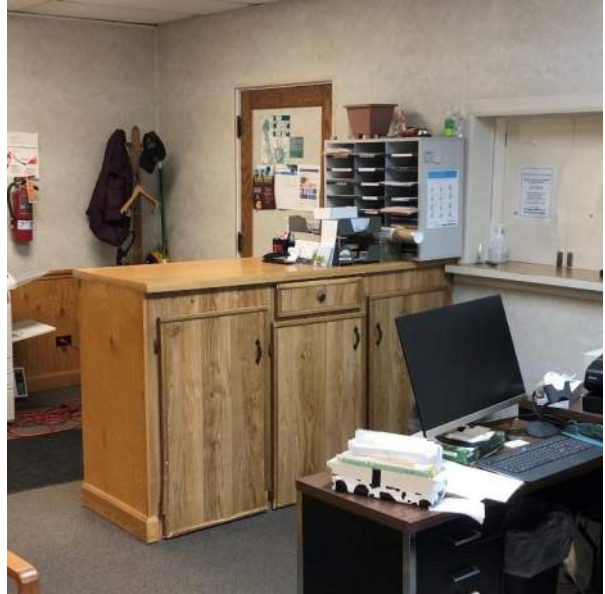
F-xxxvii: Cabinet

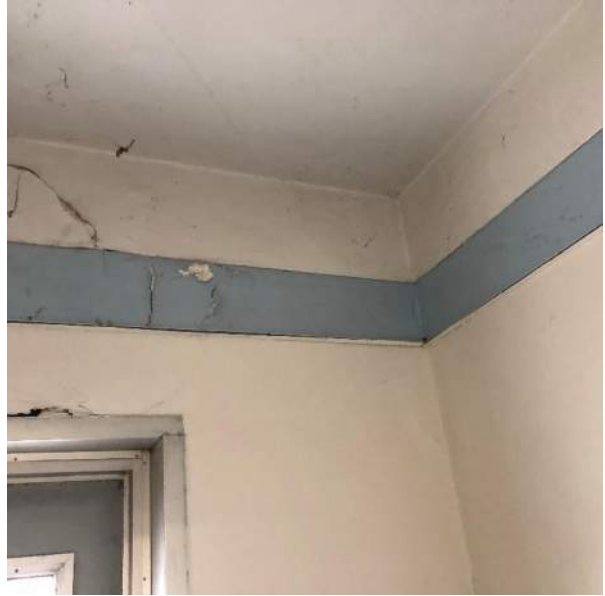
F-xli & F-xlii: Plaster Walls

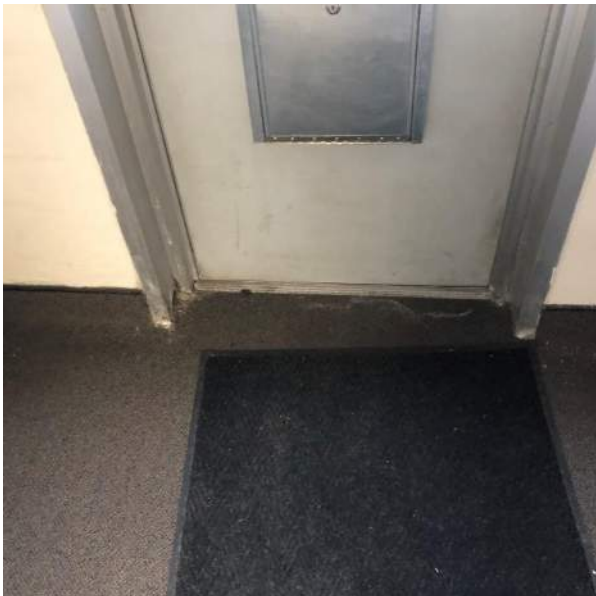
F-xliii: Carpet

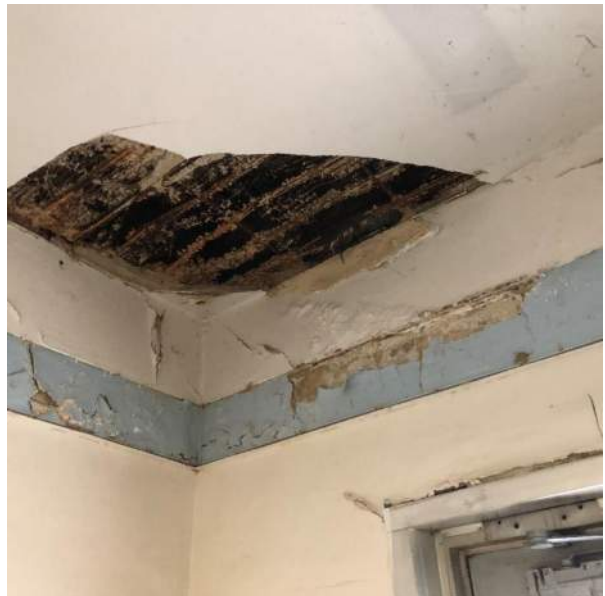
F-xliv: Water Damage

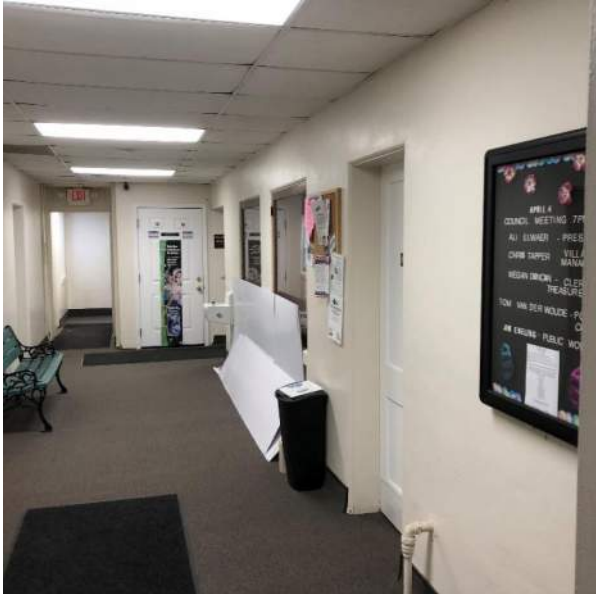
F-xlv: Wall

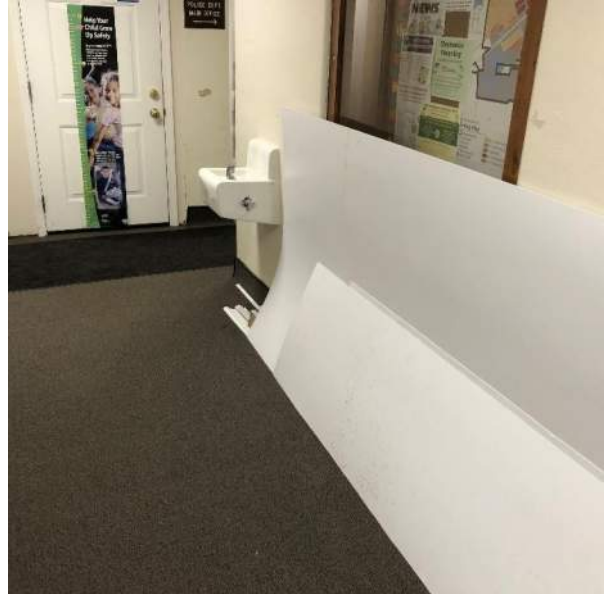
F-xlvi: Carpet

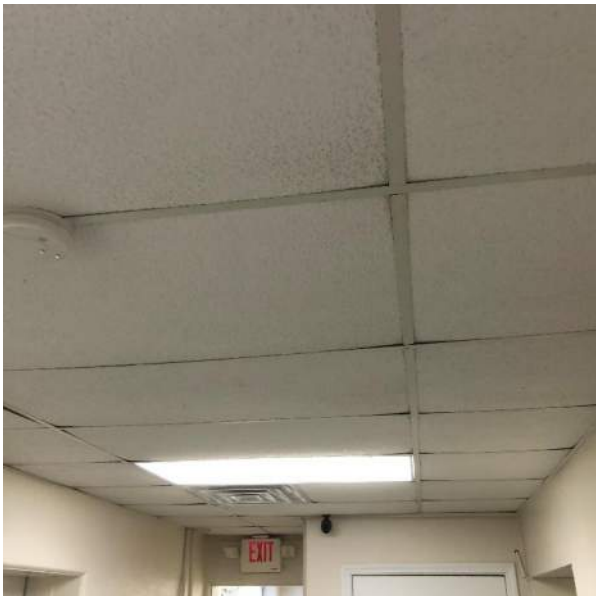
F-xlvii: Ceiling

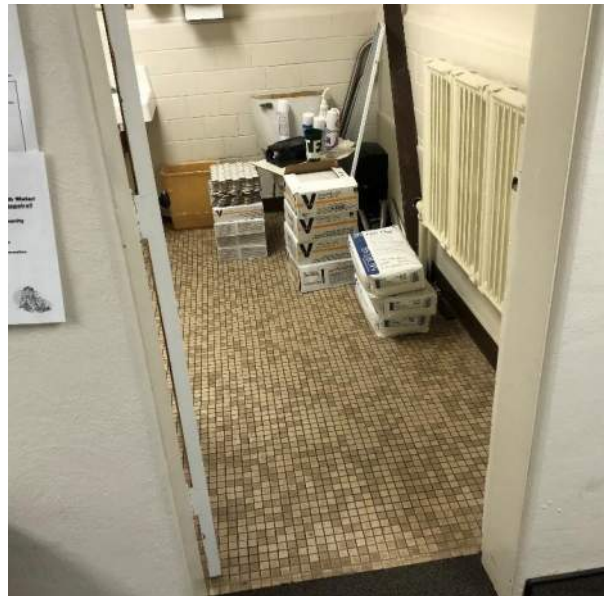
F-xlviii: Floor Tile

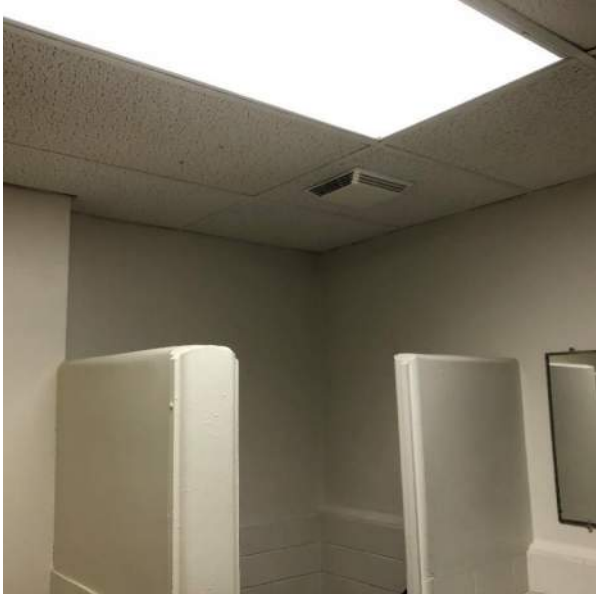
F-xlix: Wall

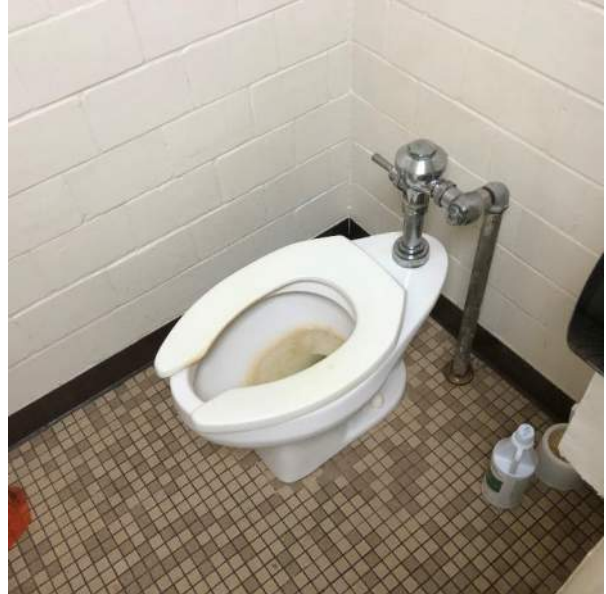
F-I: Plumbing Fixture

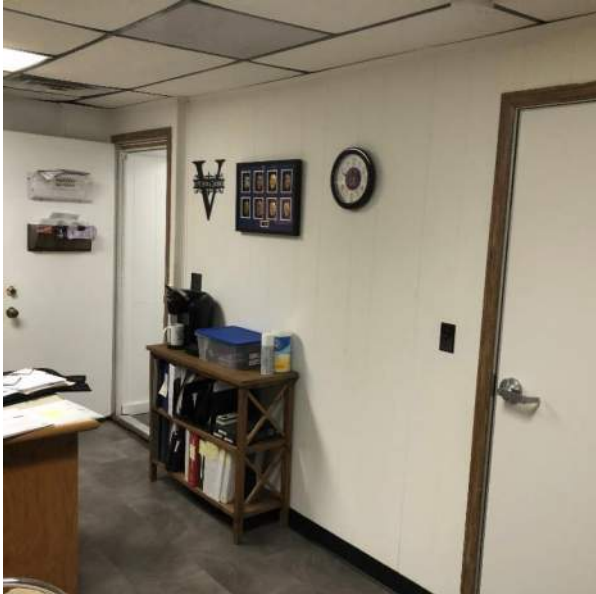
F-liv: Wall

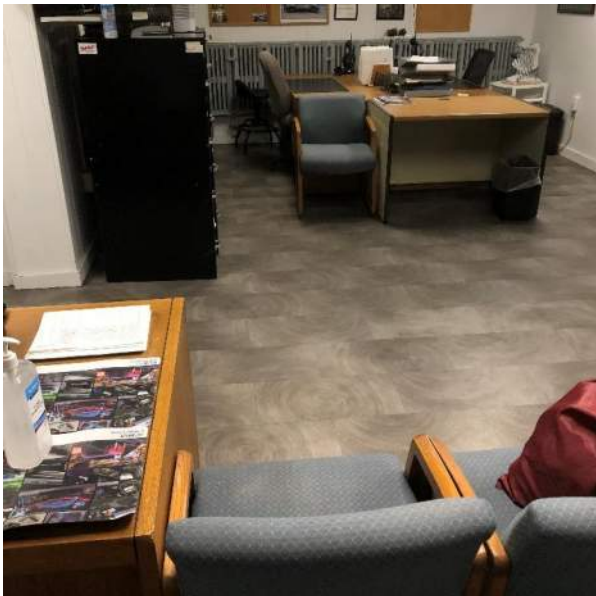
F-lvi: Floor Tile

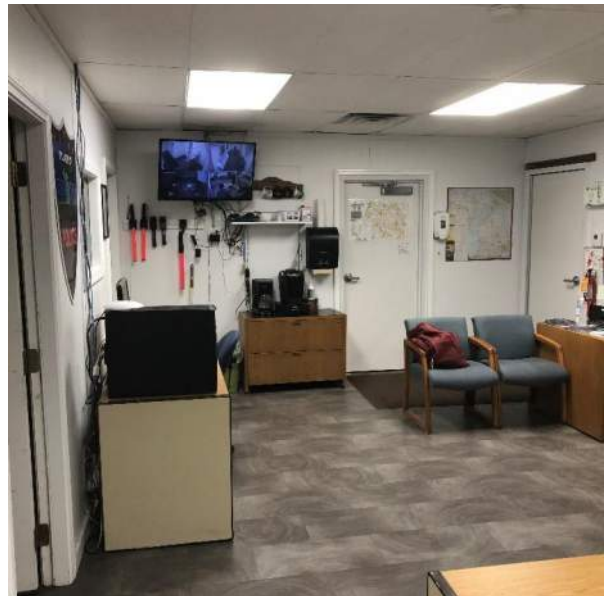
F-lvii: Wall

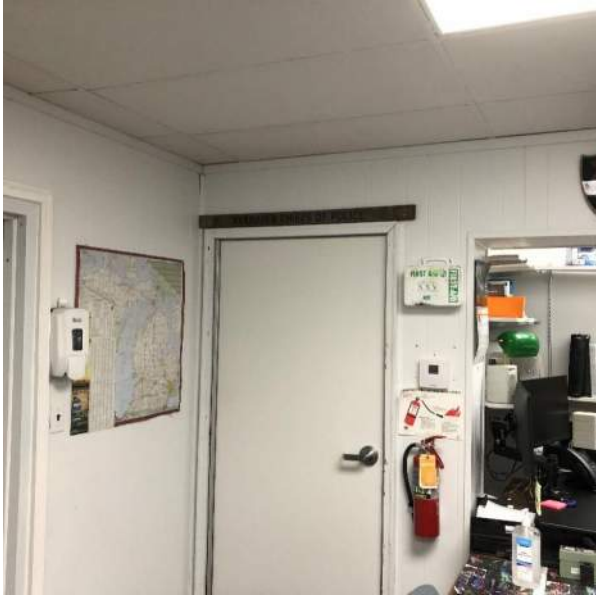
F-lviii: Ceiling

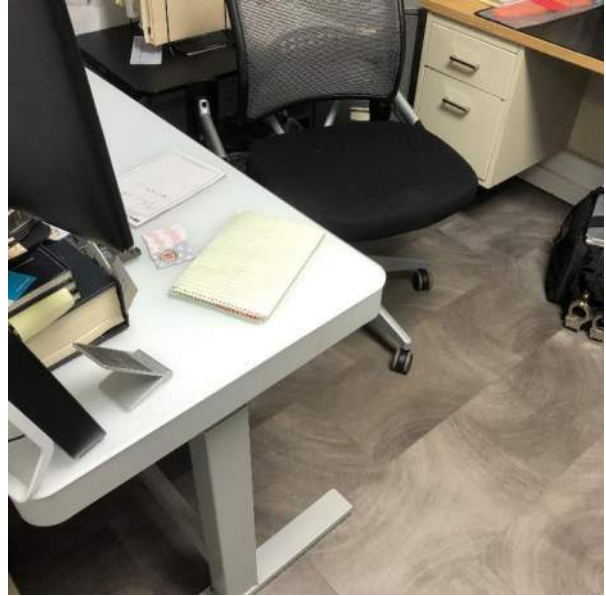
F-lix: Flooring

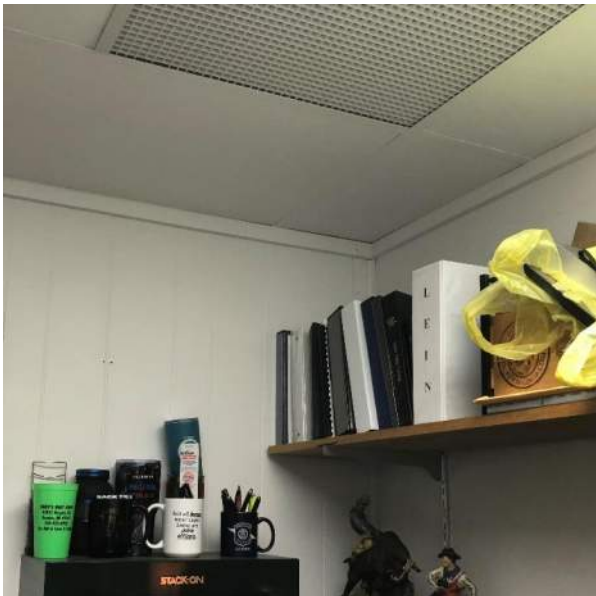
F-lx & F-lxi: Wall & Ceiling

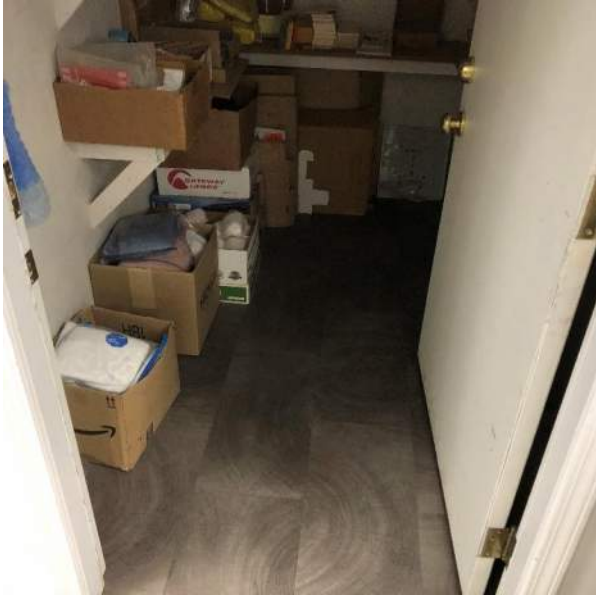
F-lxii: Flooring

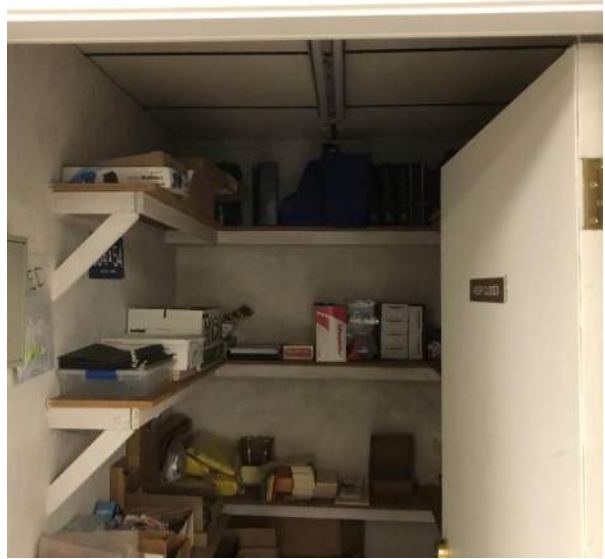
F-lxiii & F-lxiv: Walls & Ceiling

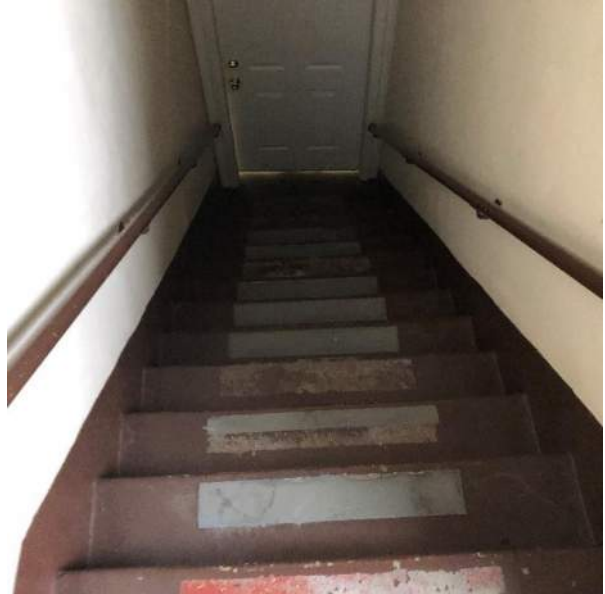
F-lxix & F-xxi: Stairs/Walls

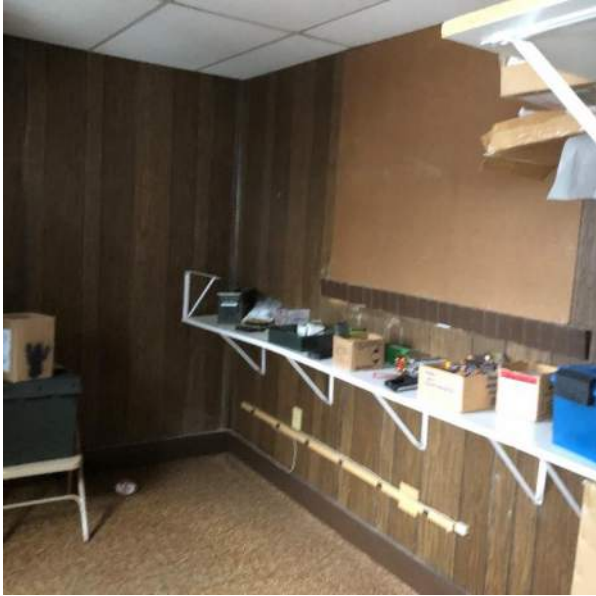
F- lxxiii: Wall

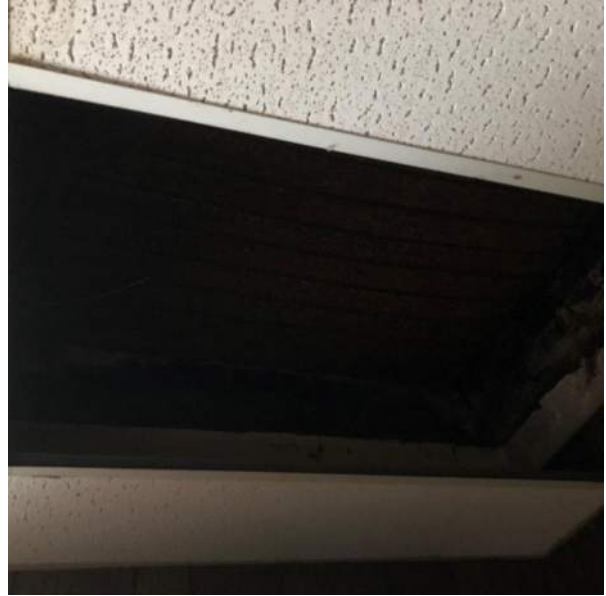
F-lxxiv: Ceiling

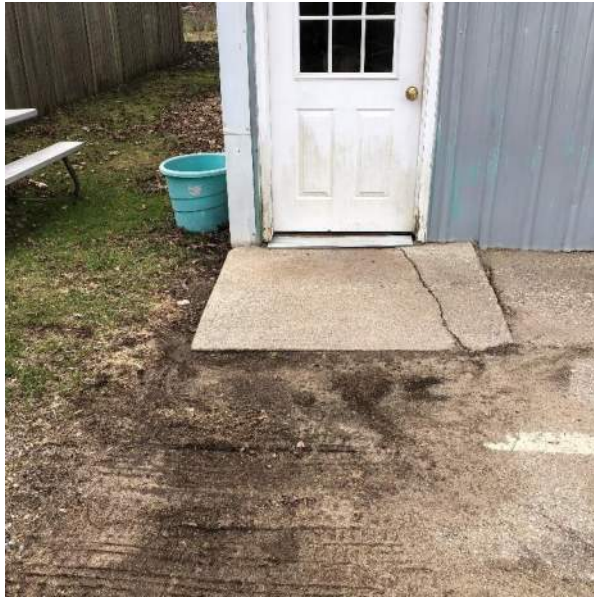
- A. Overall the concrete pads at entry door is in poor condition, with the following highlighted items noted:
- Concrete Pad** – (Maintenance Building)
- i. Concrete Landing Pad Cracked at entry door, presents trip hazard. (Photo A-i)  
**Recommendation:** Remove & Replace new.  
**Cost Parameters:** \$200-\$500
  - ii. Concrete Apron Cracked at garage door, presents trip hazard. (Photo A-ii)  
**Recommendation:** Remove & Replace new.  
**Cost Parameters:** \$3,000-\$5,000

A-i: Concrete Pad

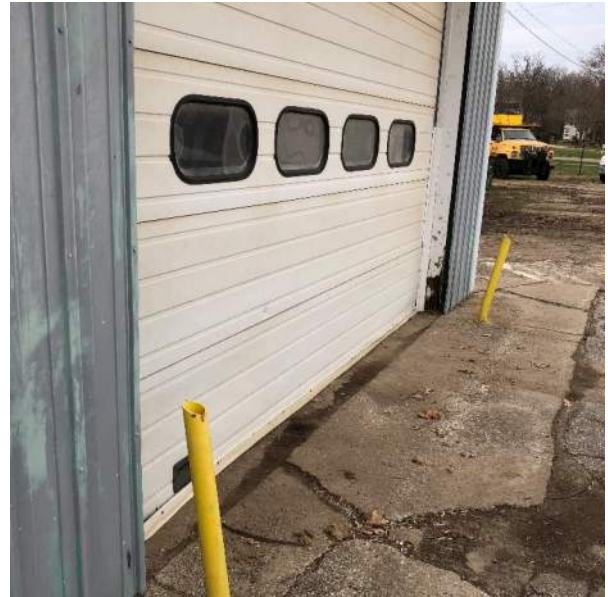
Aii: Concrete Apron

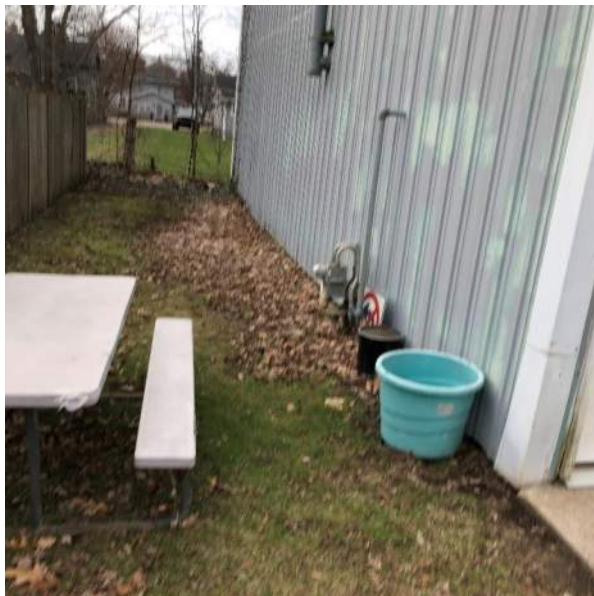
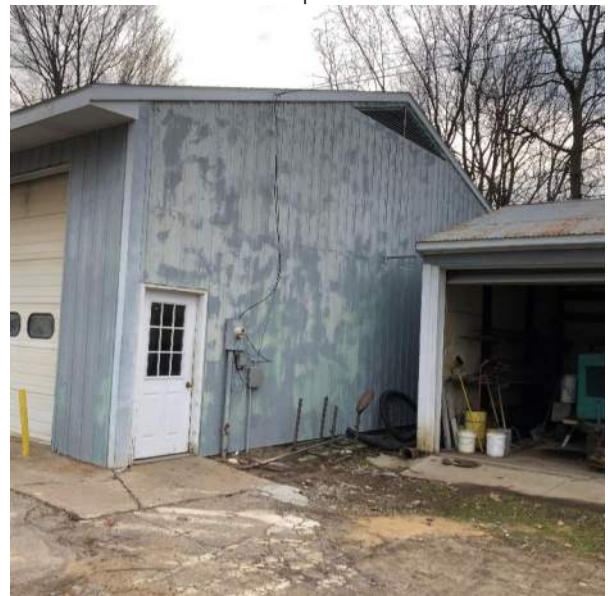
- B. Overall the exterior walls are in fair to poor condition, with the following highlighted items noted:
- Wall**– (Maintenance Building)
- i. Metal siding is paint fading. (Photo B-i)

B-i: Metal Siding

**Recommendation:** Prep & Paint.  
**Cost Parameters:** \$15,000-\$25,000
  - ii. Repair hole in siding below office window. Located on West side of building potential water penetration. (Photo B-ii)

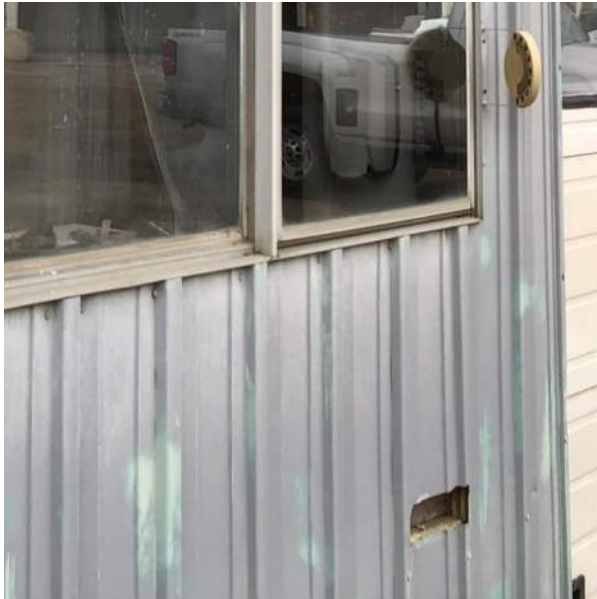
B-ii: Hole in Siding

**Recommendation:** Replace metal siding panel (4'x8') and paint to match existing  
**Cost Parameters:** \$300-\$800
  - iii. Seal joints at edge of metal panels typical. (Photo B-iii)

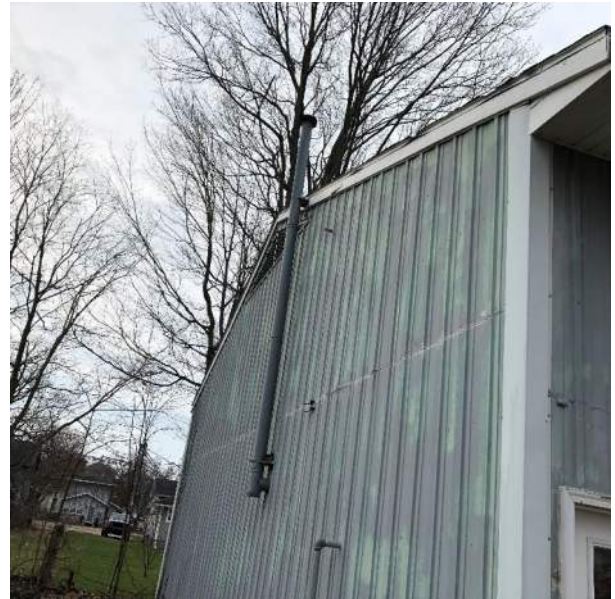
B-iii: Siding Panel

**Recommendation:** Seal Joint Panel  
**Cost Parameters:** \$500-\$1,000
- Wall**– (Storage Garage)
- iv. Metal siding is paint fading. (Photo B-iv)  
**Recommendation:** Prep & Paint.

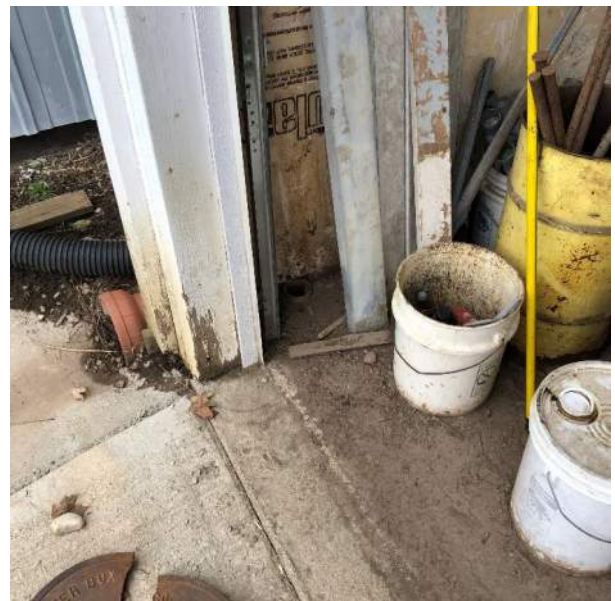
**Cost Parameters:** \$500-\$1,000
  - v. Repair metal siding & trim at open storage & garage jambs. (Photo B-v)  
**Recommendation:** Replace metal siding panel (4'x8'), trim and paint to match

B-v: Metal Siding & Trim

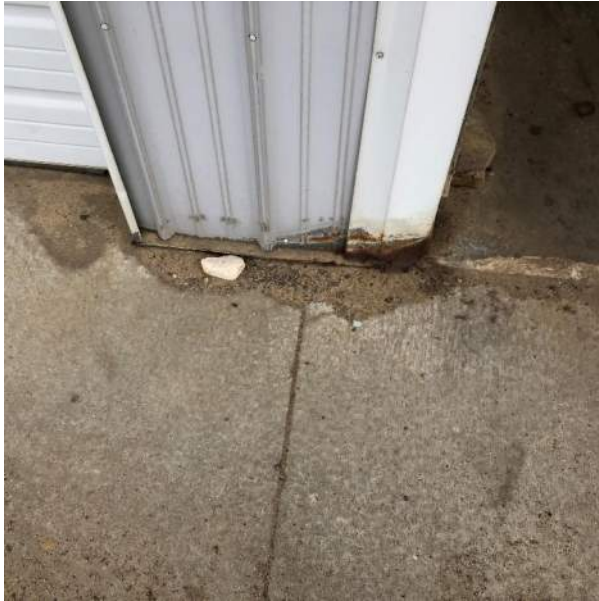
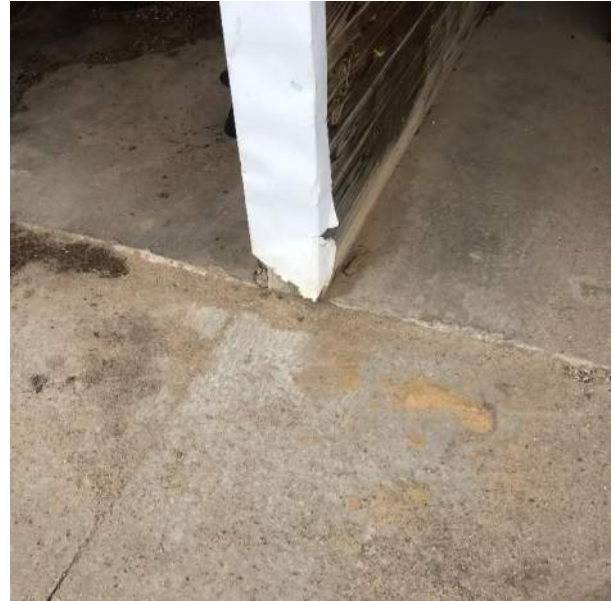
- vi. Repair metal siding & trim at open storage & garage jambs. (Photo B-vi)  
**Recommendation:** Replace metal siding panel (4'x8'), trim and paint to match existing  
**Cost Parameters:** \$2,000-\$3,000

B-vi: Siding Trim

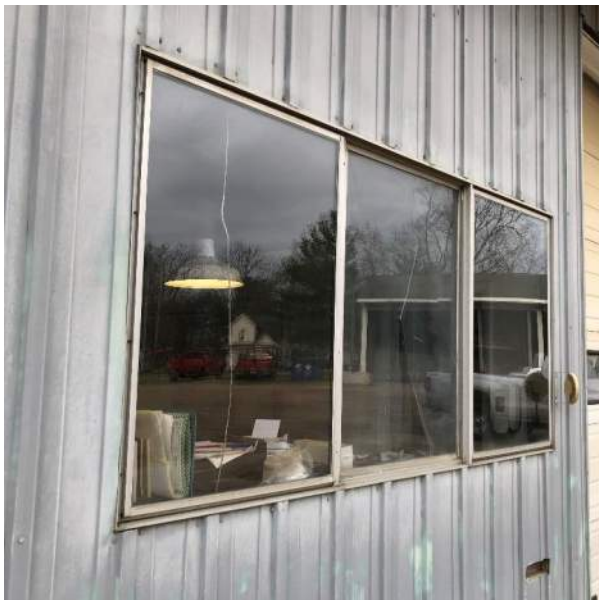
C-i: Broken panes of glass

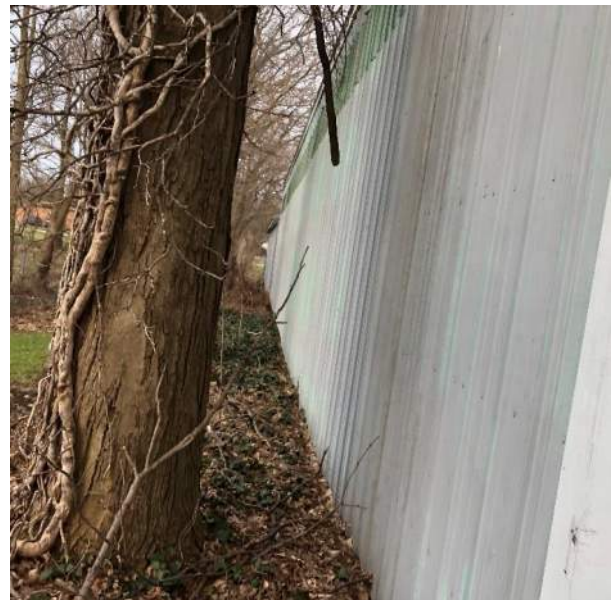
- i. Broken panes of glass on West side of the building. (Photo C-ii)  
**Recommendation:** Replace Aluminum Window  
**Cost Parameters:** \$3,000-\$5,000
- ii. Replace Translucent panel East side of the building. (Photo C-ii)  
**Recommendation:** Replace Translucent panel  
**Cost Parameters:** \$2,000-\$4,000

C-ii: Translucent panel

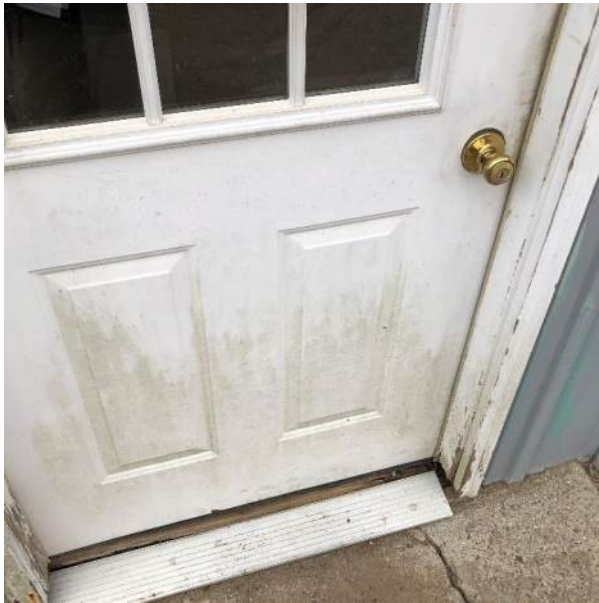
- i. Damaged (2) Entry Door trim & sill. (Typical) (Photo D-i)  
**Recommendation:** Replace door, trim and hardware (ADA compliant)  
**Cost Parameters:** \$1,000-\$1,500
- ii. (2) Overhead Doors trim are in fair condition. (Photo D-i)  
**Recommendation:** Paint existing overhead doors and fix damaged trim and repaint.  
**Cost Parameters:** \$1,000-\$1,500
- iii. Damaged (3) Interior Wood Doors & trim. (Typical) (Photo D-i)  
**Recommendation:** Replace door and trim and hardware (ADA compliant)  
**Cost Parameters:** \$1,000-\$3,000

D-i: Peeling Paint

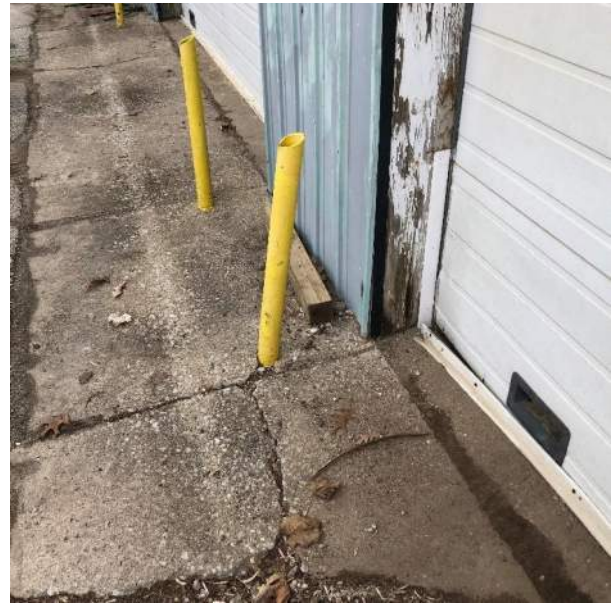
D-ii: Missing Mullion

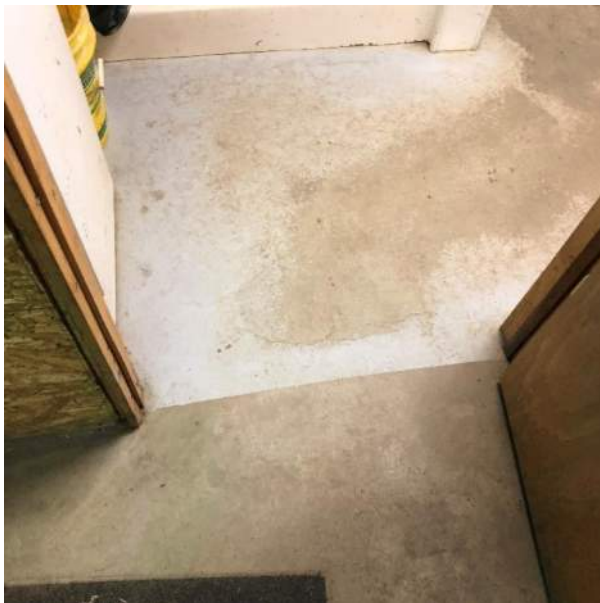
F-iv: Paint Wood Panels

- v. Existing concrete flooring is in fair condition (Photo F-v)  
**Recommendation:** Clean, Seal and re-coat flooring  
**Cost Parameters:** \$1,000-\$3,000
- vi. Paint plaster at wall and ceiling (Photo F-vi)  
**Recommendation:** Repair & Paint  
**Cost Parameters:** \$1,000-\$3,000
- vii. Damaged old dated sinks, faucet & Vanity ADA compliant (Photo F-vii)  
**Recommendation:** Replace  
**Cost Parameters:** \$1,000-\$2,000
- viii. Not ADA compliant (Photo F-viii)  
**Recommendation:** Reconfigure Bath to be ADA compliant  
**Cost Parameters:** \$5,000-\$7,000
- ix. No ceiling or exhaust system (Photo F-ix)  
**Recommendation:** Install new  
**Cost Parameters:** \$2,000-\$4,000

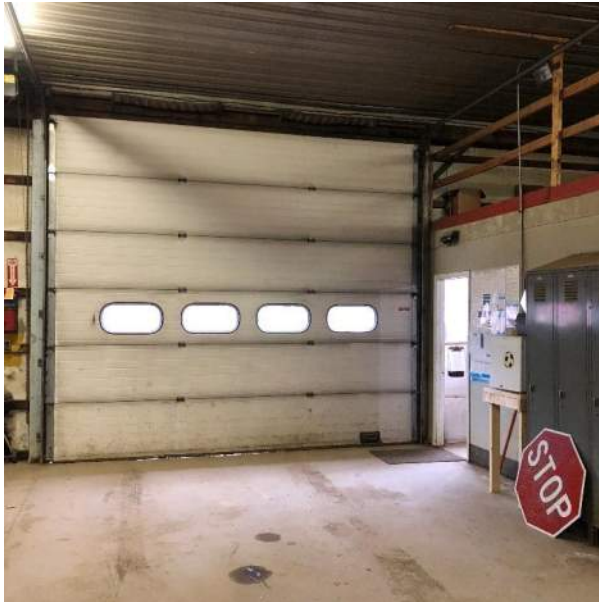
F-ix: Ceiling & Exhaust

- x. Existing concrete flooring is in fair condition (Photo F-x)  
**Recommendation:** Clean & Seal flooring  
**Cost Parameters:** \$3,000-\$4,000
- xi. Dirty walls (Photo F-xi)  
**Recommendation:** Repair & Paint  
**Cost Parameters:** \$1,000-\$2,000

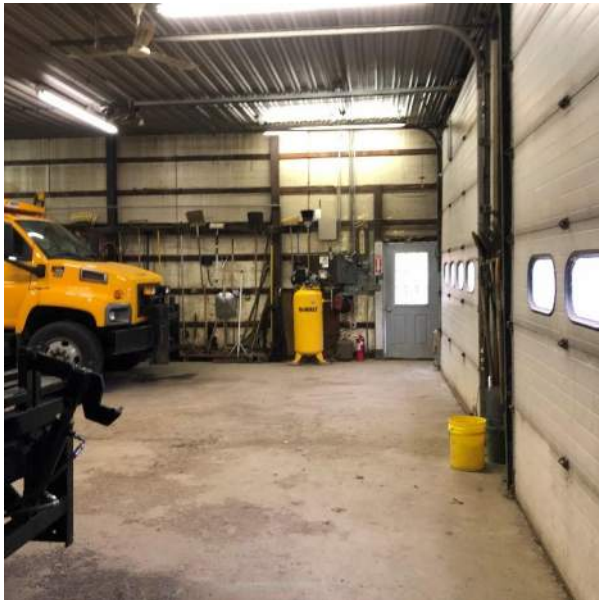
F-xi: Walls

- xii. Existing concrete flooring is in fair condition (Photo F-xii)  
**Recommendation:** Clean & Seal flooring  
**Cost Parameters:** \$3,000-\$5,000
- xiii. Dirty walls (Photo F-xiii)  
**Recommendation:** Repair & Paint  
**Cost Parameters:** \$1,000-\$2,000

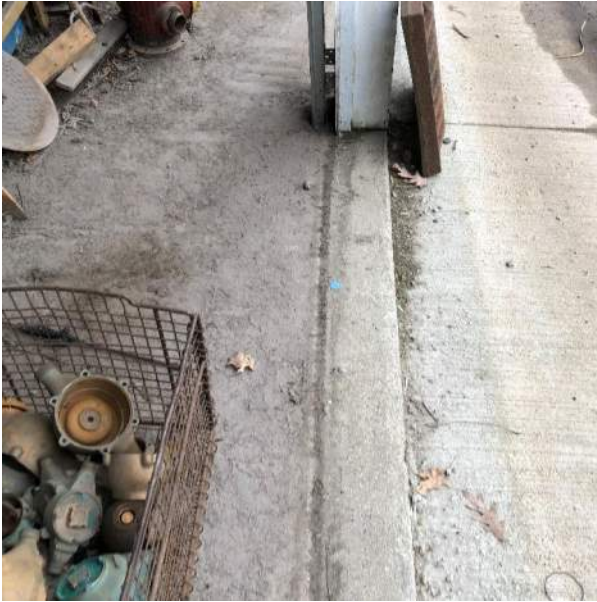
F-xiv: Floor

- xiv. Existing concrete flooring is in fair condition (Photo F-xiv)  
**Recommendation:** Clean & Seal flooring  
**Cost Parameters:** \$2,000-\$3,000

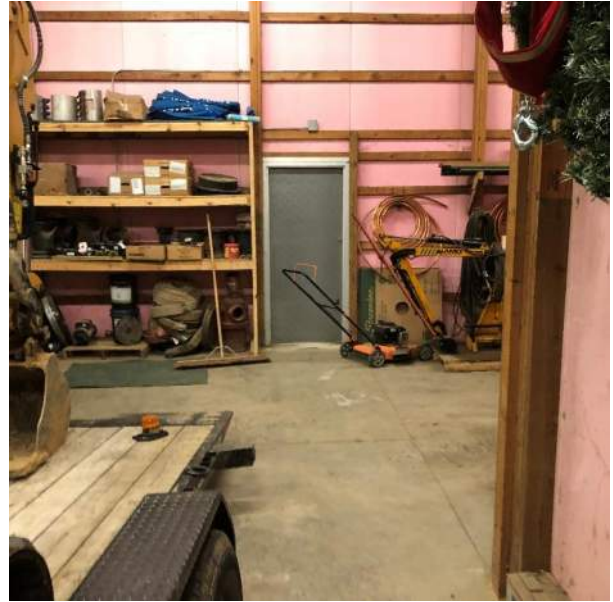
F-xv: Floor

- xv. Existing concrete flooring is in fair condition (Photo F-xv)  
**Recommendation:** Clean & Seal flooring  
**Cost Parameters:** \$2,000-\$3,000
- xvi. Mezzanine Stair Not Code Compliant Railing (Photo F-xvi)  
**Recommendation:** Replace Railing  
**Cost Parameters:** \$4,000-\$6,000
- xvii. Storage #1-#3 interior wood boards is in fair condition (Photo F-xvii)  
**Recommendation:** Replace damaged wood boards  
**Cost Parameters:** \$2,000-\$3,000
