ADDENDUM NO. 1

**MHA Central Office
Window, Lighting, and HVAC Renovation
Memphis, TN**

**RE: Hazardous Material Survey
Memphis Housing Authority
700 Adams Avenue
Memphis, Tennessee 38105**

Hazardous Materials Survey

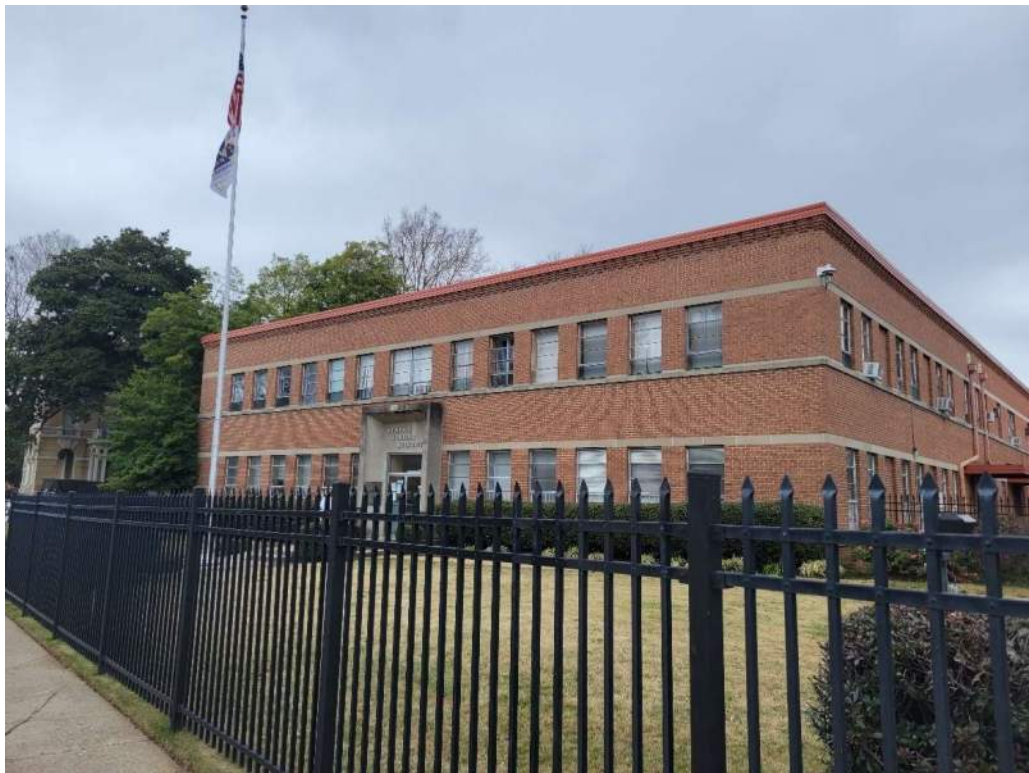
Client Name: Memphis Housing Authority		Site Location: MHA Main Offices 700 North Adams Avenue	Project No. 251214.00
Photo No. 1	Date: 12/1/2021

Description: General view of Front Entrance South facing side of the building "A" Side for Lead-Based Paint Survey			
Photo No. 2	Date: 12/1/2021

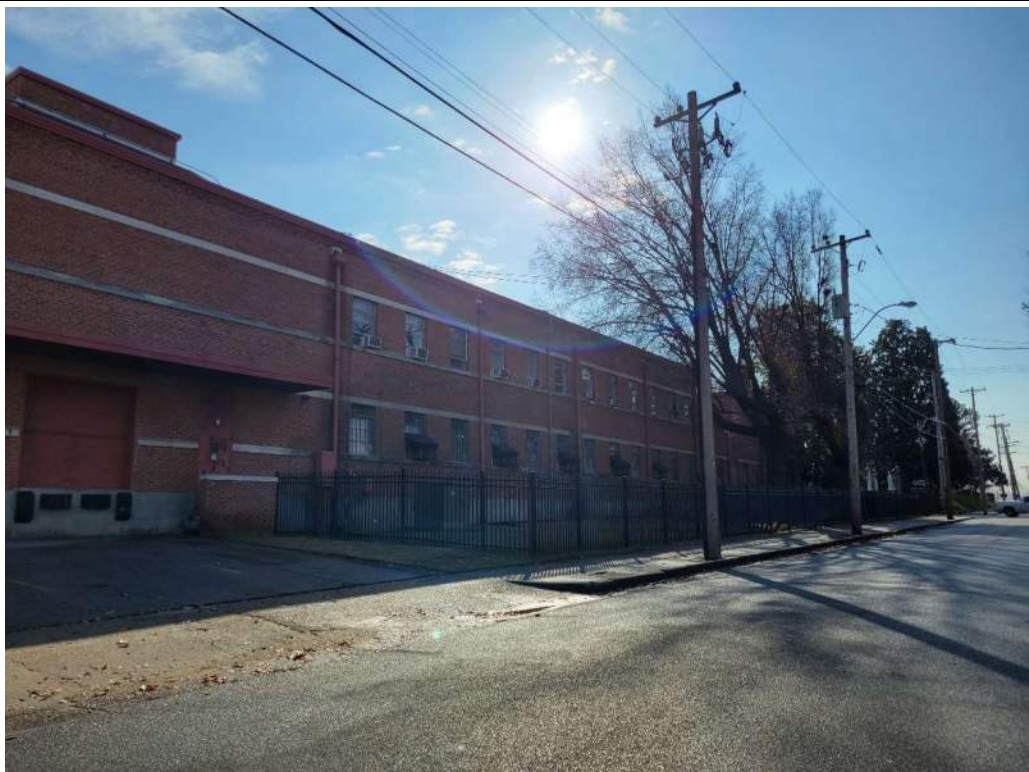
Description: General View of West facing side of the building "B" Side for Lead-Based Paint Survey

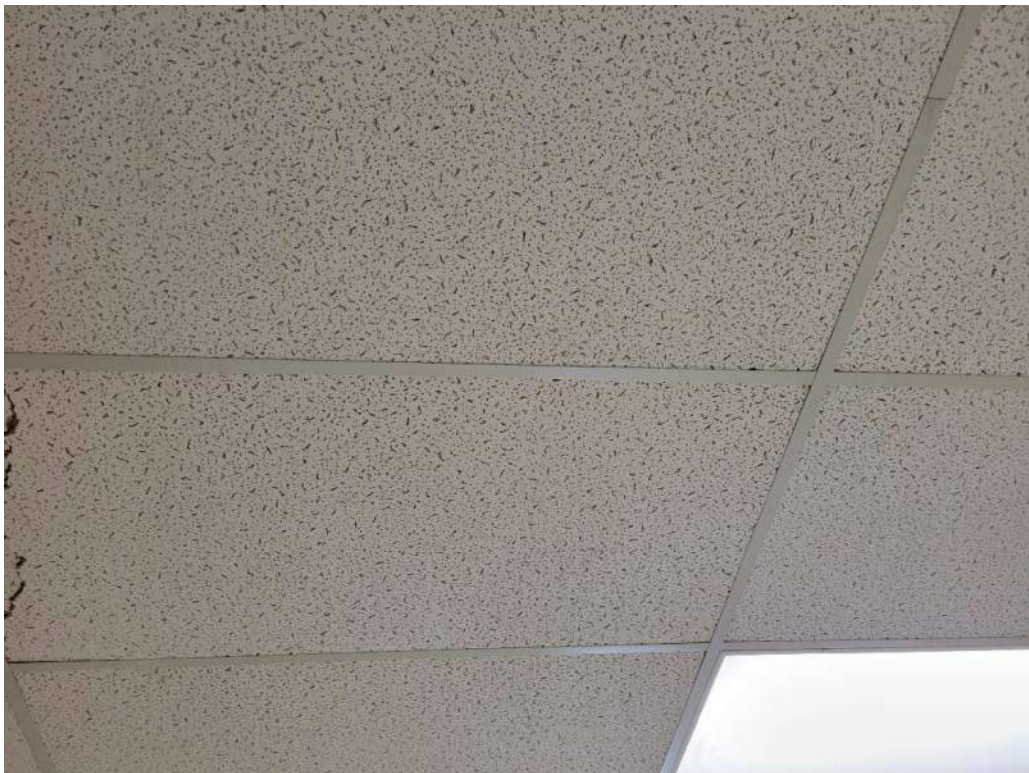
Client Name: Memphis Housing Authority		Site Location: MHA Main Offices 700 North Adams Avenue	Project No. 251214.00
Photo No. 9	Date: 12/1/2021

Description: Asbestos Sample MHA-01 White Fissure Ceiling Tile Tested Negative for Asbestos			
Photo No. 10	Date: 12/1/21

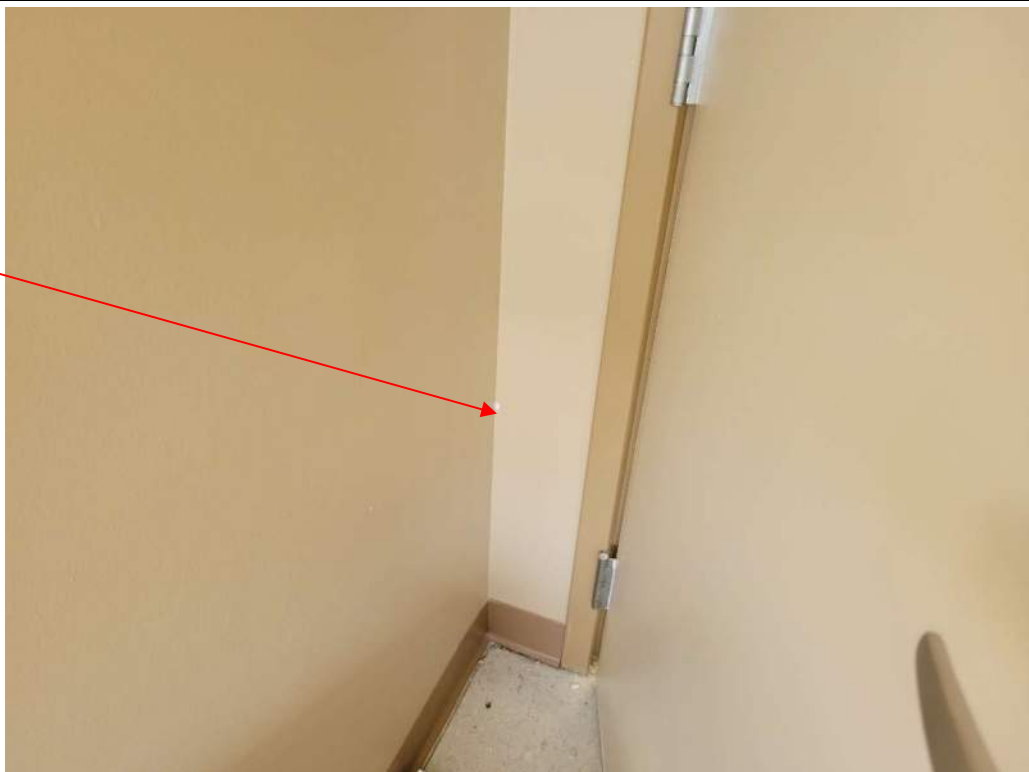
Description: Asbestos Sample MHA-02 Dry Wall with Joint Compound Tested Negative for Asbestos

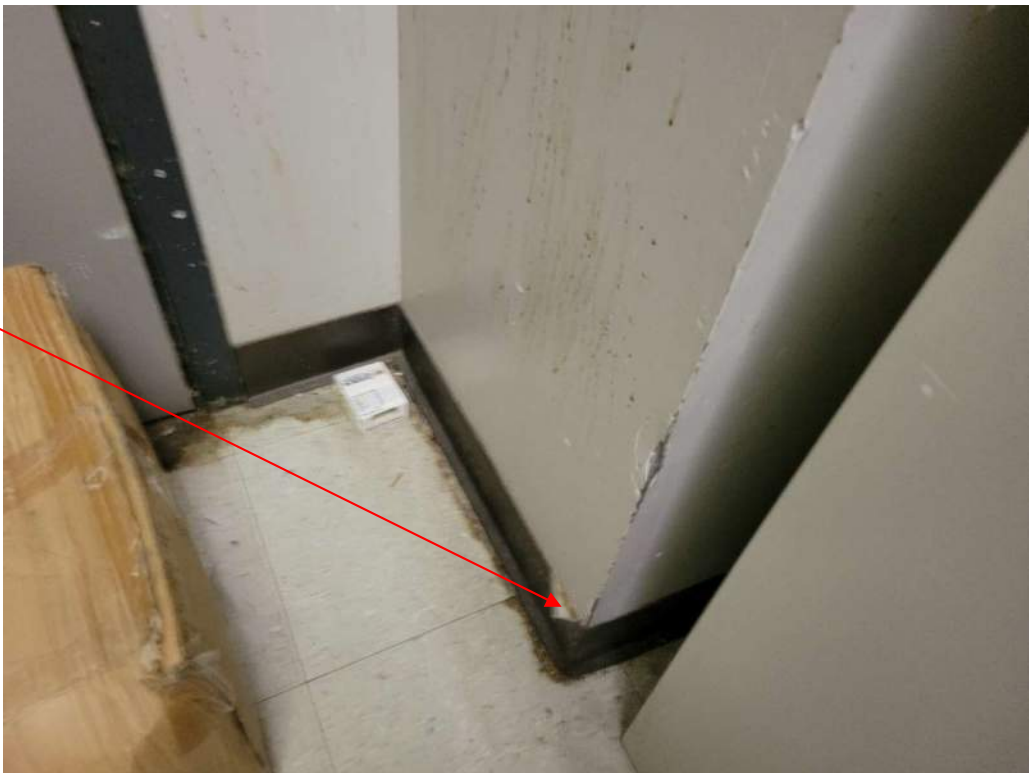
Client Name: Memphis Housing Authority		Site Location: MHA Main Offices 700 North Adams Avenue	Project No. 251214.00
Photo No. 15	Date: 12/1/2021

Description: Asbestos Sample MHA-07 Gray Base Cove with Yellow Mastic Tested Negative for Asbestos			
Photo No. 16	Date: 12/1/2021

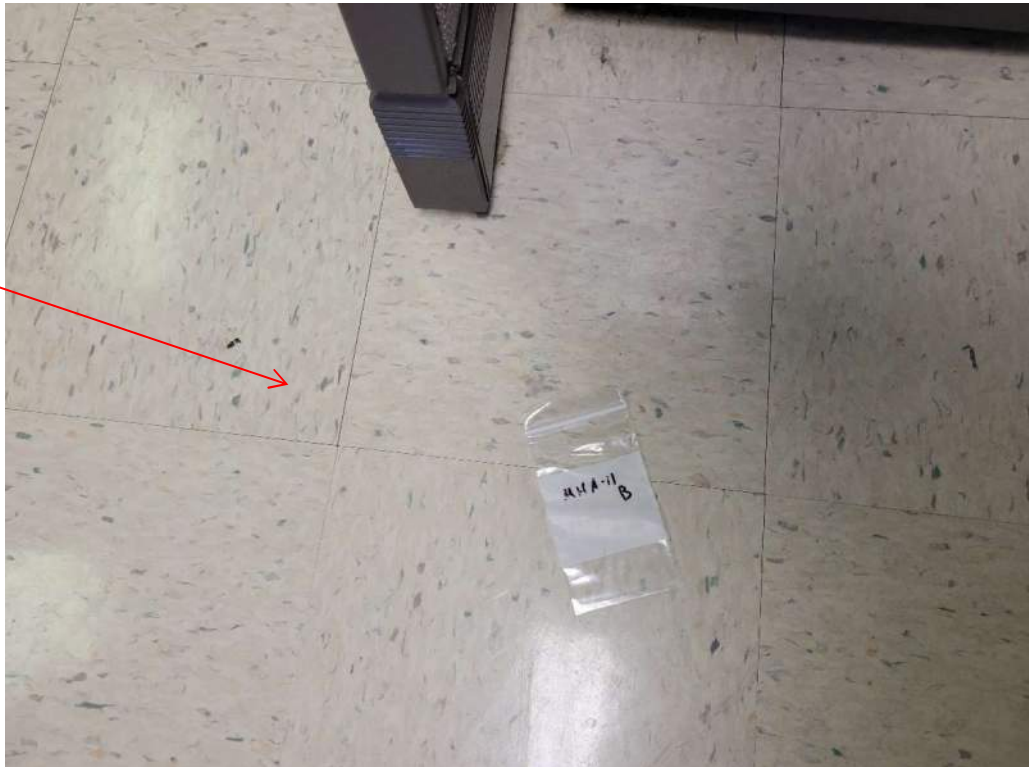
Client Name: Memphis Housing Authority		Site Location: MHA Main Offices 700 North Adams Avenue	Project No. 251214.00
Photo No. 19	Date: 12/1/2021

Description: Asbestos Sample MHA-11 12"x12" White and Blue Floor Tile with Tan Mastic and Clear Mastic Tested Negative for Asbestos			
Photo No. 20	Date: 12/1/2021

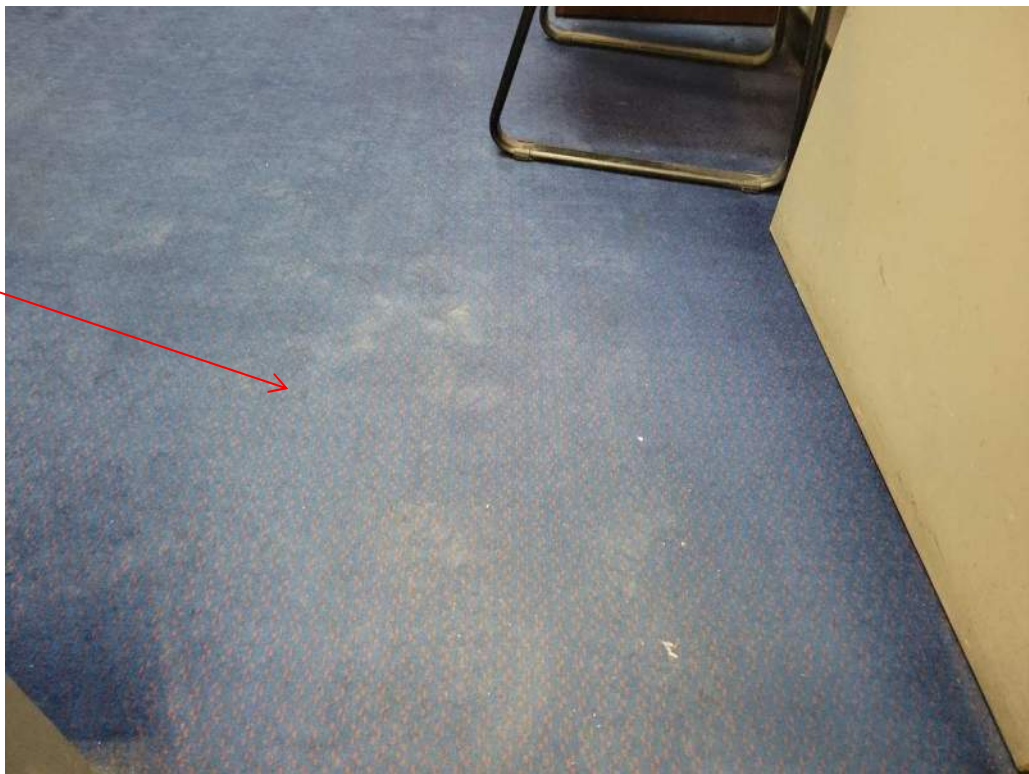
Description: Asbestos Sample MHA-12 Red and Blue Carpet with White Mastic Tested Negative for Asbestos

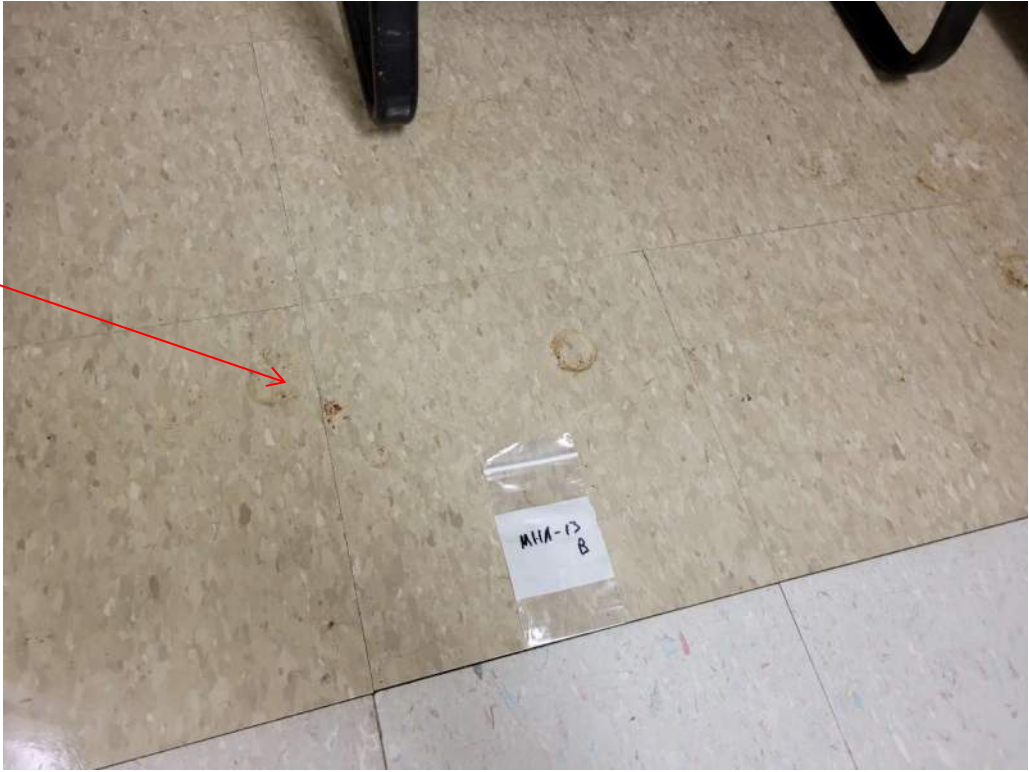
Client Name: Memphis Housing Authority		Site Location: MHA Main Offices 700 North Adams Avenue	Project No. 251214.00
Photo No. 21	Date: 12/1/2021

Description: Asbestos Sample MHA-13 12"x12" Tan Floor Tile w/ Streaks & Clear Mastic, Tan Mastic, & Brown Mastic Tested Negative for Asbestos			
Photo No. 22	Date: 12/1/2021

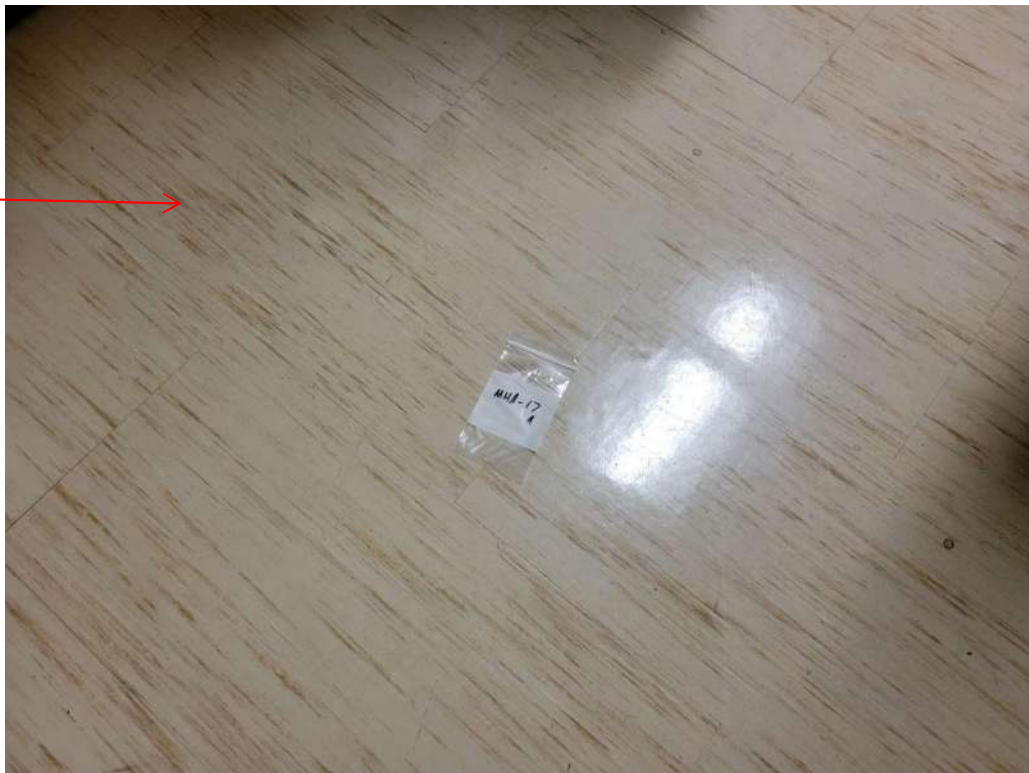
Client Name: Memphis Housing Authority		Site Location: MHA Main Offices 700 North Adams Avenue	Project No. 251214.00
Photo No. 25	Date: 12/1/2021

Description: Asbestos Sample MHA-17 12"x24" Beige Streak Floor Tile with Yellow Mastic Tested Negative for Asbestos			
Photo No. 26	Date: 12/1/2021

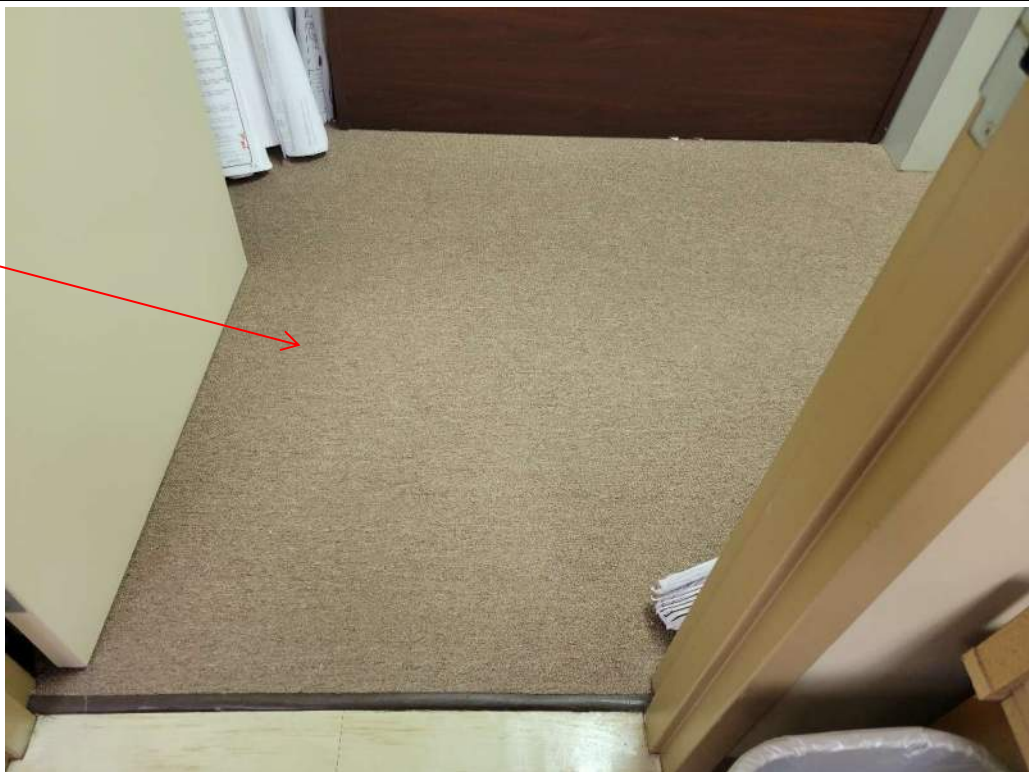
Description: Asbestos Sample MHA-18 Brown Carpet with Yellow Mastic Tested Negative for Asbestos

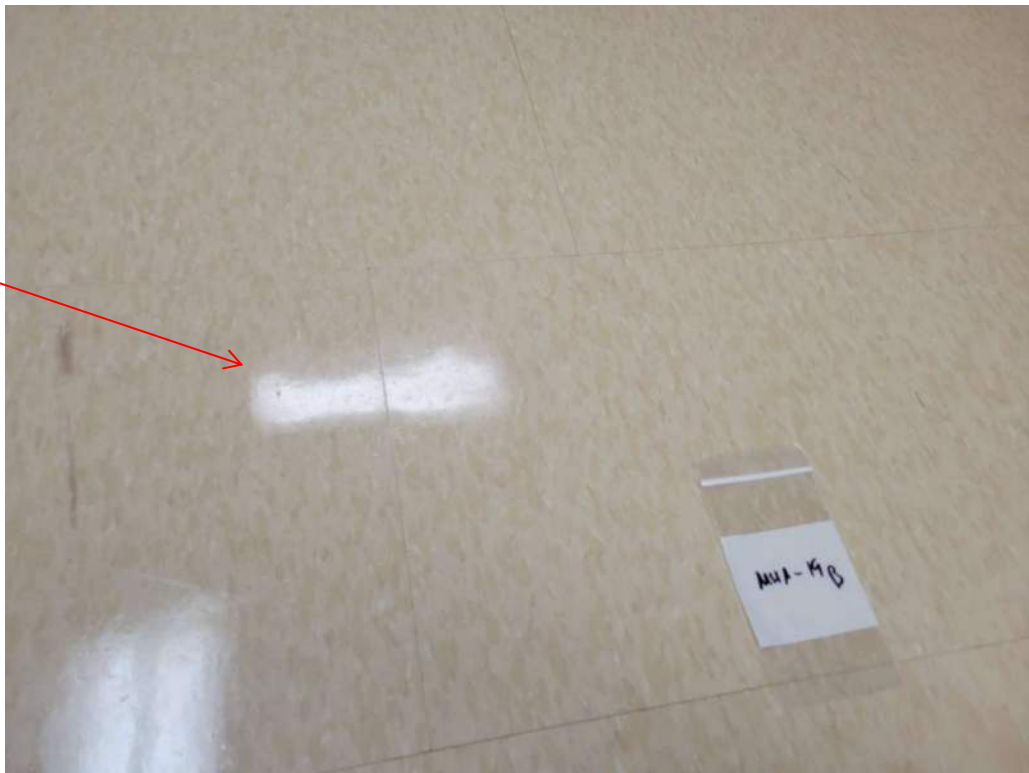
Client Name: Memphis Housing Authority		Site Location: MHA Main Offices 700 North Adams Avenue	Project No. 251214.00
Photo No. 27	Date: 12/1/2021

Description: Asbestos Sample MHA-19 12"x12" Tan and Off-white Floor Tile with Yellow Mastic and Black Mastic Tested Negative for Asbestos			
Photo No. 28	Date: 12/1/2021

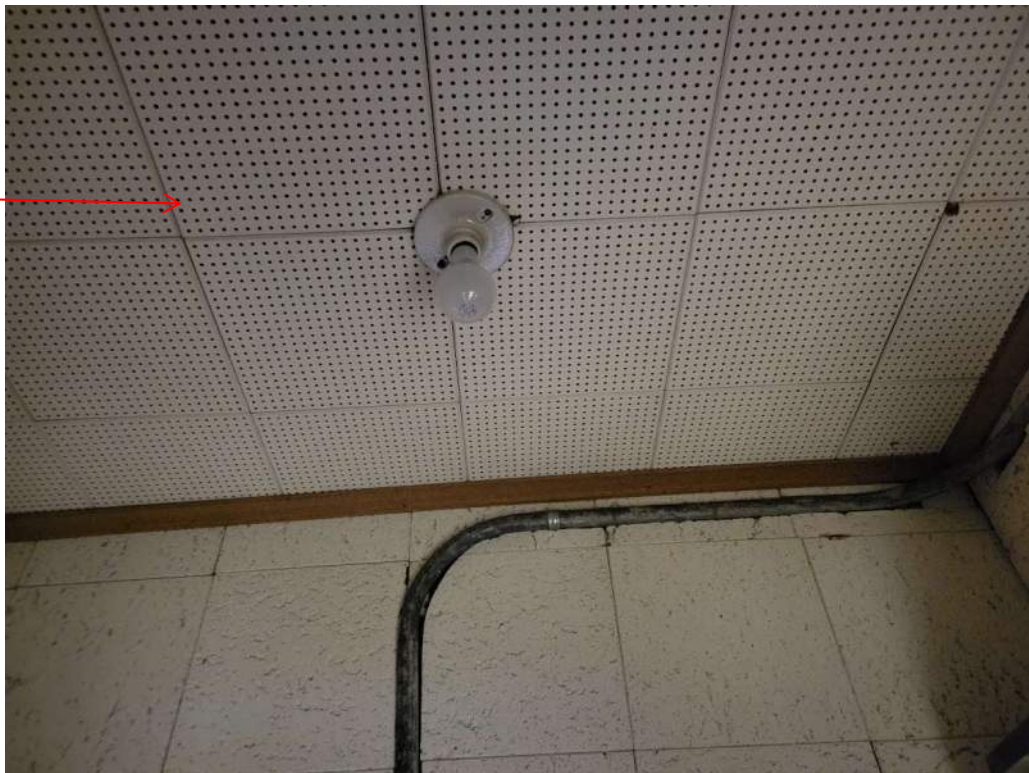
Client Name: Memphis Housing Authority		Site Location: MHA Main Offices 700 North Adams Avenue	Project No. 251214.00
Photo No. 31	Date: 12/1/2021

Description: Asbestos Sample MHA-23 1'x1' Acoustic Ceiling Tile Tested Negative for Asbestos			
Photo No. 32	Date: 12/1/2021

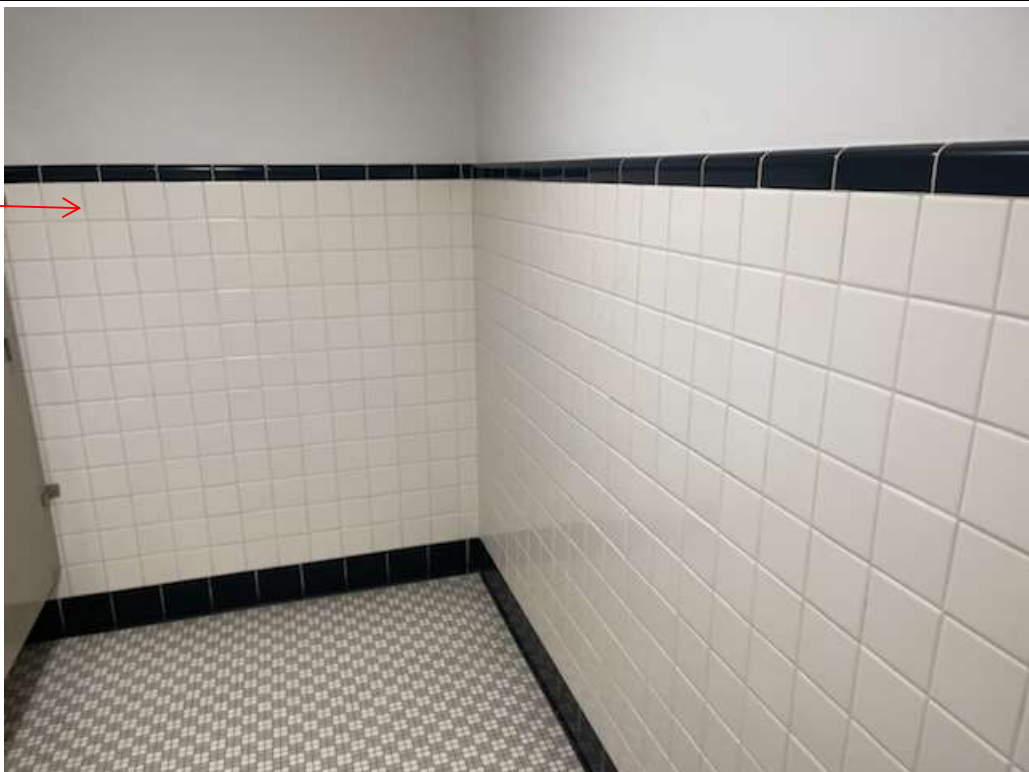
Description: Asbestos Sample MHA-24 6" Black and White Wall Tile; White Grout Tested Negative for Asbestos

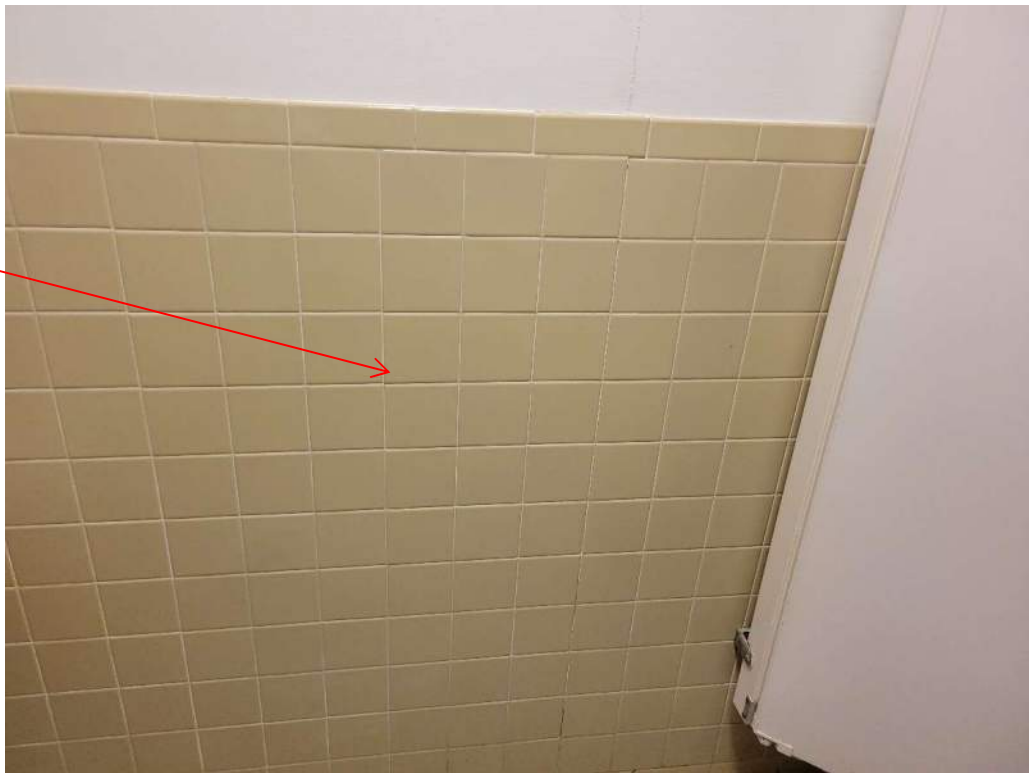
Client Name: Memphis Housing Authority		Site Location: MHA Main Offices 700 North Adams Avenue	Project No. 251214.00
Photo No. 35	Date: 12/1/2021

Description: Asbestos Sample MHA-27 6" Olive Wall Tile with White Grout (1 st Floor) Tested Negative for Asbestos			
Photo No. 36	Date: 12/1/2021

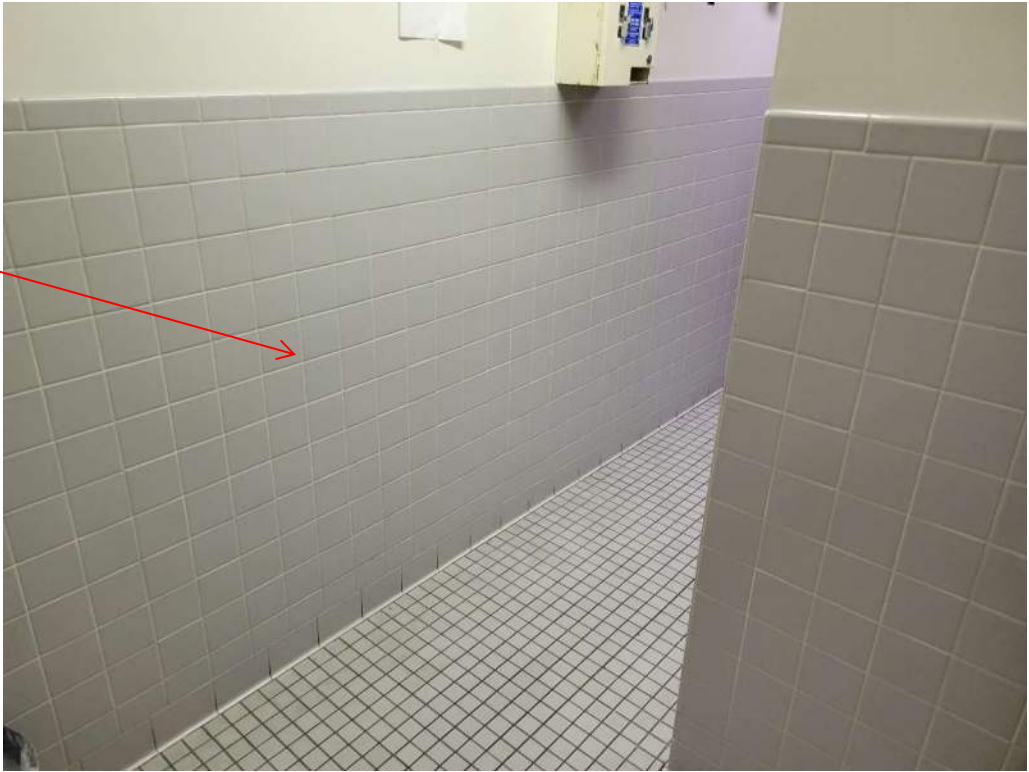
Client Name: Memphis Housing Authority		Site Location: MHA Main Offices 700 North Adams Avenue	Project No. 251214.00
Photo No. 37	Date: 12/1/2021

Description: Asbestos Sample MHA-29 6" Grey Ceramic Wall Tile with White Grout Tested Negative for Asbestos			
Photo No. 38	Date: 12/1/2021

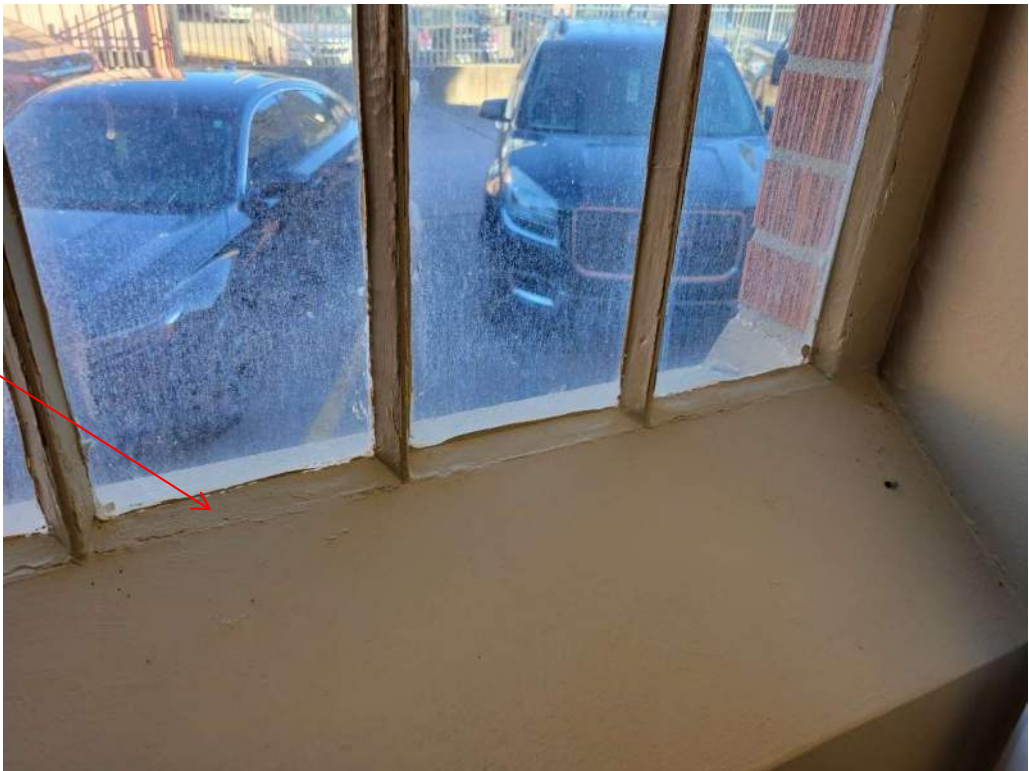
Description: Asbestos Sample MHA-30 White Interior Window Glaze Tested Negative for Asbestos

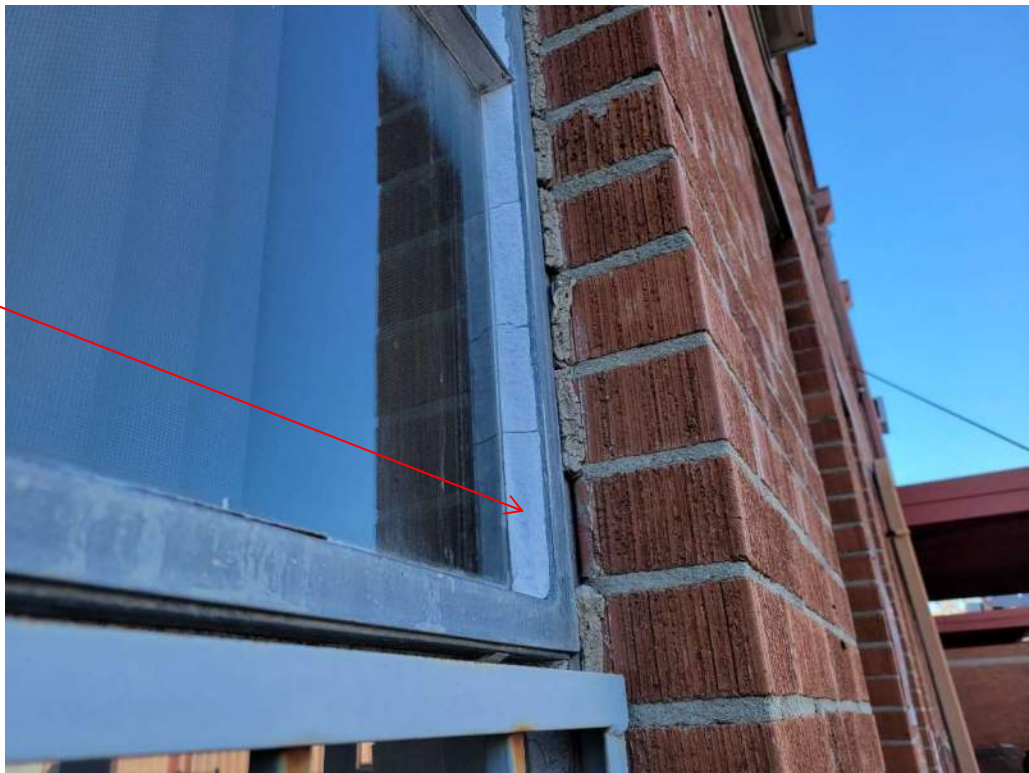
Client Name: Memphis Housing Authority		Site Location: MHA Main Offices 700 North Adams Avenue	Project No. 251214.00
Photo No. 39	Date: 12/1/2021

Description: Asbestos Sample MHA-31 White Exterior Window Glaze Tested Negative for Asbestos			
Photo No. 40	Date: 12/1/2021

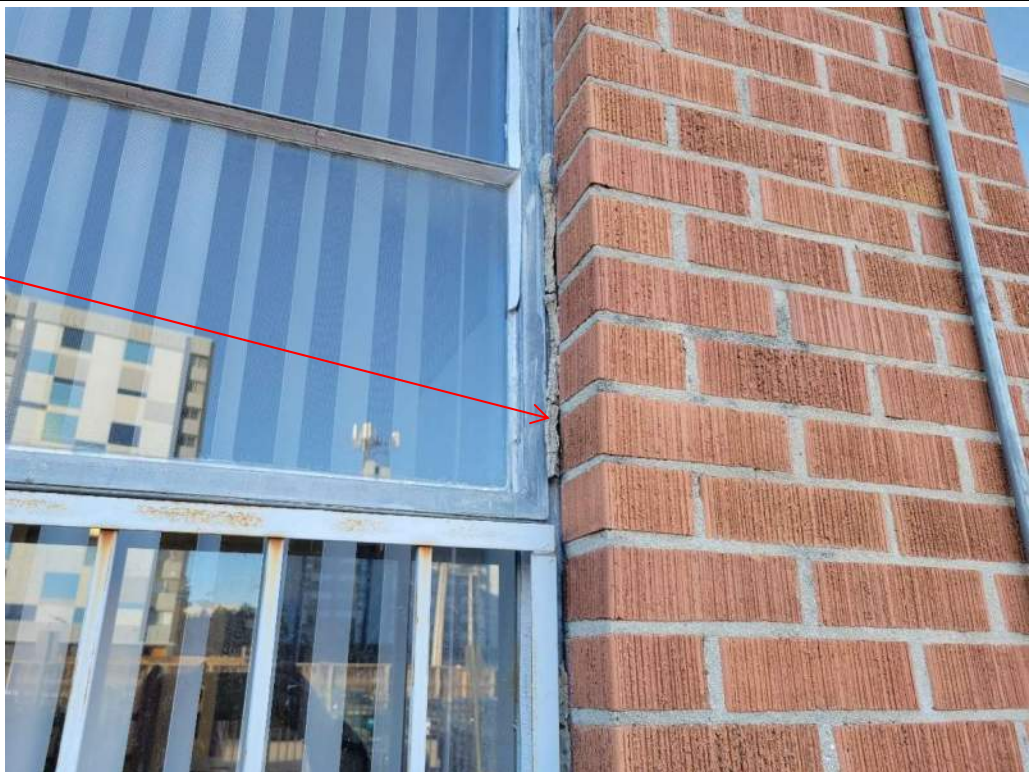
- Interior window caulk found in the 2nd floor windows, grey exterior window caulk found in all exterior windows, and black roof tar are non-friable Category I materials. If the scope of the renovation will disturb asbestos containing window caulk, these materials must be removed by a licensed asbestos abatement contractor prior to renovation activities.

Description: Asbestos Sample MHA-32 Grey Exterior Window Caulk Tested Positive for Asbestos

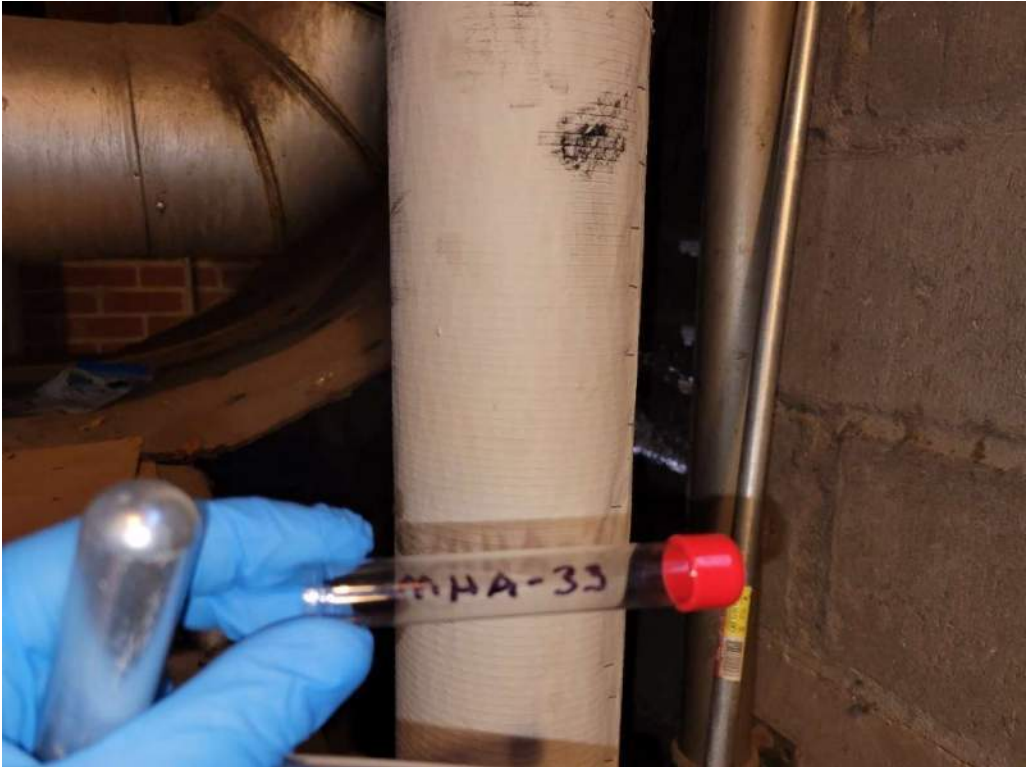
Client Name: Memphis Housing Authority		Site Location: MHA Main Offices 700 North Adams Avenue	Project No. 251214.00
Photo No. 41	Date: 12/1/2021

Description: Asbestos Sample MHA-33 6" White TSI Pipe Insulation Tested Negative for Asbestos			
Photo No. 42	Date: 12/1/2021

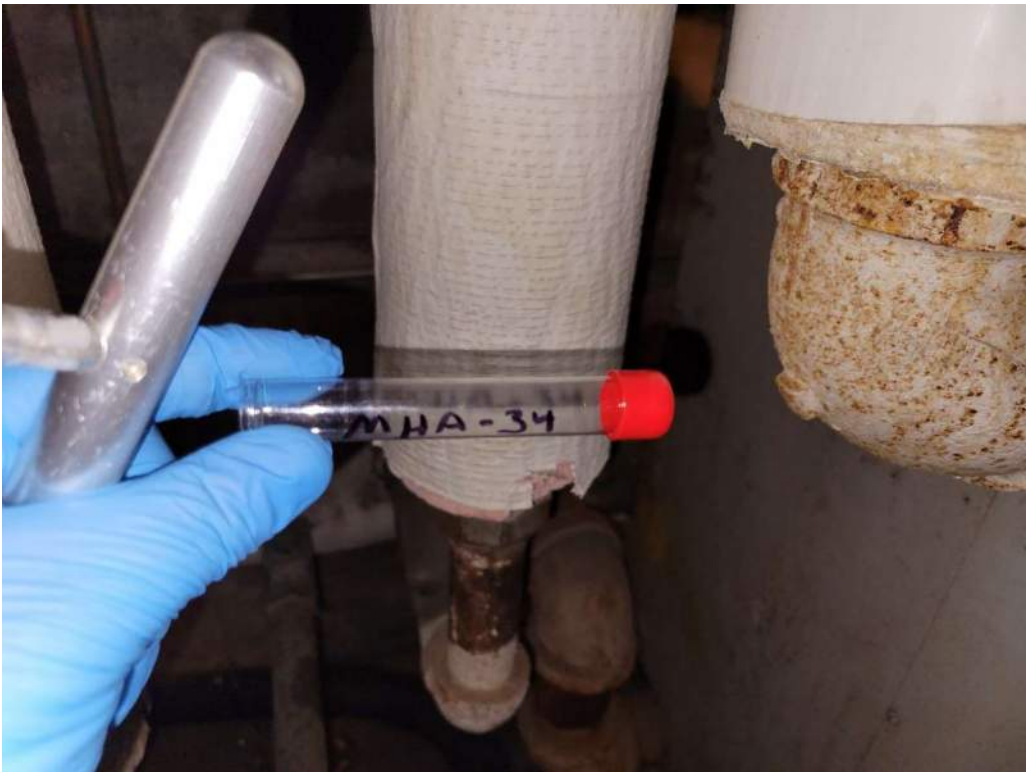
Description: Asbestos Sample MHA-34 6" TSI Pink Pipe Insulation Tested Negative for Asbestos

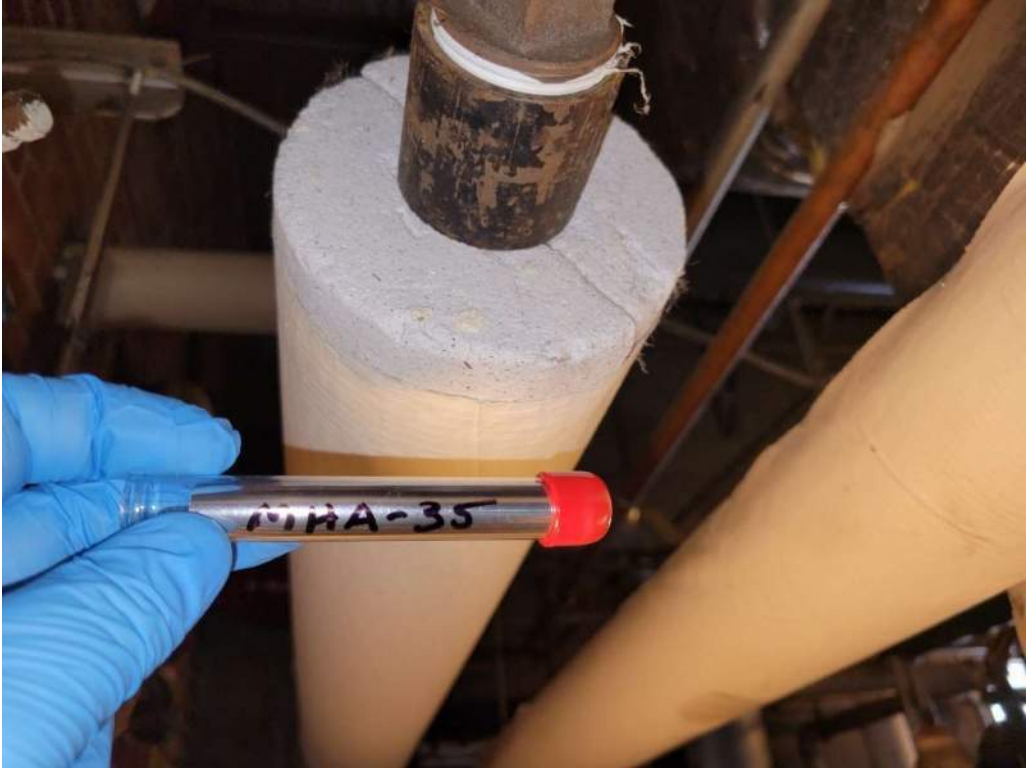
Client Name: Memphis Housing Authority		Site Location: MHA Main Offices 700 North Adams Avenue	Project No. 251214.00
Photo No. 43	Date: 9/27/2021

Description: Asbestos Sample MHA-35 6" TSI White Pipe Insulation Tested Negative for Asbestos			
Photo No. 44	Date: 9/27/2021

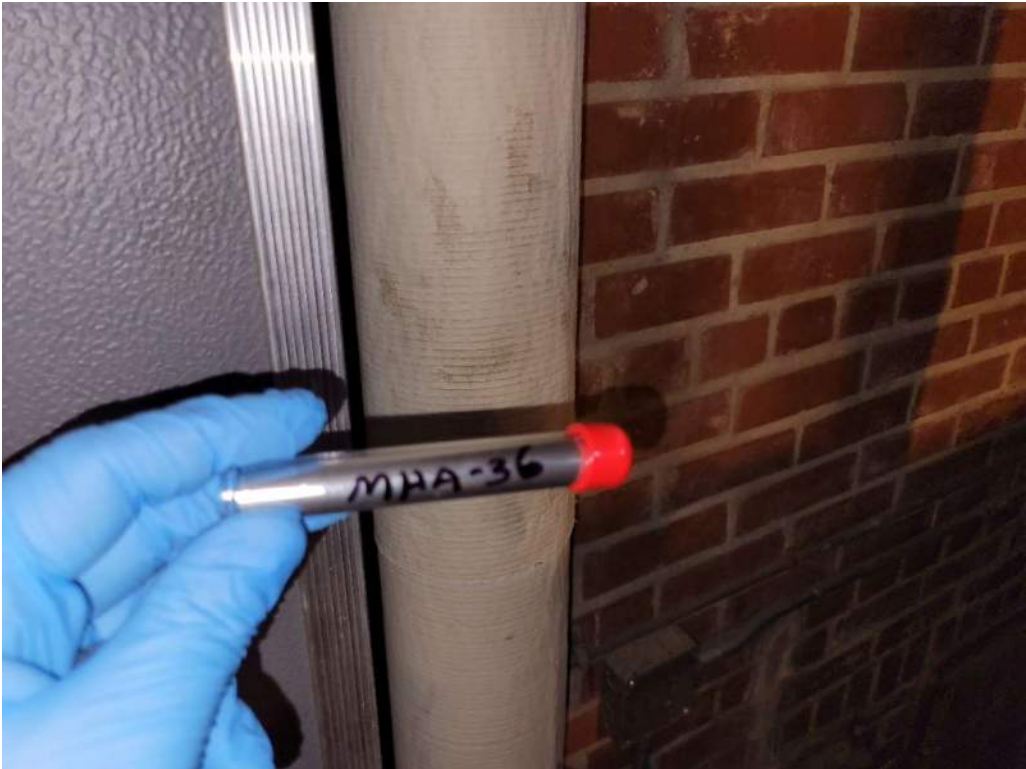
Description: Asbestos Sample MHA-36 8" TSI White Pipe Insulation Tested Negative for Asbestos

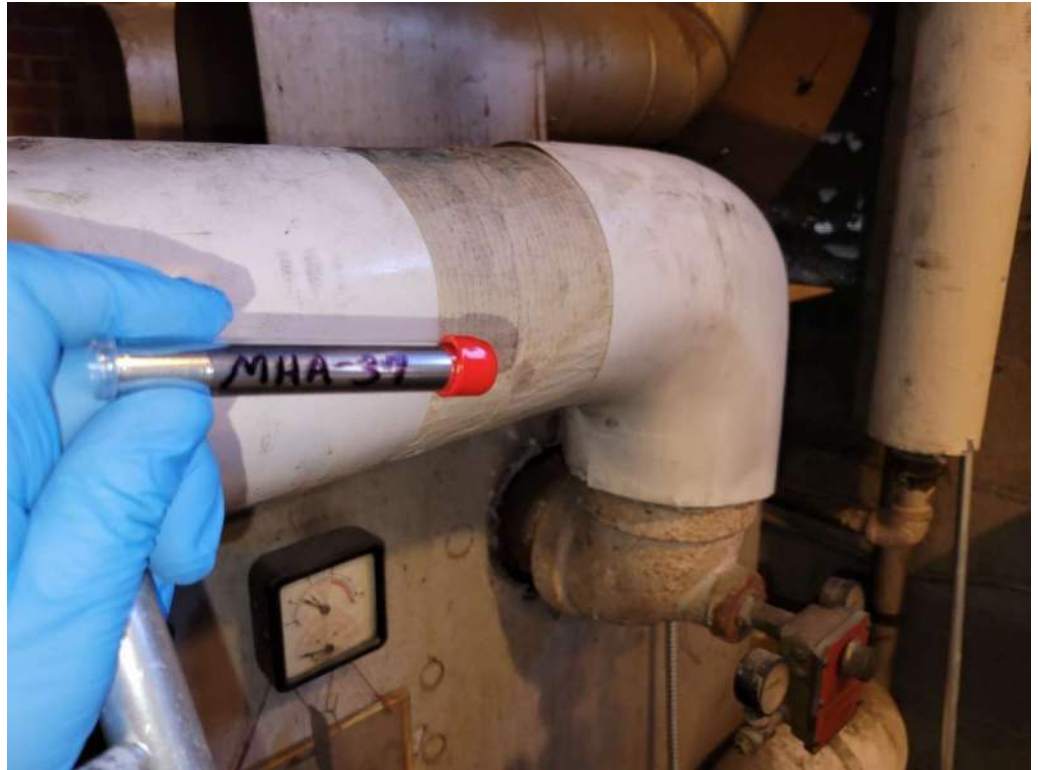
10" TSI Pink Pipe
 Insulation

Tested Negative for
 Asbestos

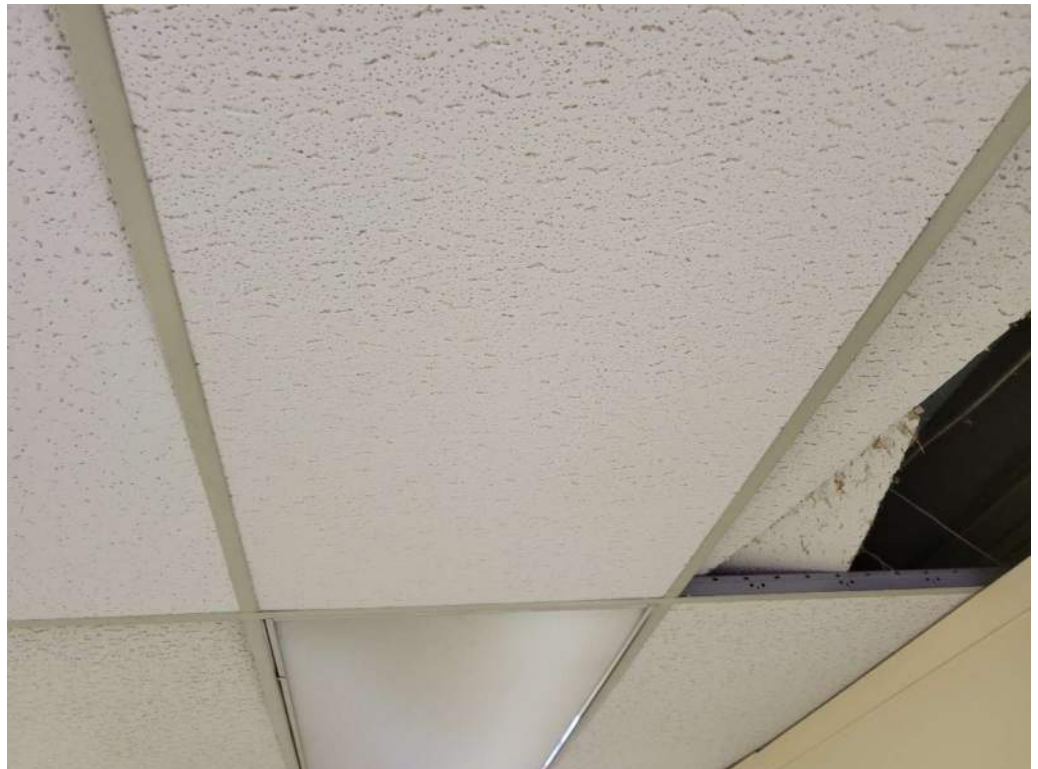
Photo No.
46
Date:
 12/1/2021

2'x4' White Fissure/Pinhole
 Ceiling Tile

Tested Negative for
 Asbestos

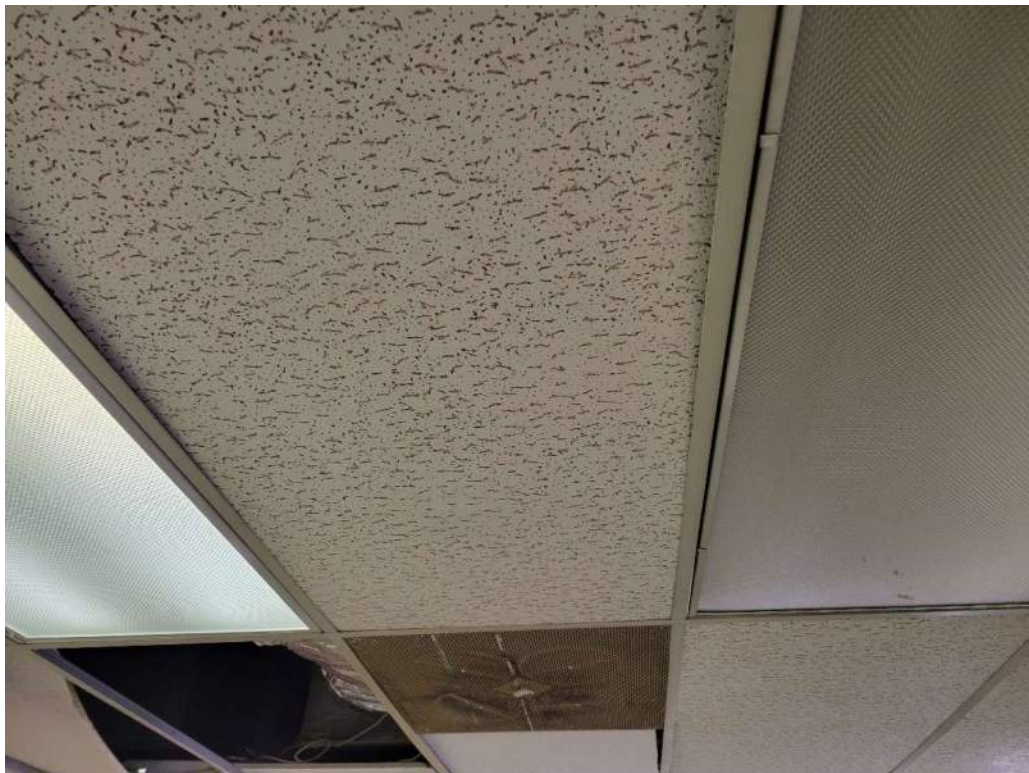
Client Name: Memphis Housing Authority		Site Location: MHA Main Offices 700 North Adams Avenue	Project No. 251214.00
Photo No. 47	Date: 12/1/2021

Description: Asbestos Sample MHA-39 2'x4' White Fissure/Pinhole Ceiling Tile #2 Tested Negative for Asbestos			
Photo No. 48	Date: 12/1/2021

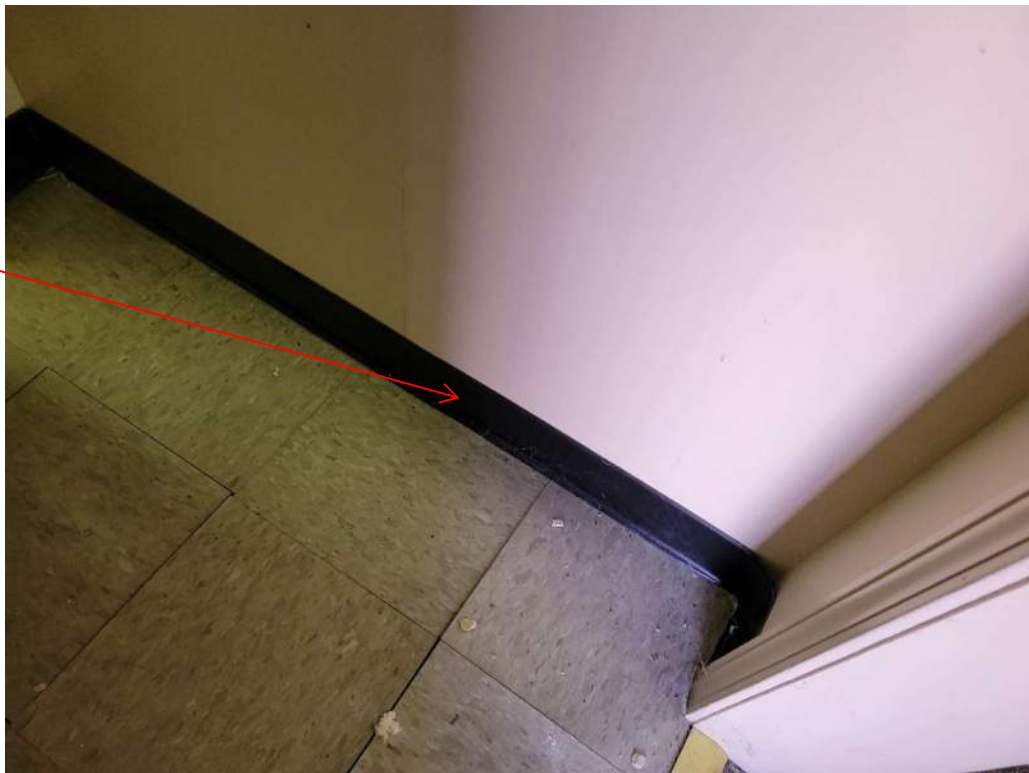
Client Name: Memphis Housing Authority		Site Location: MHA Main Offices 700 North Adams Avenue	Project No. 251214.00
Photo No. 49	Date: 12/1/2021

Description: Asbestos Sample MHA-41 4" Black Base Cove with Yellow with Off-white mastic Tested Negative for Asbestos			
Photo No. 50	Date: 12/1/2021

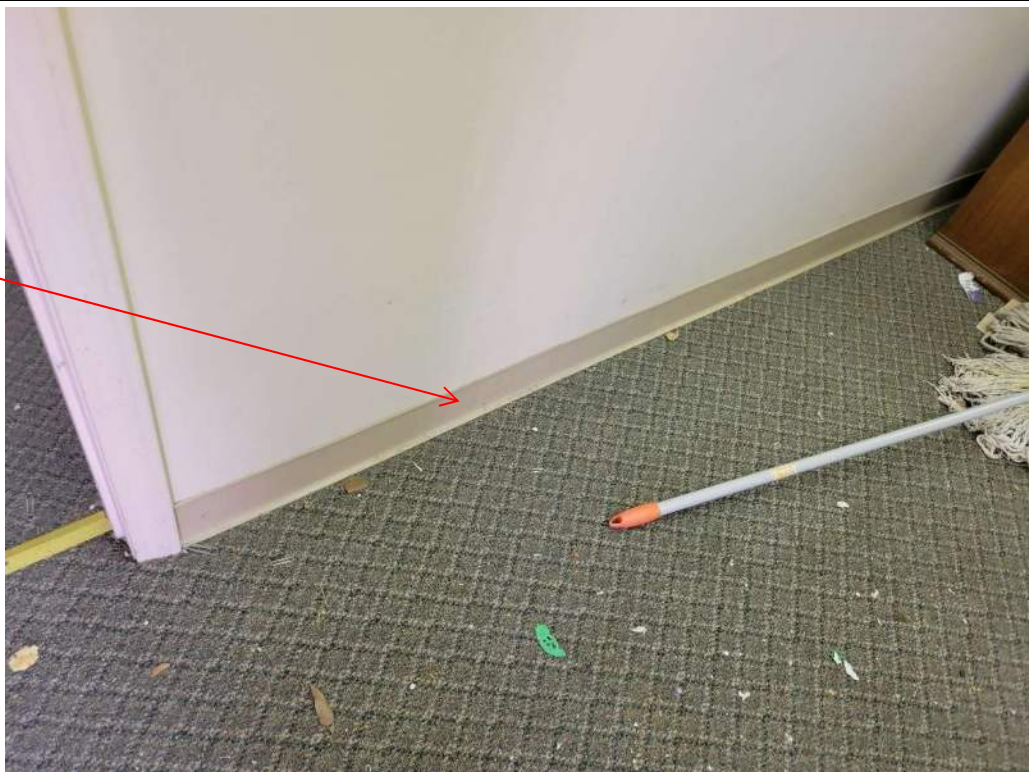
Description: Asbestos Sample MHA-42 4" Beige Base Cove with Yellow with Off-white Mastic Tested Negative for Asbestos
