ADDENDUM NO. 1

**MHA Central Office
Window, Lighting, and HVAC Renovation
Memphis, TN**

**RE: Hazardous Material Survey
Memphis Housing Authority
700 Adams Avenue
Memphis, Tennessee 38105**

Hazardous Materials Survey

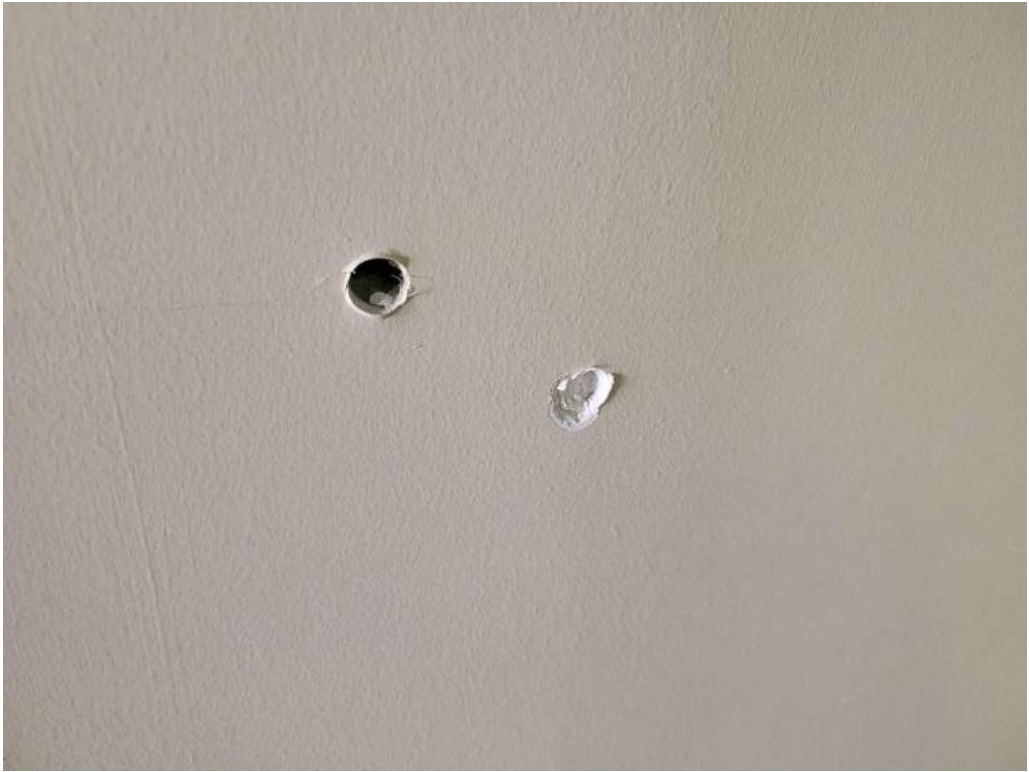
Client Name: Memphis Housing Authority		Site Location: MHA Main Offices 700 North Adams Avenue	Project No. 251214.00
Photo No. 51	Date: 12/1/2021

Description: Asbestos Sample MHA-43 Drywall with Joint Compound Tested Negative for Asbestos			
Photo No. 52	Date: 12/1/2021

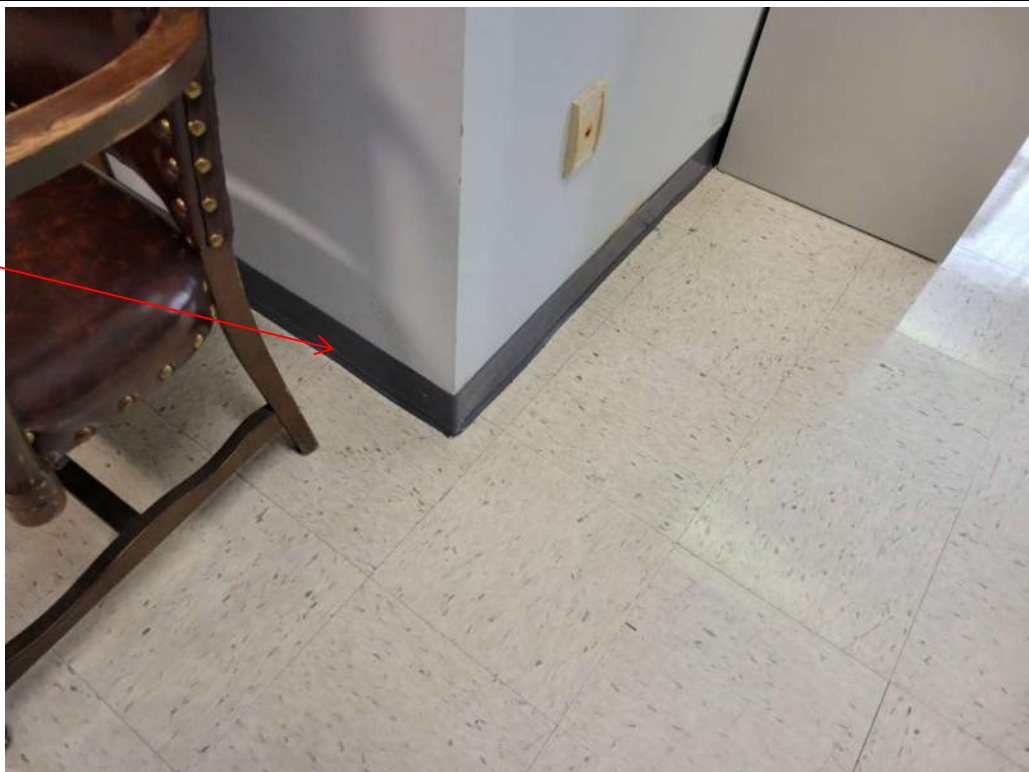
Description: Asbestos Sample MHA-46 4" Grey Base Cove with Beige Mastic Tested Negative for Asbestos

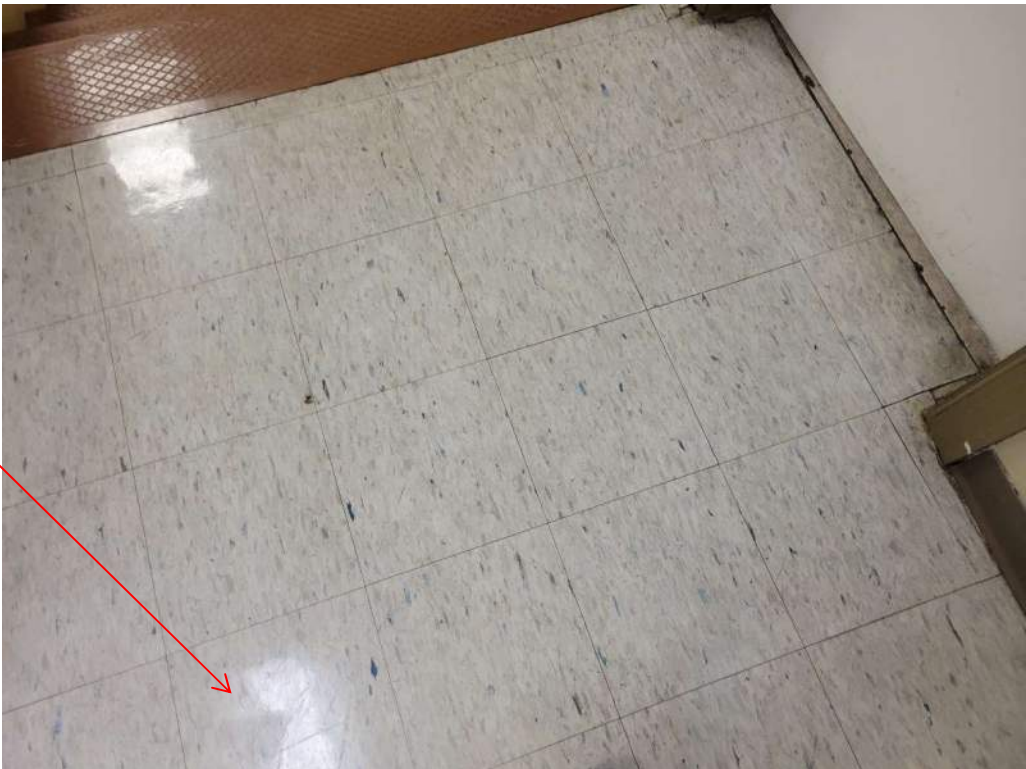
Description: Asbestos Sample MHA-64 12'x12' White Floor Tile w/ Blue Streaks with Black Mastic Tested Positive for Asbestos

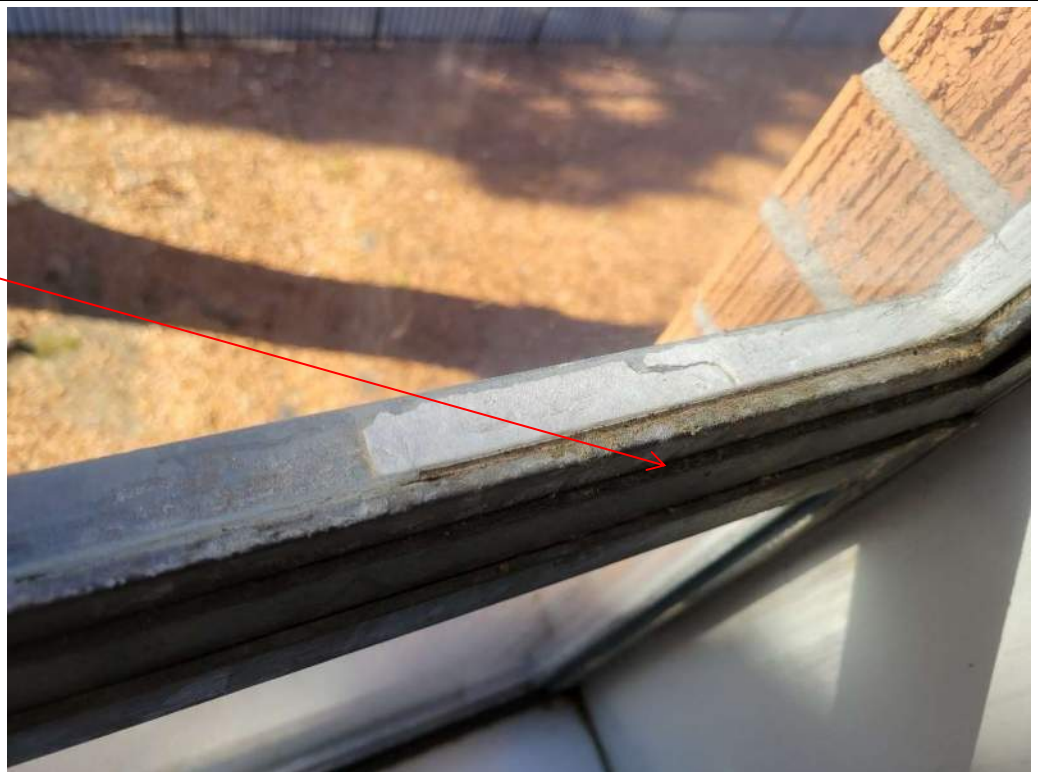
- Interior window caulk found in the 2nd floor windows, grey exterior window caulk found in all exterior windows, and black roof tar are non-friable Category I materials. If the scope of the renovation will disturb asbestos containing window caulk, these materials must be removed by a licensed asbestos abatement contractor prior to renovation activities.

Interior Aluminum Window
Caulk (2nd Floor)

Tested Positive for
Asbestos

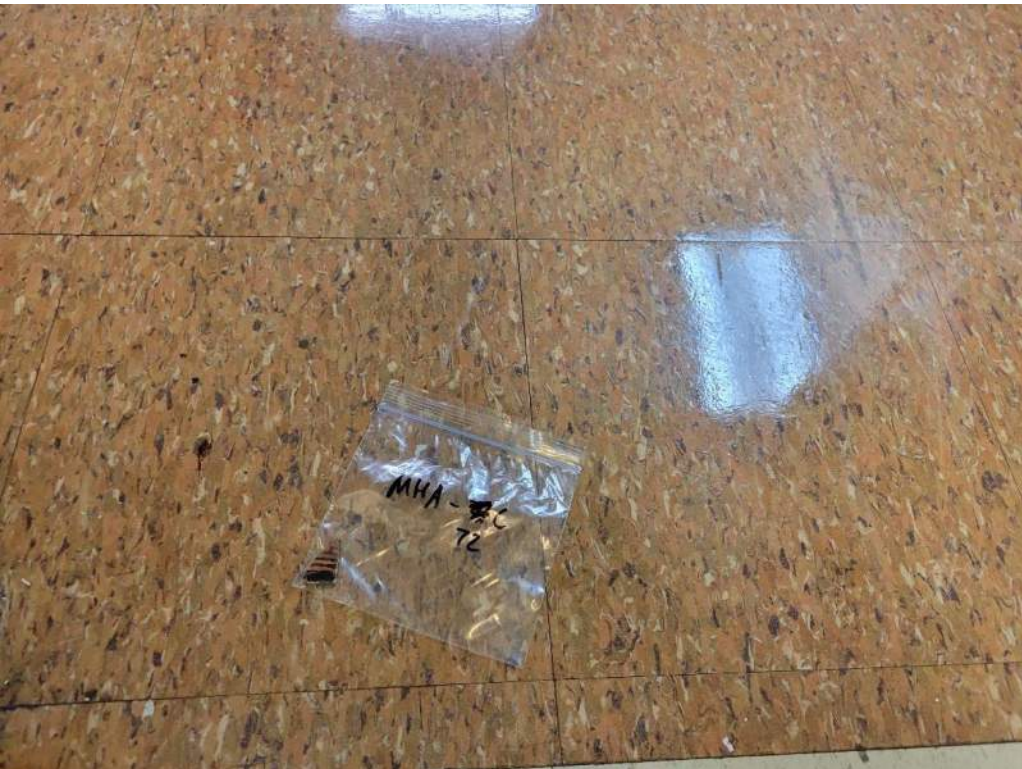
Description: Asbestos Sample MHA-72 12"x12" Mauve Floor Tile; Black Mastic Tested Positive for Asbestos

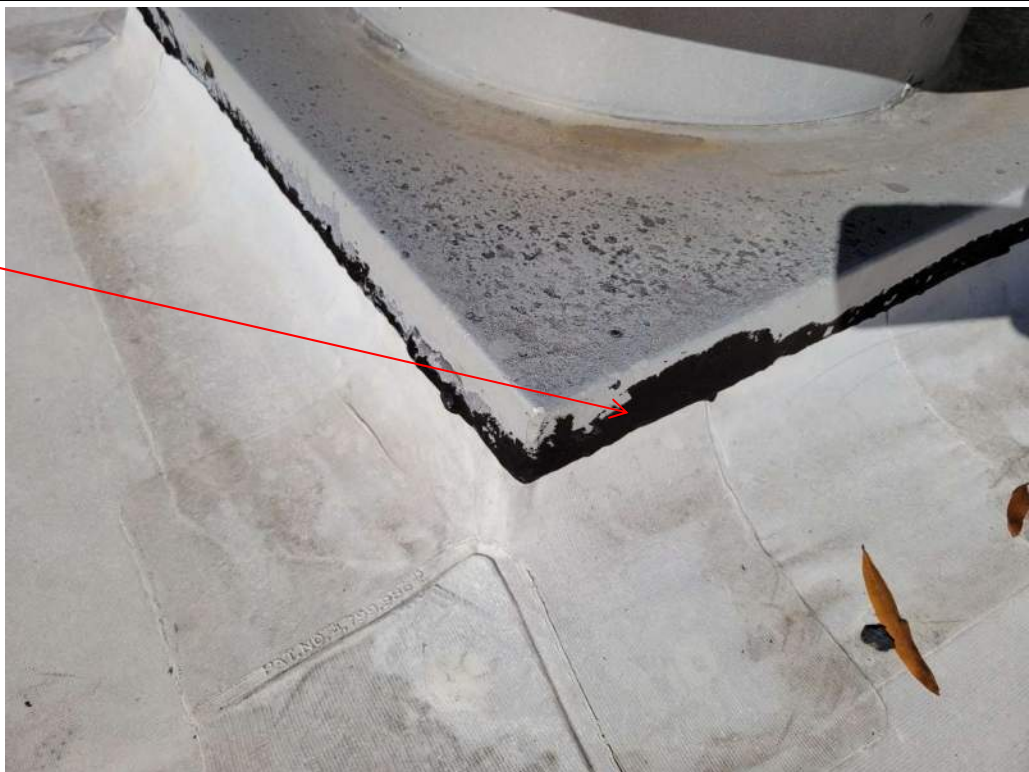
Description: Asbestos Sample MHA-84 Roof Tar Tested Negative for Asbestos Identified as ACM during 2008 Survey

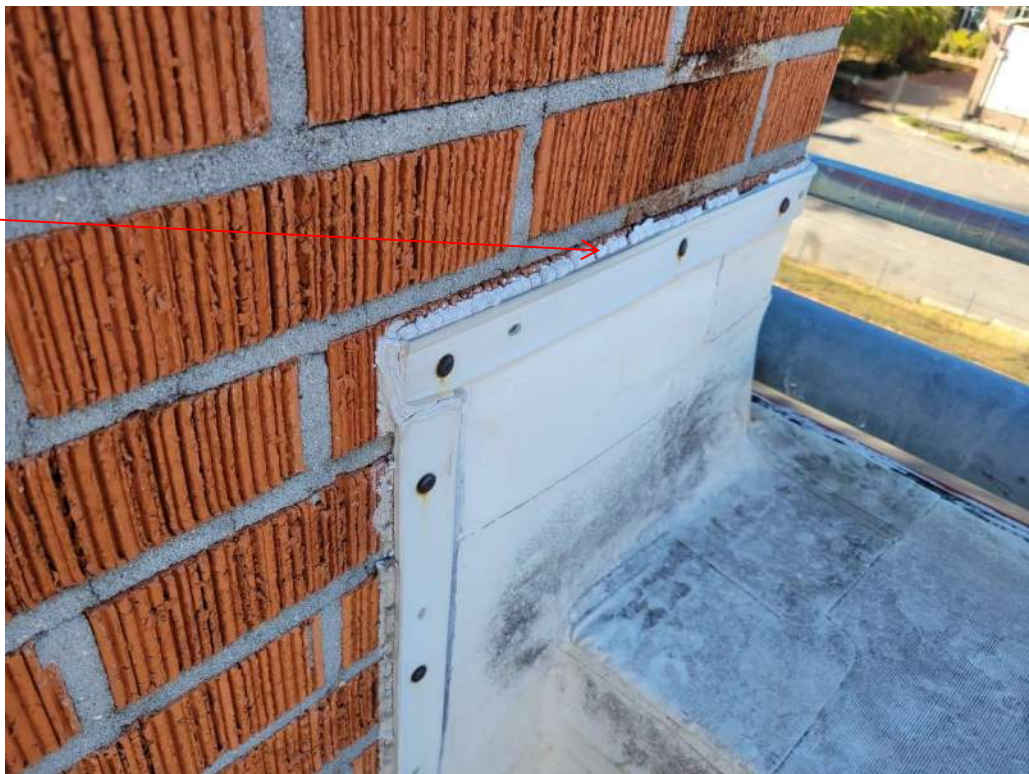
Description: Asbestos Sample MHA-86 White Roof Flashing #2 (older in appearance) Tested Negative for Asbestos

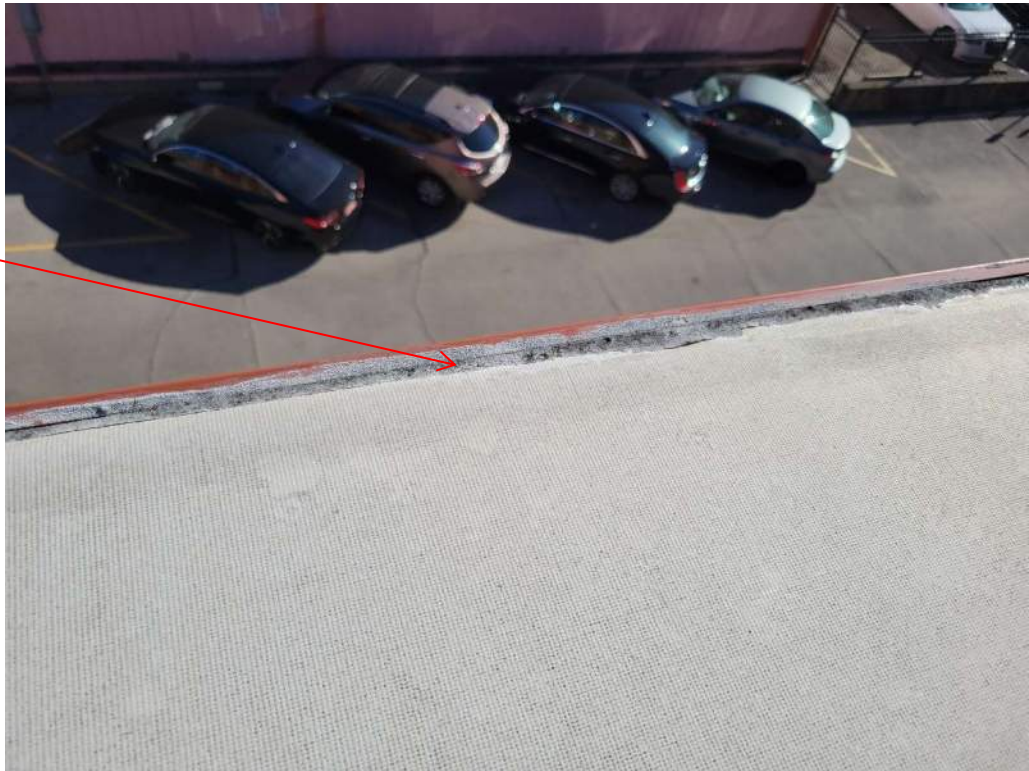
Client Name: Memphis Housing Authority		Site Location: MHA Main Offices 700 North Adams Avenue	Project No. 251214.00
Photo No. 95	Date: 12/1/2021

Description: Asbestos Sample MHA-87 White Roof Caulk Tested Negative for Asbestos			
Photo No. 96	Date: 12/1/2021

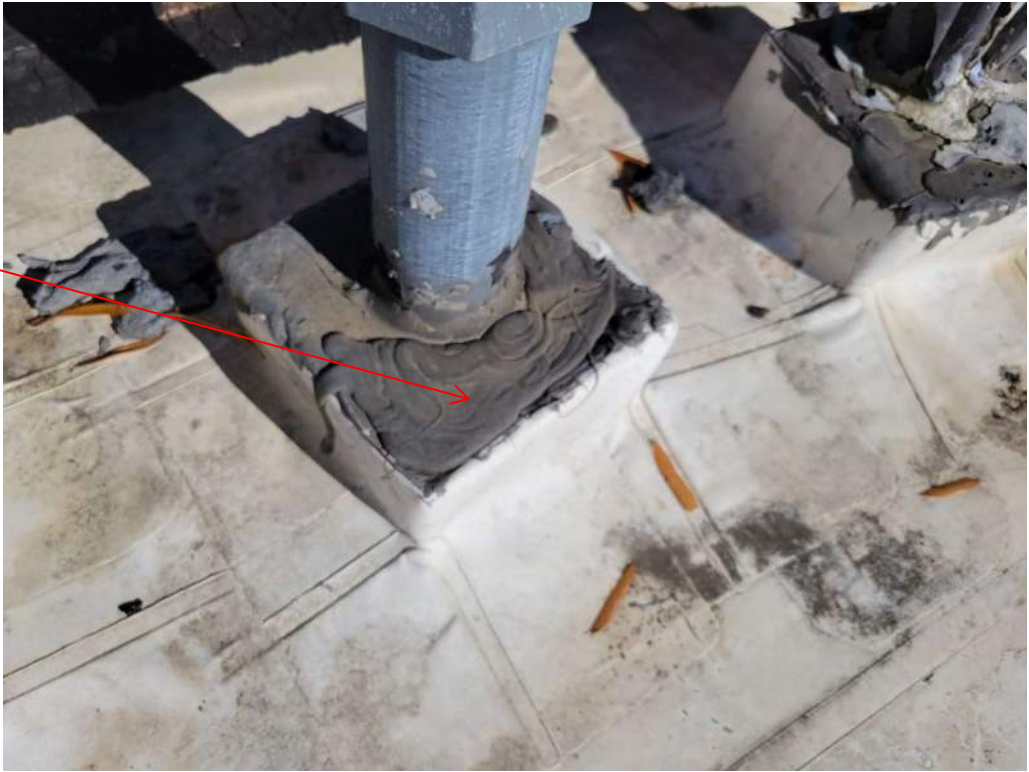
Client Name: Memphis Housing Authority		Site Location: MHA Main Offices 700 North Adams Avenue	Project No. 251214.00
Photo No. 97	Date: 12/1/2021

Description: Asbestos Sample MHA-89 Black and Grey HVAC Caulk Tested Negative for Asbestos			
Photo No. 98	Date: 12/1/2021

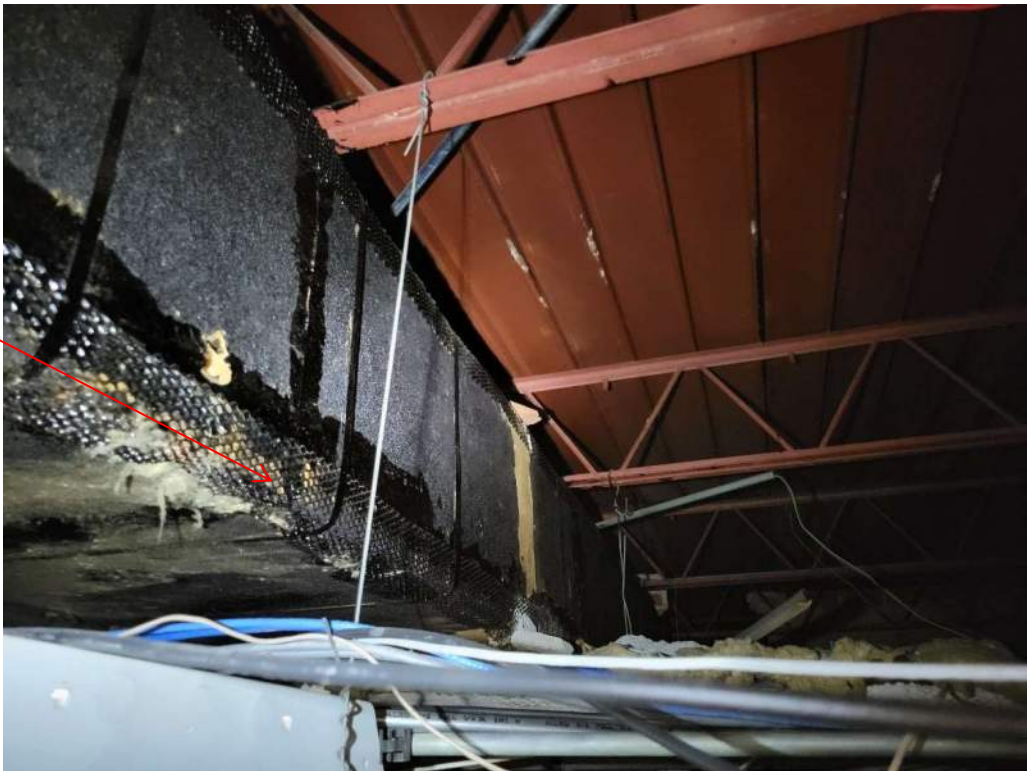
Description: Asbestos Sample MHA-90 Black HVAC Condensate Coating Tested Negative for Asbestos

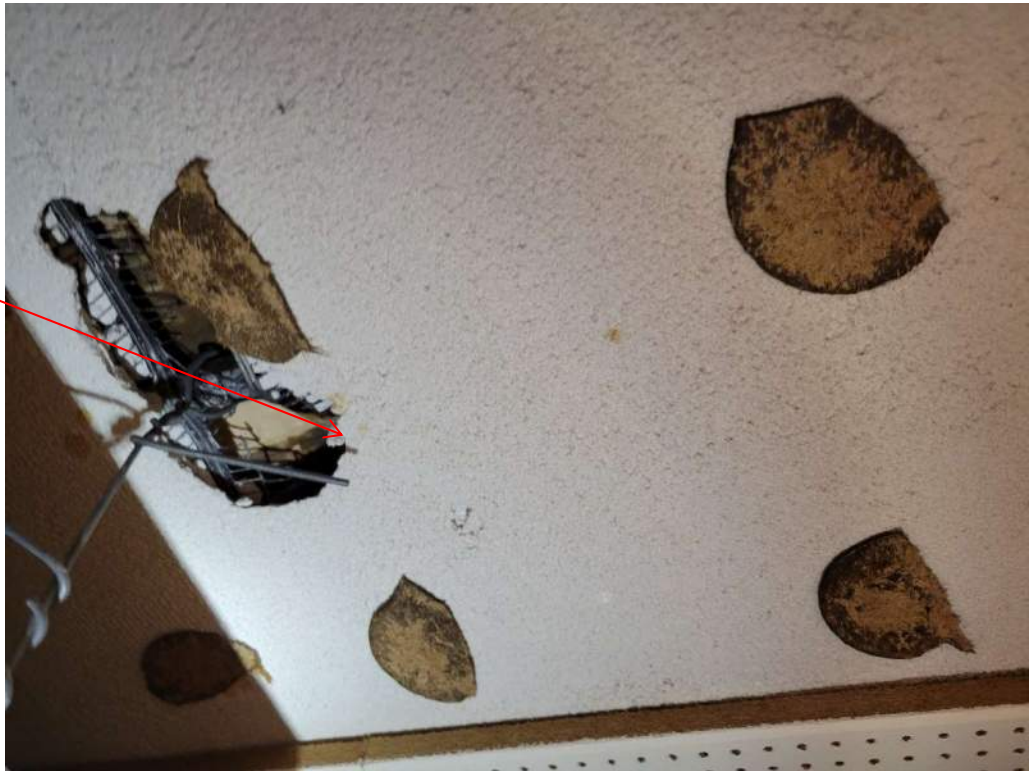
Client Name: Memphis Housing Authority		Site Location: MHA Main Offices 700 North Adams Avenue	Project No. 251214.00
Photo No. 99	Date: 12/1/2021

Description: Asbestos Sample MHA-91 White Ceiling Plaster Tested Negative for Asbestos			
Photo No. 100	Date: 12/1/2021

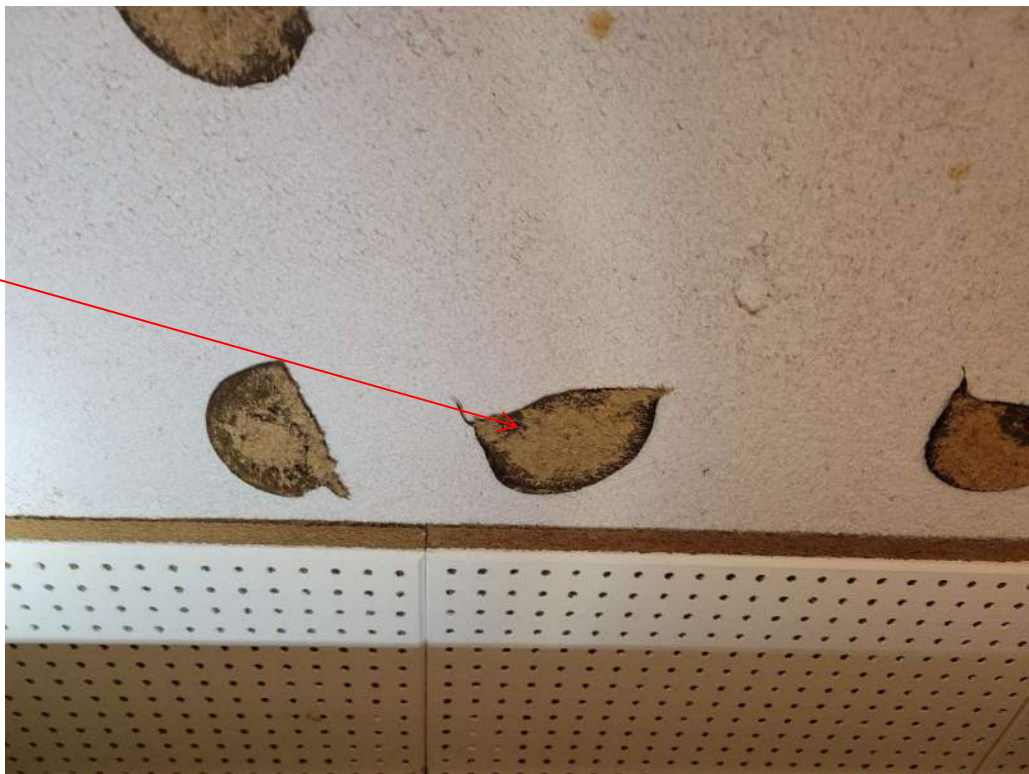
Description: Asbestos Sample MHA-92 Brown Ceiling Tile Glue Dots Tested Negative for Asbestos

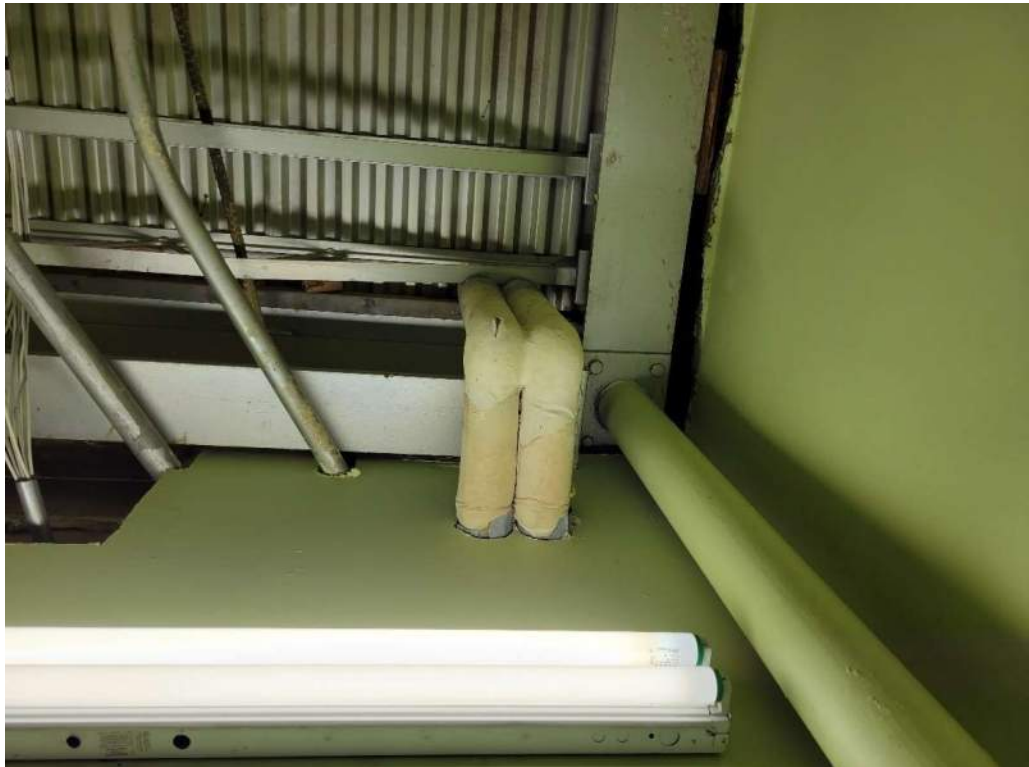
Client Name: Memphis Housing Authority		Site Location: MHA Main Offices 700 North Adams Avenue	Project No. 251214.00
Photo No. 101	Date: 12/1/2021

Description: 1 st Floor Pipe Wrap Insulation Located in 1 st Floor Elevator Closet Identified as ACM during 2008 Survey			
Photo No. 102	Date: 12/1/2021

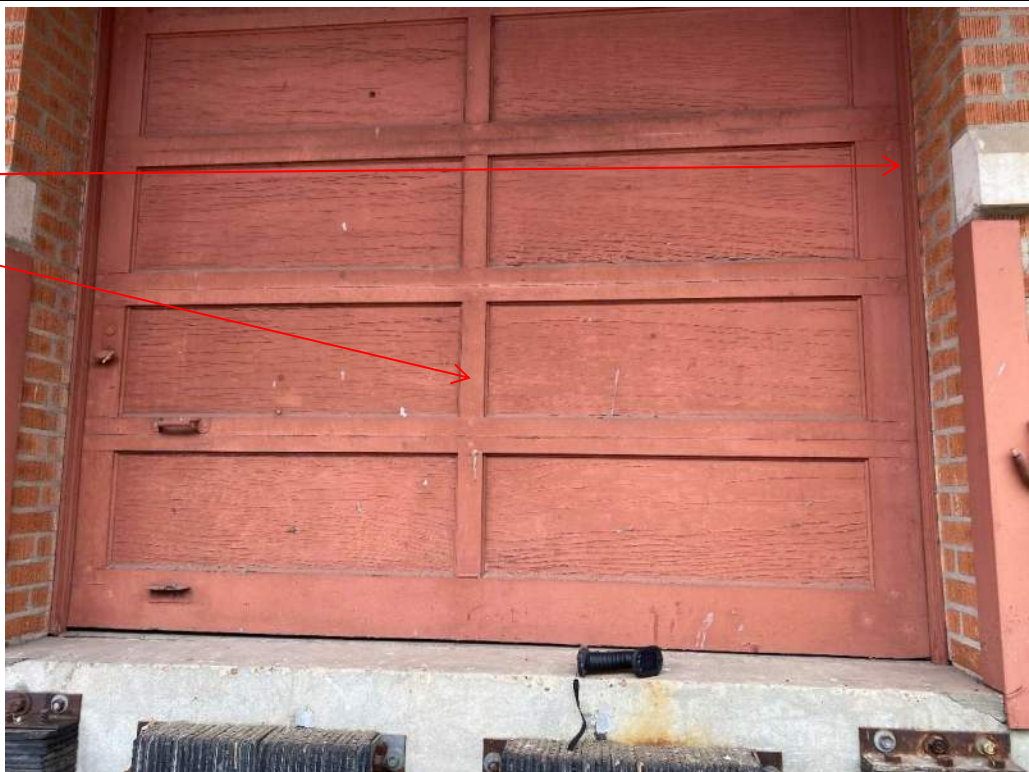
Description: "B" Side Exterior Garage Door & Garage Casing Tested Positive for Lead Based Paint

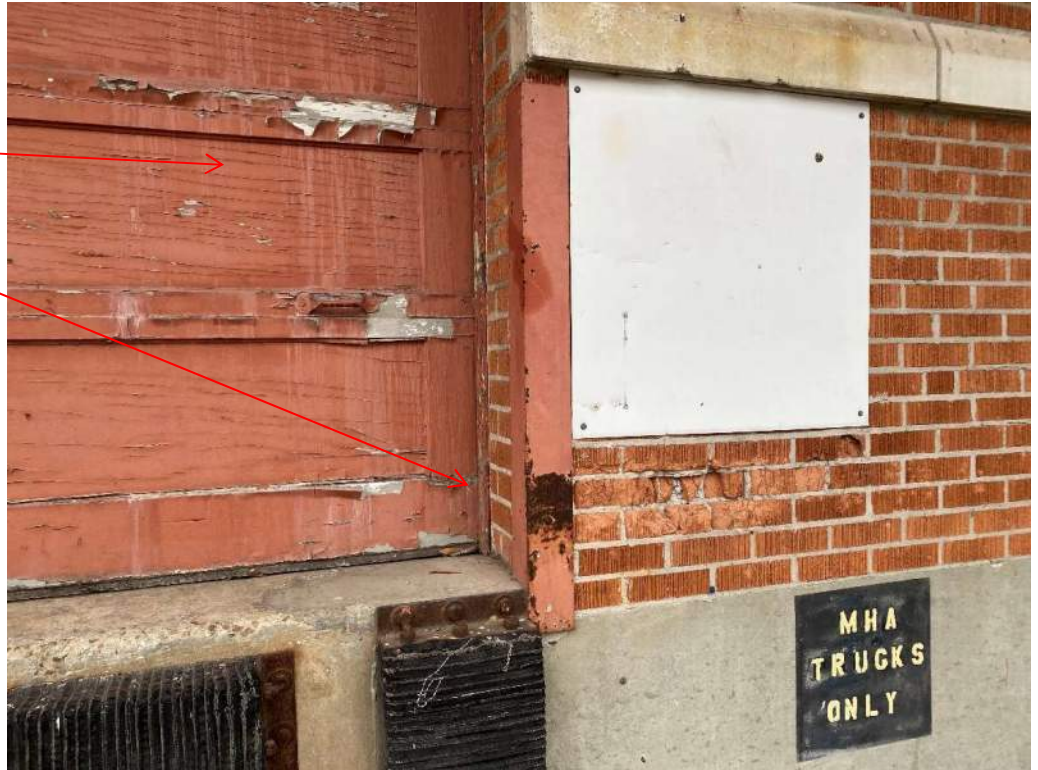
"C" Side Garage Door &
Casing

Tested Positive for Lead
Based Paint

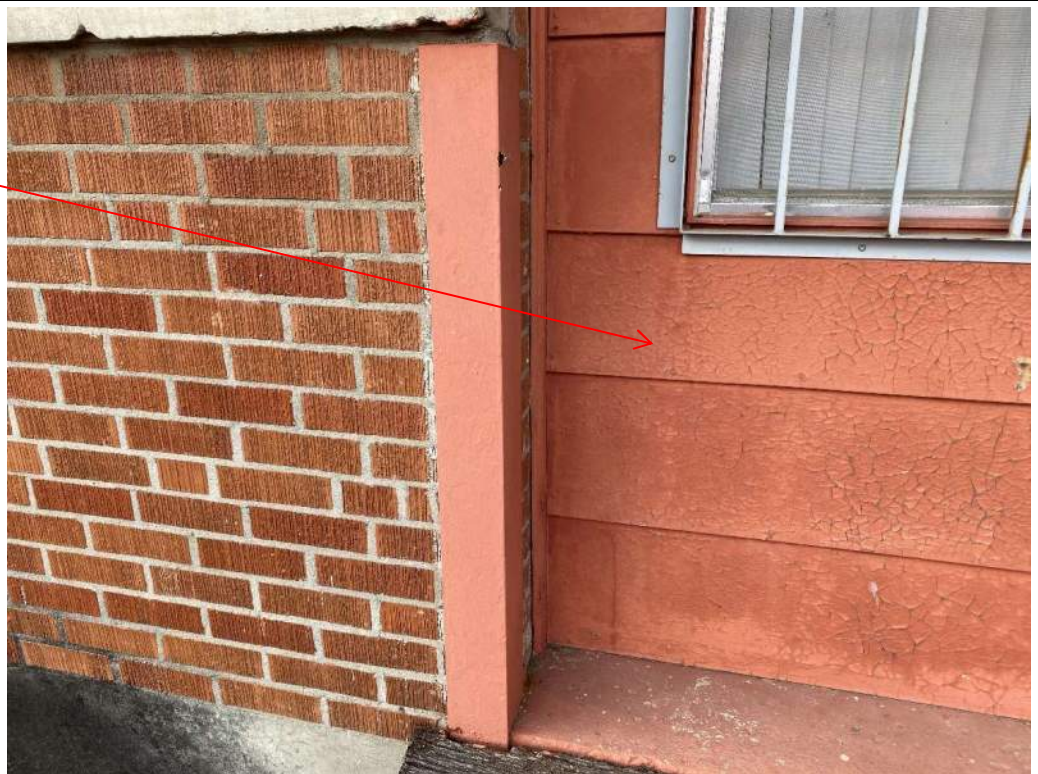
"D" Side Wall Trim

Tested Positive for Lead
Based Paint

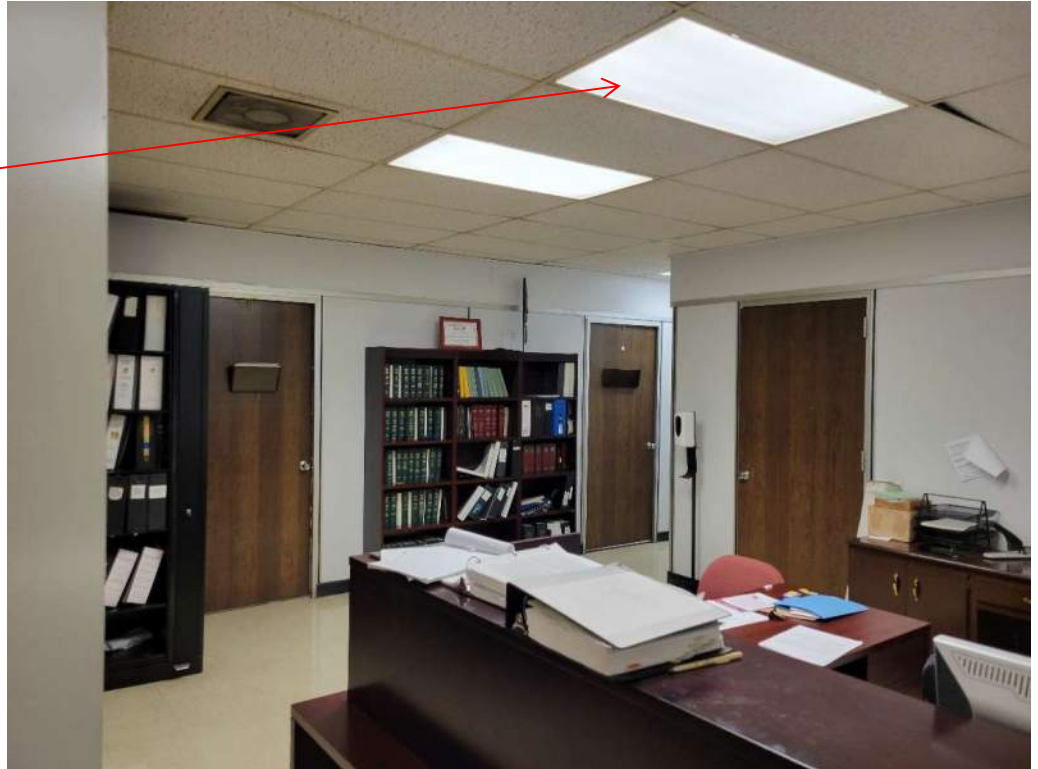
Example of Mercury
 Containing Fluorescent
 Light Bulbs

Potentially Hazardous
 Material

- Mercury-containing bulbs and thermostats must be properly recycled or disposed of as universal waste.
- Refrigerants must be recovered for reuse or proper disposal by an EPA-certified technician prior to removal. Refrigerants contained in small appliances may be recovered at the final disposal facility.
- PCB-containing ballasts must be removed prior to demolition and will require proper disposal as hazardous wastes per federal regulations. Many observed ballasts appeared to be PCB free, however, ballast without “Non PCB” labelling found during renovation activities must be disposed of as hazardous waste.
- Batteries must be properly disposed of as universal waste.

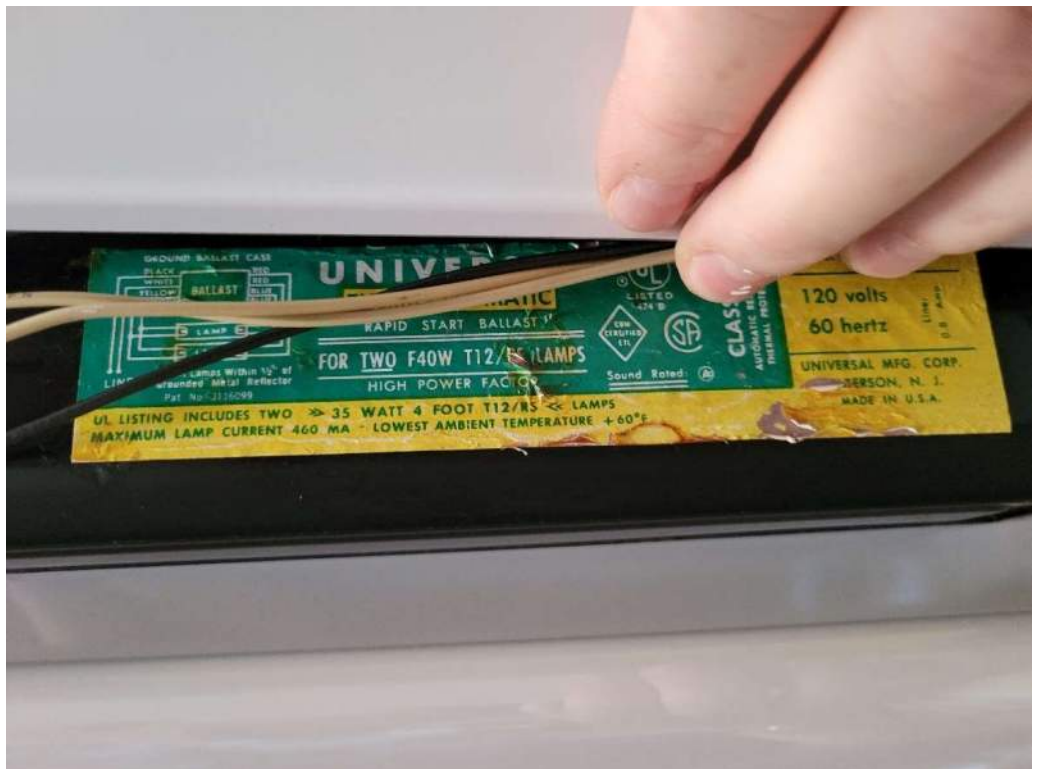
Example of Fluorescent
 Light Fixture Electric
 Ballast

Possible PCBs if no "Non-
 PCB" Label

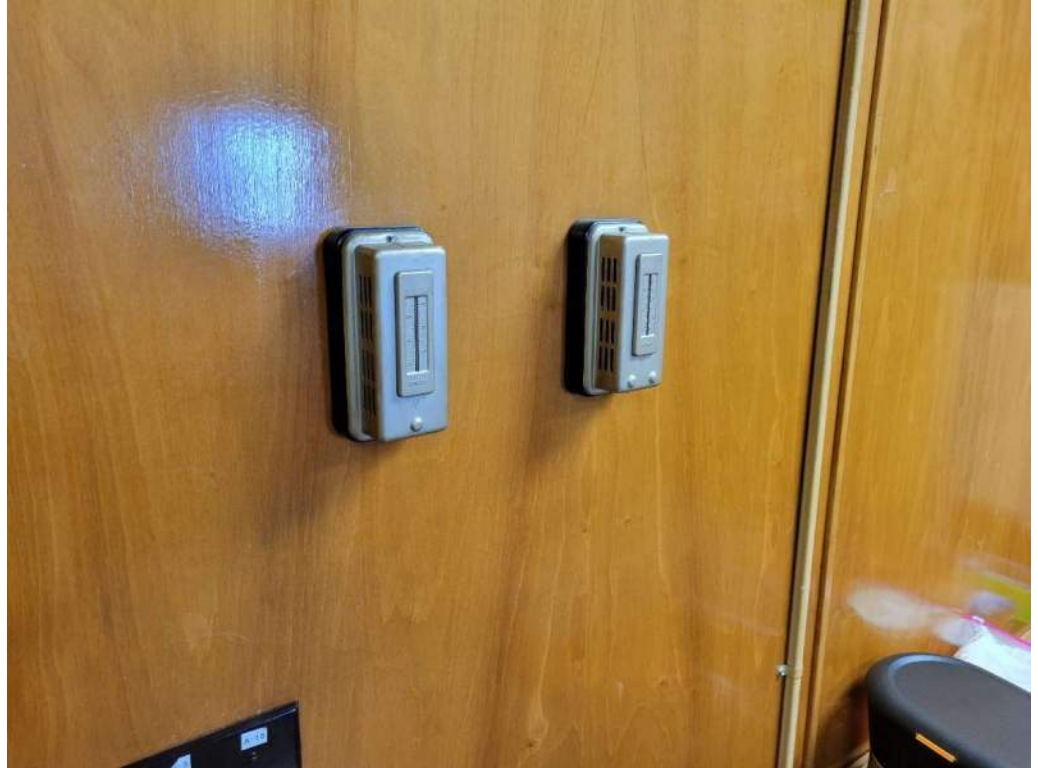
Example of Thermostats with Potential to Contain Mercury

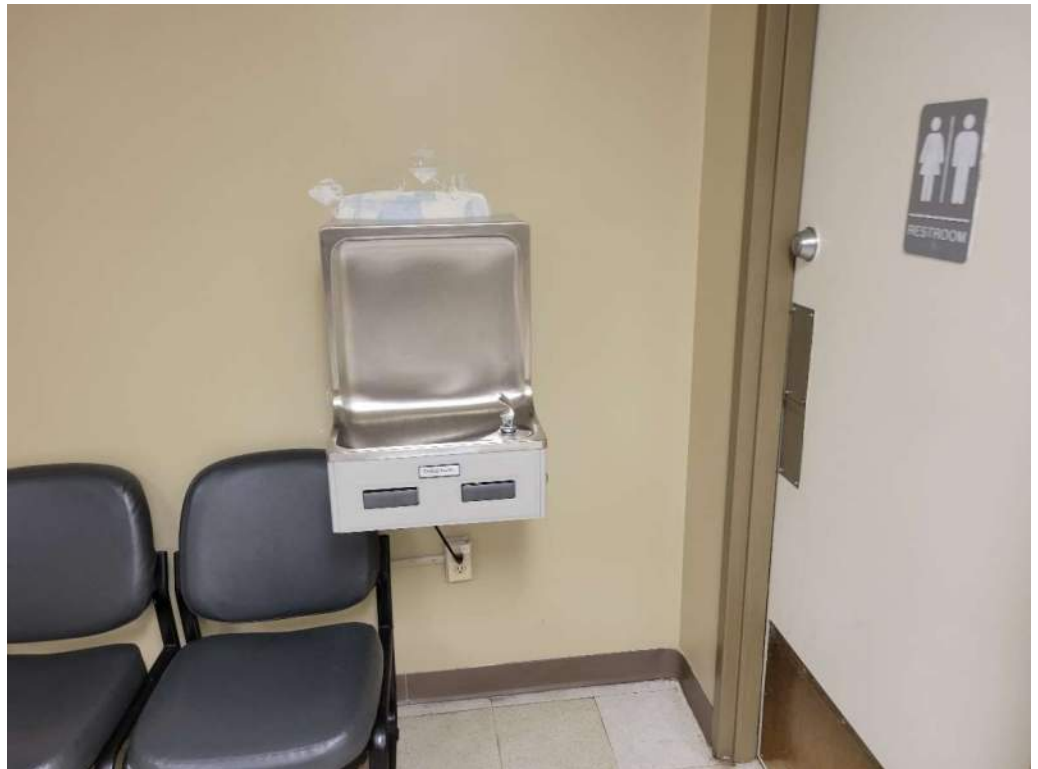
Example of Water Fountain with Possible Refrigerants to Be Recovered

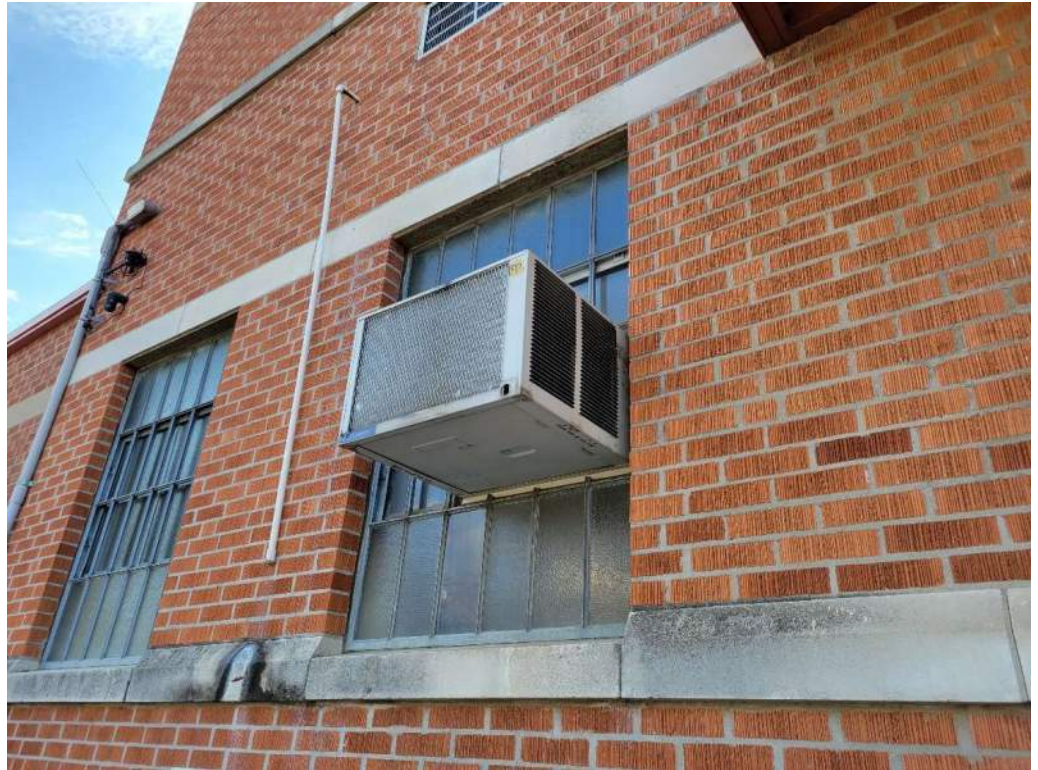
Example of HVAC Window Unit with Possible Refrigerants to Be Recovered

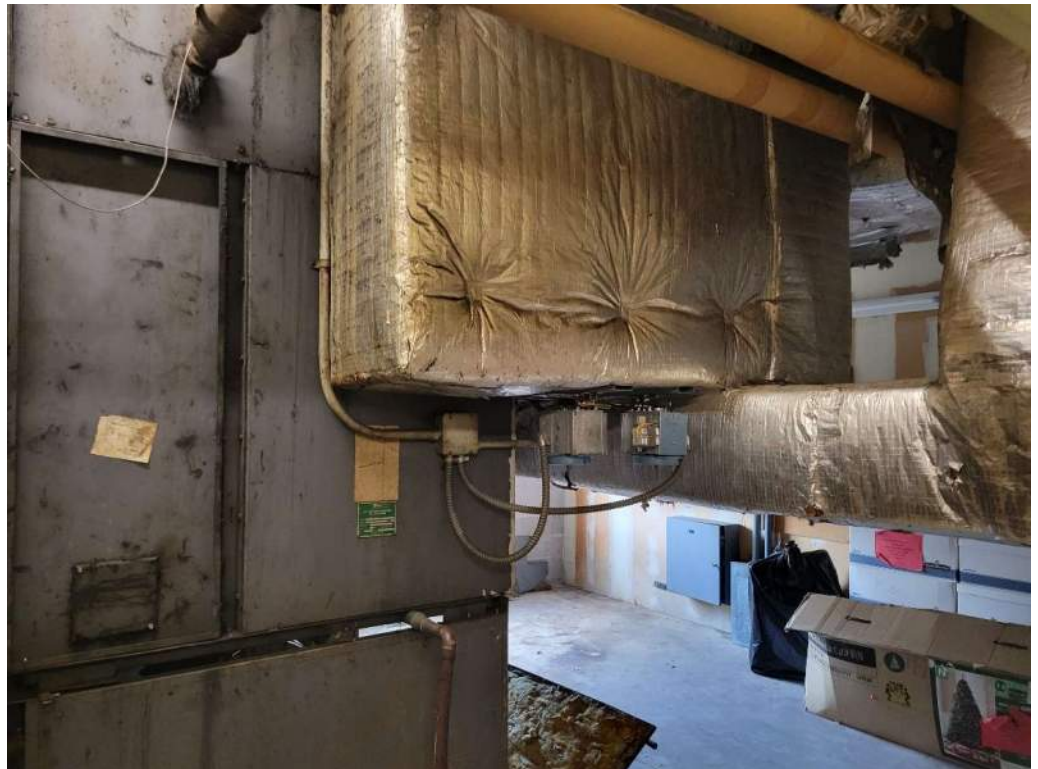
2nd Floor HVAC Unit with Possible Refrigerants to Be Recovered

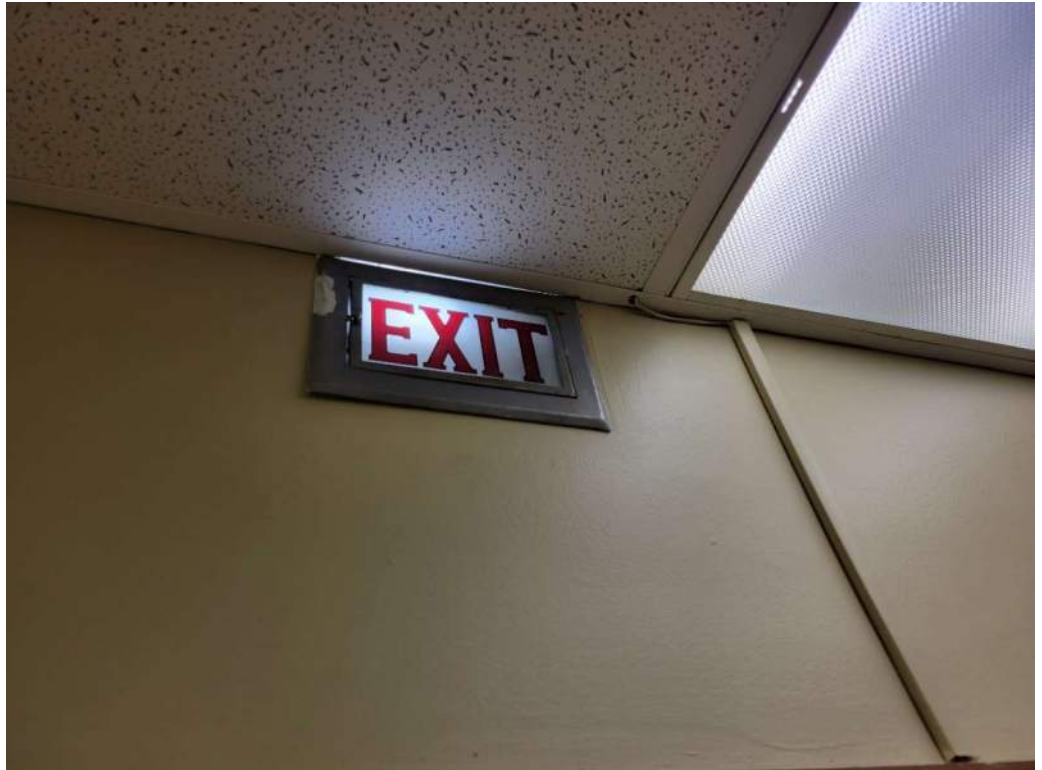
Example Exit Sign with Backup Battery
